# VEHICLE INSPECTION REPORT

**GY67TSV**

## Vauxhall Astra 1.4T 16V 150 SE 5dr

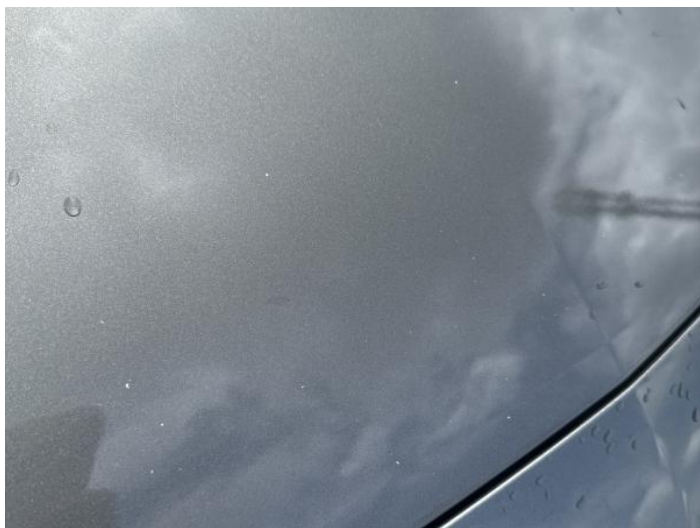
1: Bonnet  
Chipped  
Multiple Chips

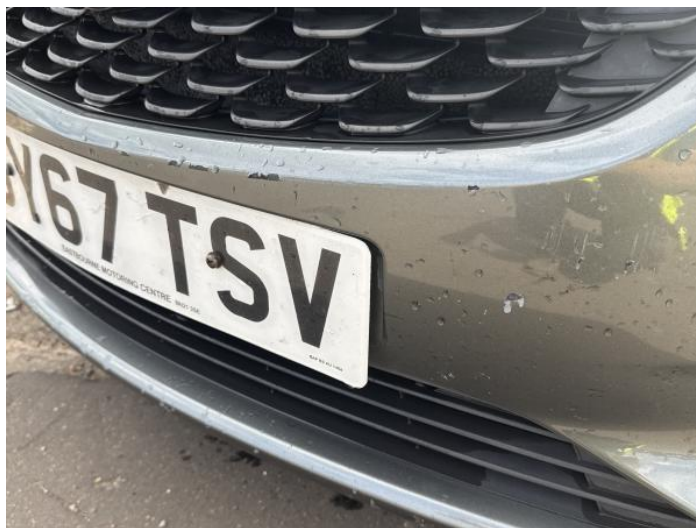
2: Bumper Front  
Scratched  
Over 100mm Thru Paint

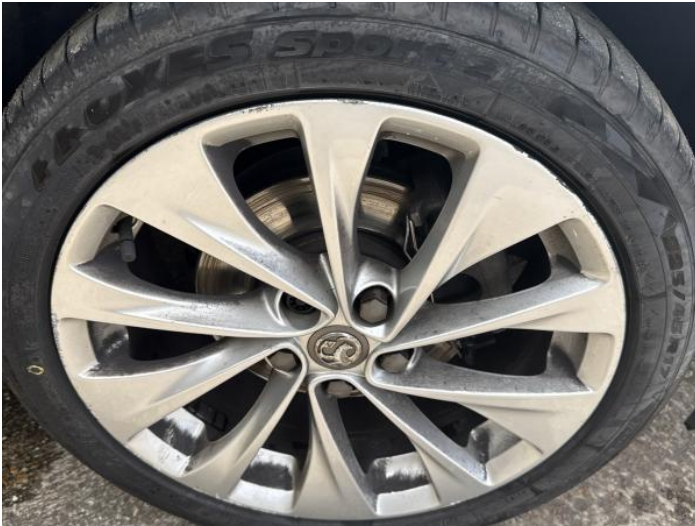
3: Wheel osf  
Scratched  
Over 50mm

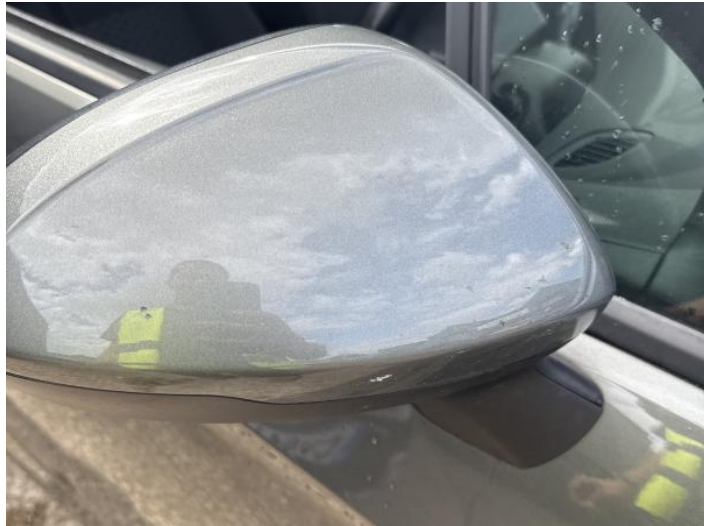
4: Door Mirror Assy osf  
Scratched (Painted)  
UpTo 25mm Thru Paint

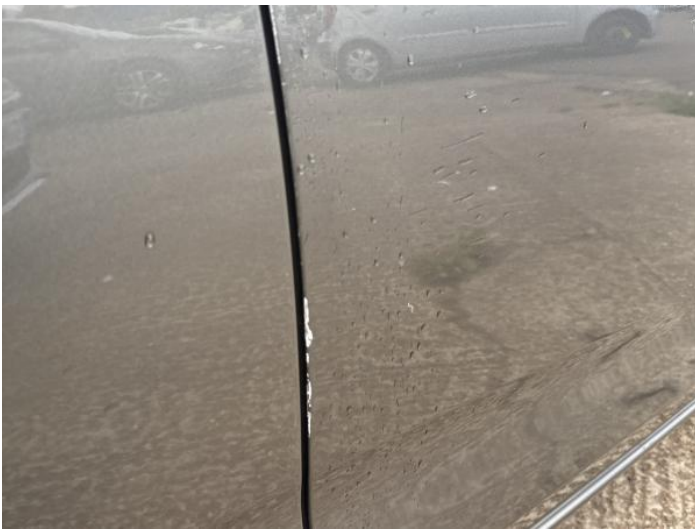
5: Door osf  
Scratched  
Over 25mm Thru Paint

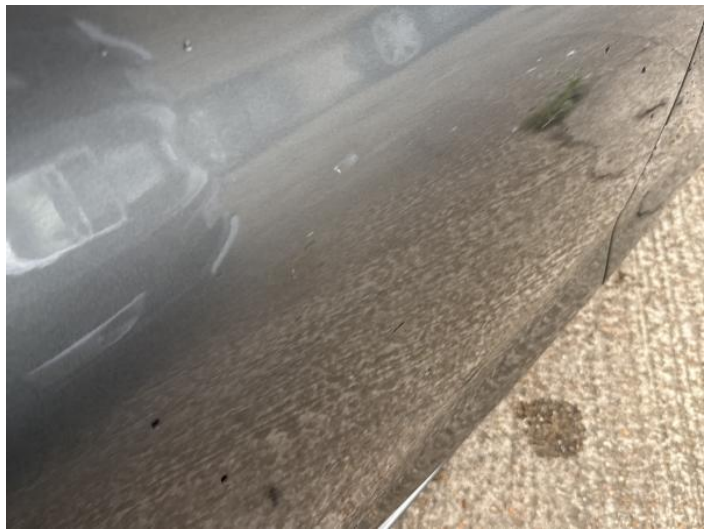
6: Door osr  
Dented  
With Paint Damage

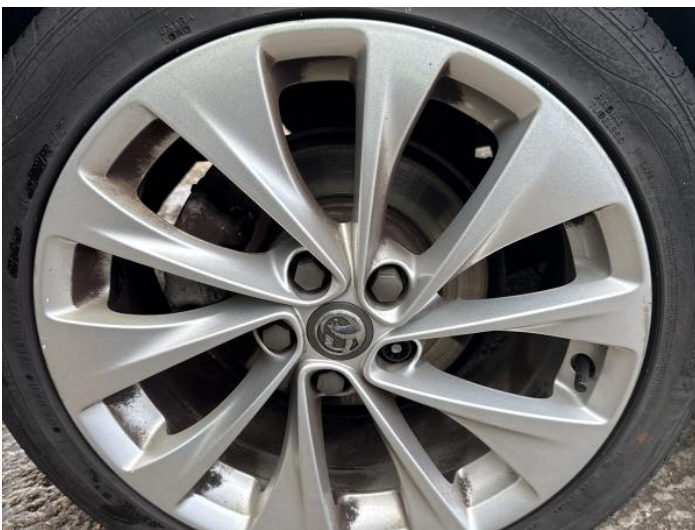
7: Wheel osr  
Scratched  
Over 50mm

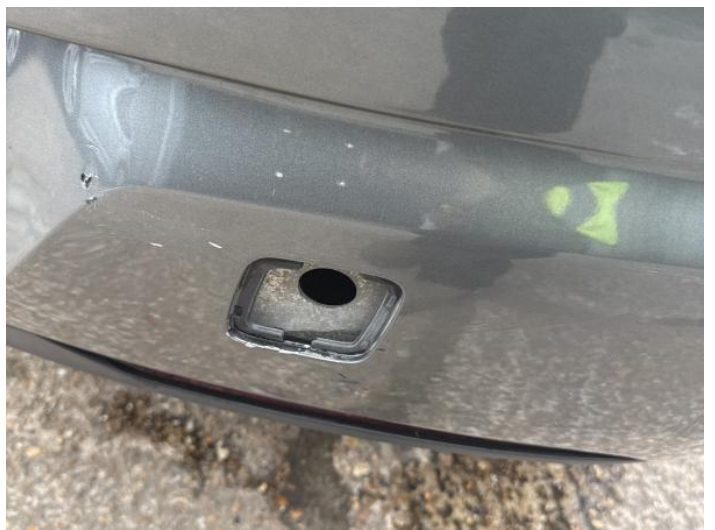
8: Rear TowEye Cvr  
Missing  
Replace

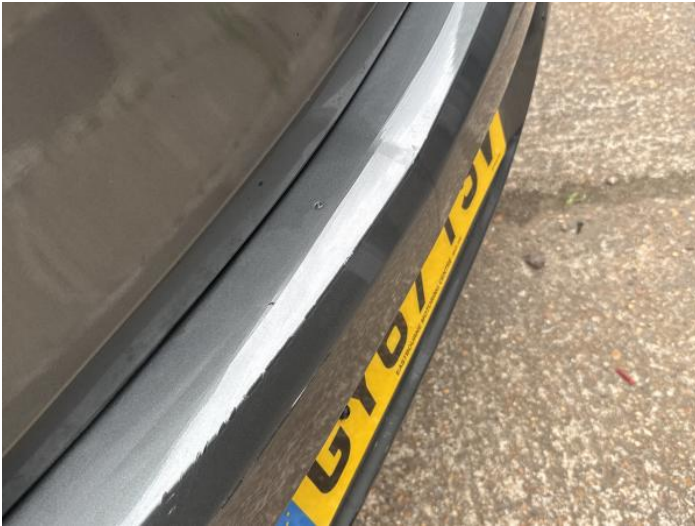
9: Bumper Rear  
Scratched  
Over 100mm Thru Paint

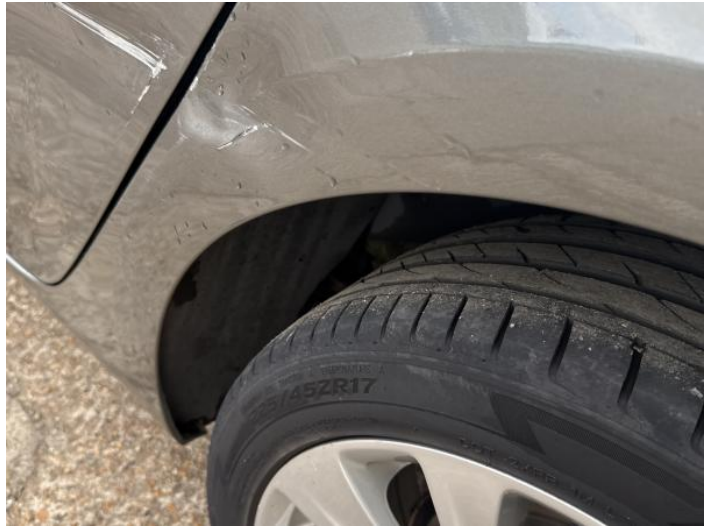
10: Qtr Panel nsr  
Dented  
Over 30mm

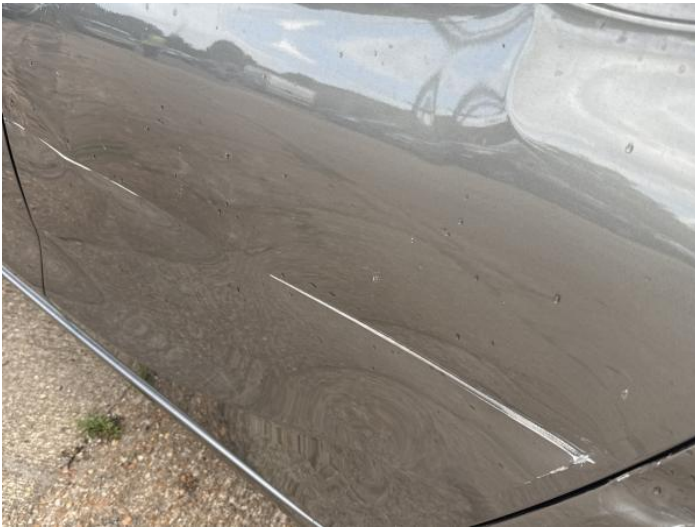
11: Door nsr  
Dented  
Over 30% Of Panel

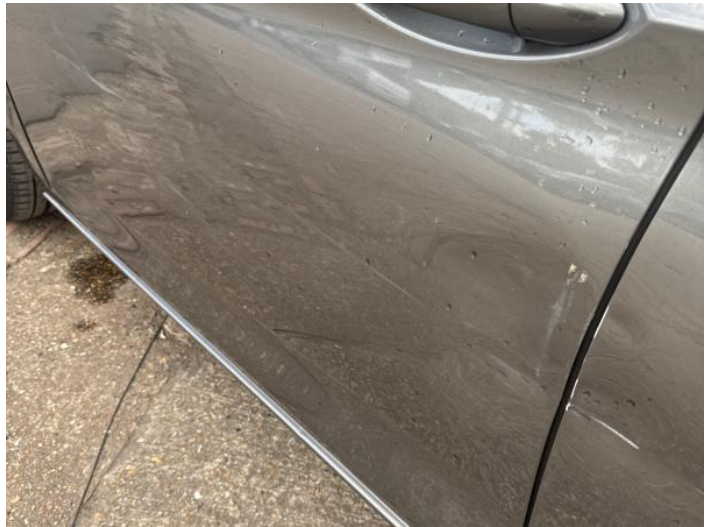
12: Door nsf  
Dented  
With Paint Damage

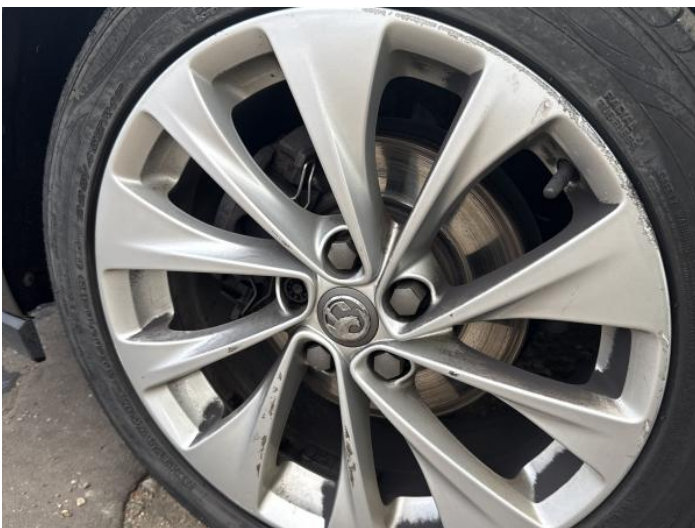
13: Wheel nsf  
Scratched  
Over 50mm

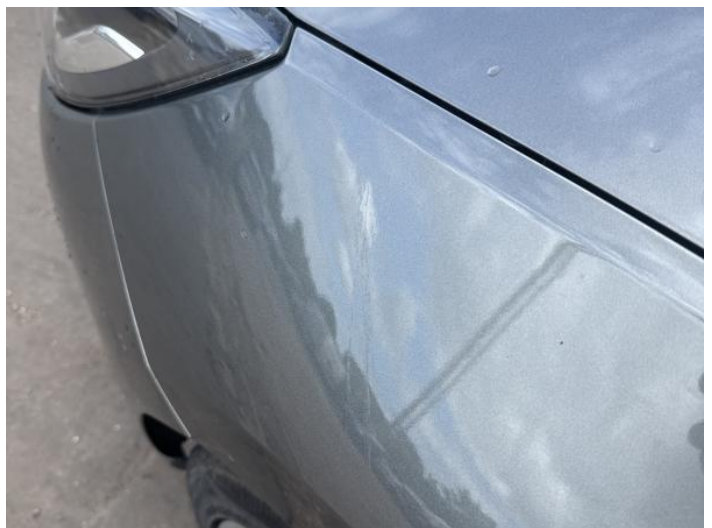
14: Wing nsf  
Scratched  
Over 25mm Not Thru Paint
