VEHICLE INSPECTION REPORT

BA19WOB

Nissan Leaf 110kW Tekna 40kWh 5dr Auto

nama
GRADE
3

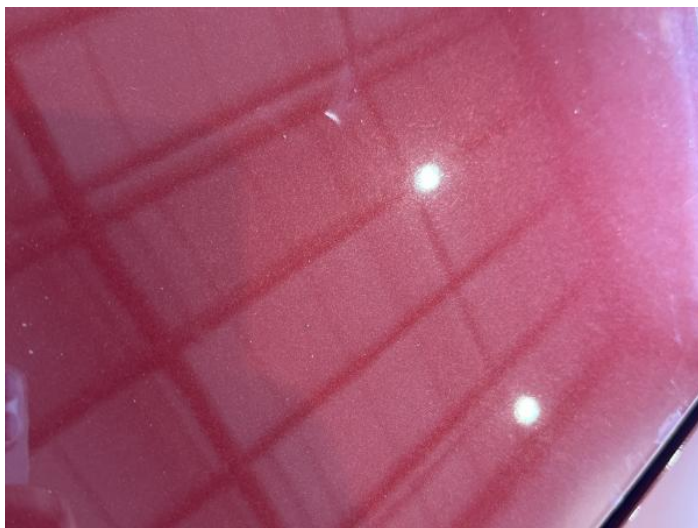
1: Bonnet
Chipped
1 To 5

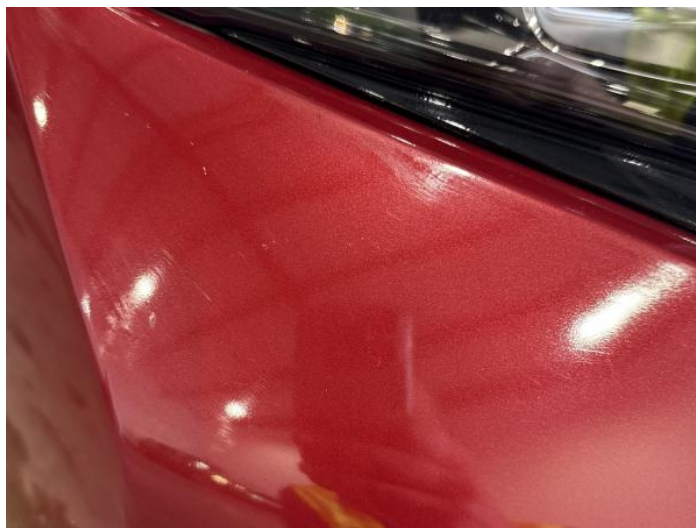
2: Bumper Front
Poor Previous Repair
Poor Paint

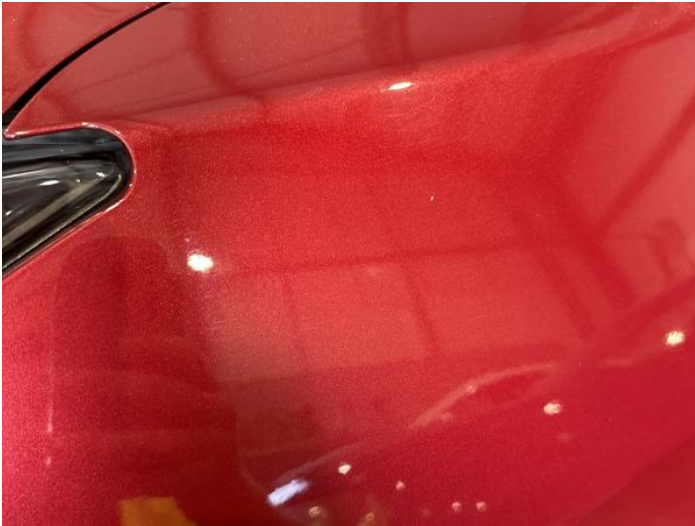
3: Wing nsf
Chipped
1 To 5

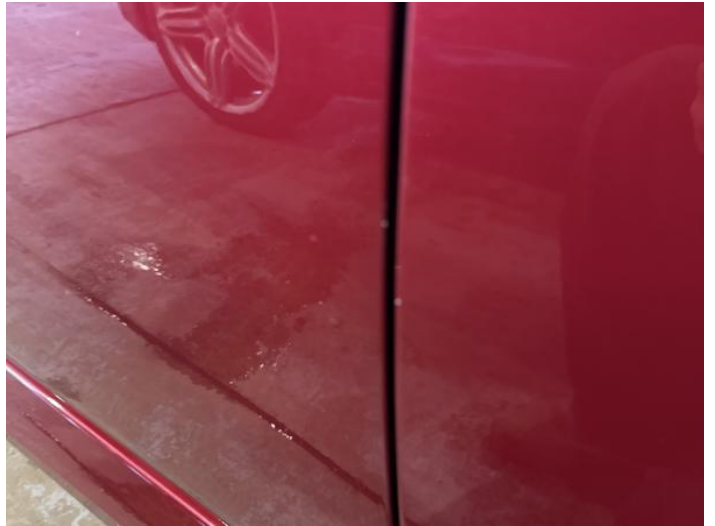
4: Door nsf
Chipped
Edge Chip

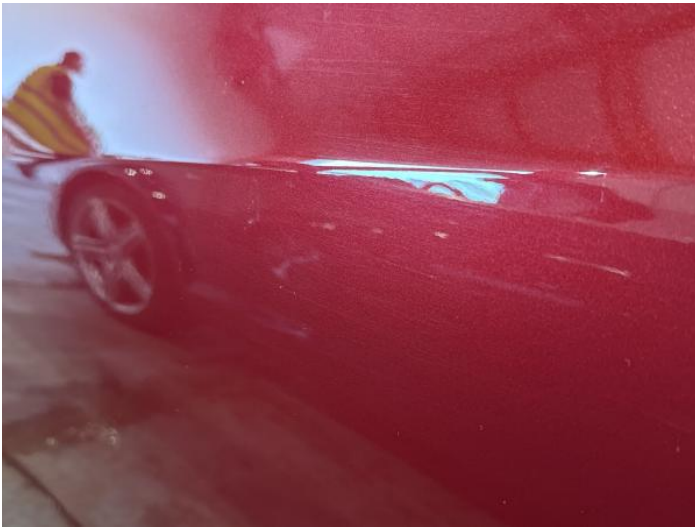
5: Door nsr
Scratched
UpTo 25mm Thru Paint

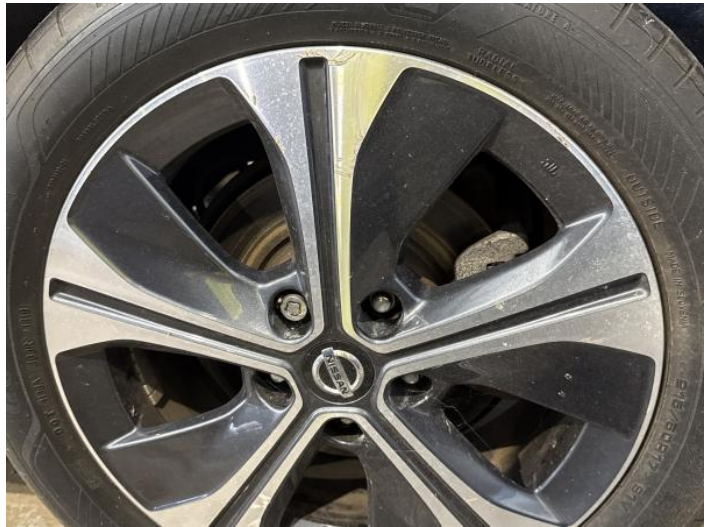
6: Wheel nsr
Scratched
Over 50mm

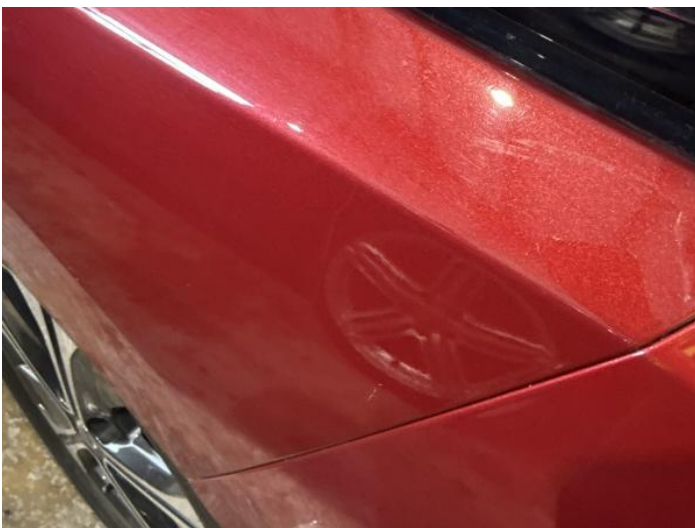
7: Qtr Panel nsr
Scratched
UpTo 25mm Thru Paint

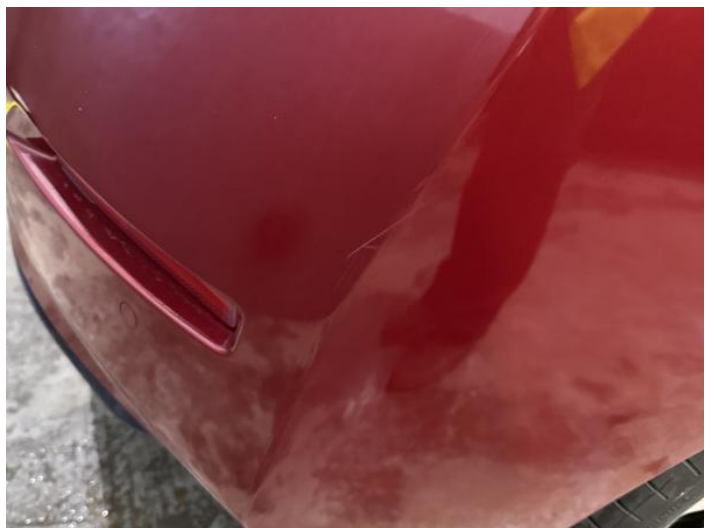
8: Bumper Rear
Scratched
25 to 100mm Thru Paint

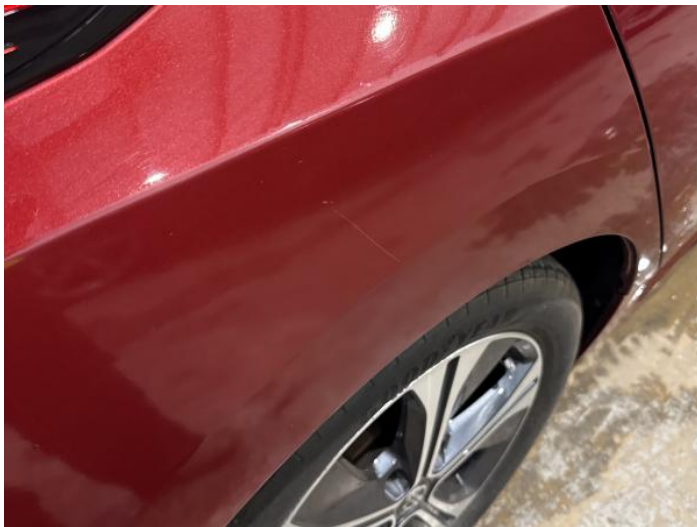
9: Qtr Panel osr
Poor Previous Repair
Poor Paint

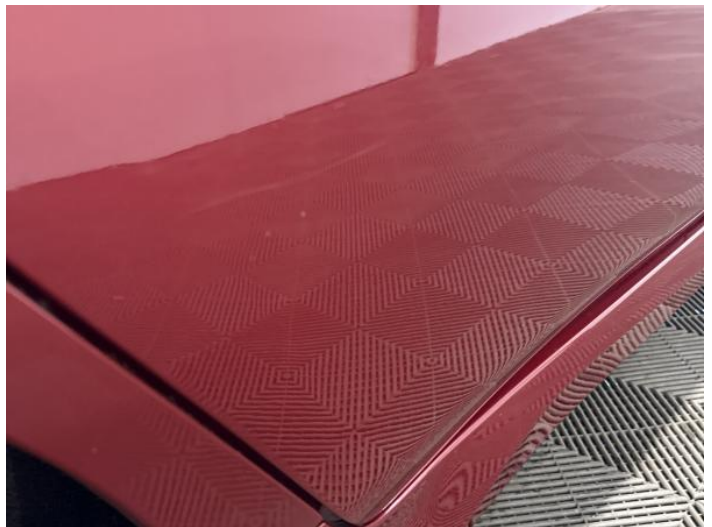
10: Door osr
Scratched
Over 25mm Thru Paint

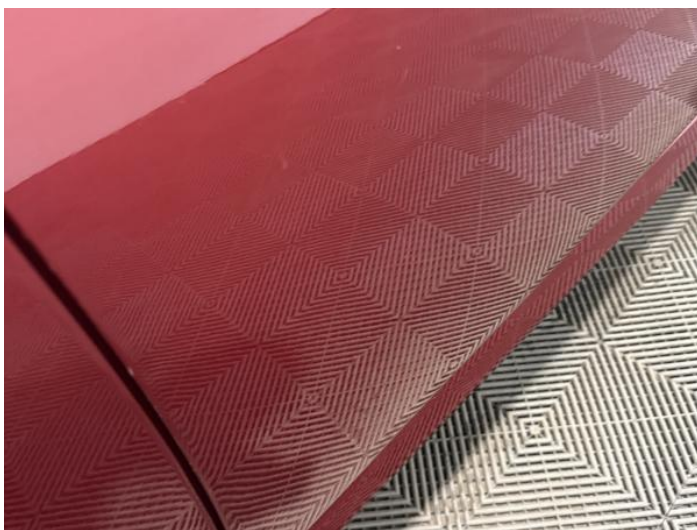
11: Door osf
Scratched
UpTo 25mm Thru Paint

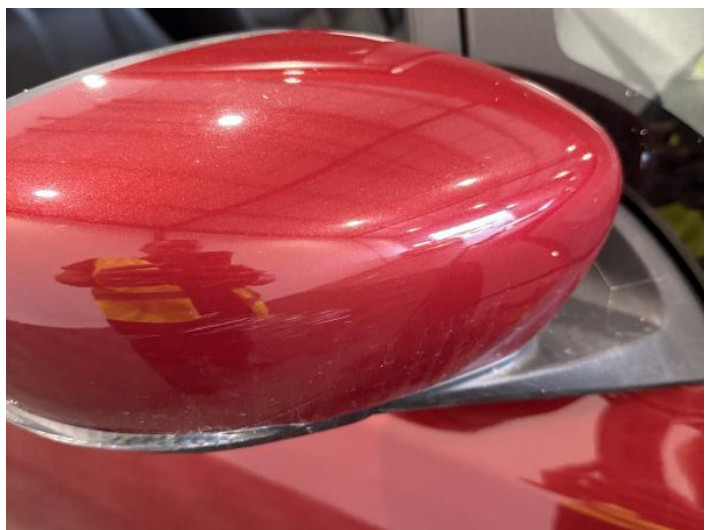
12: Door Mirror Assy osf
Scratched (Painted)
Over 25mm Thru Paint

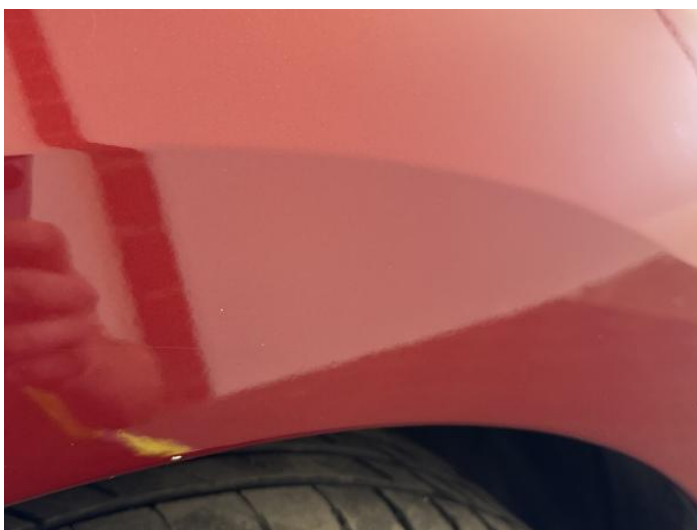
13: Wing osf
Chipped
1 To 5

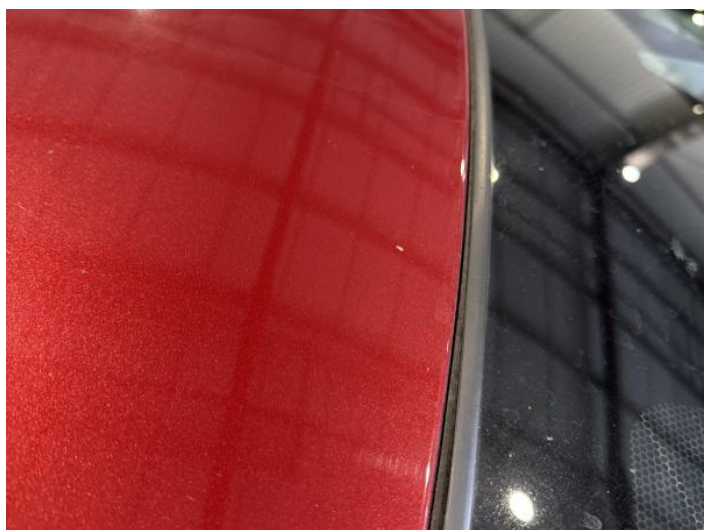
14: Roof
Chipped
1 To 5
