# VEHICLE INSPECTION REPORT

**GY71JWO**

## MG Mg 5 EXCLUSIVE

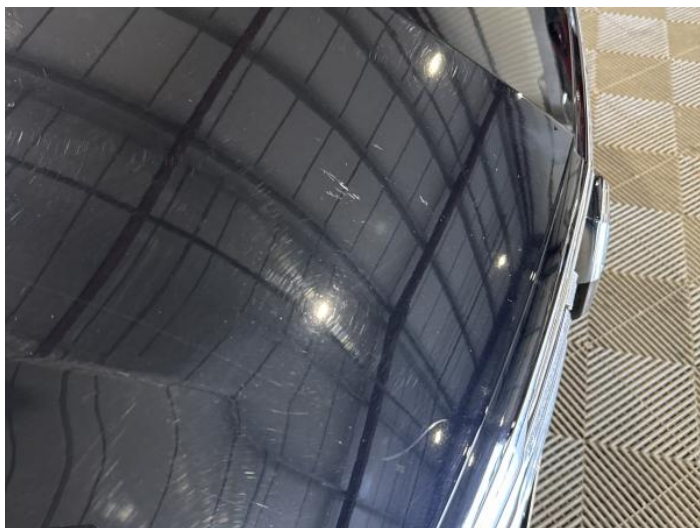
1: Bonnet  
Scratched  
Over 25mm Thru Paint

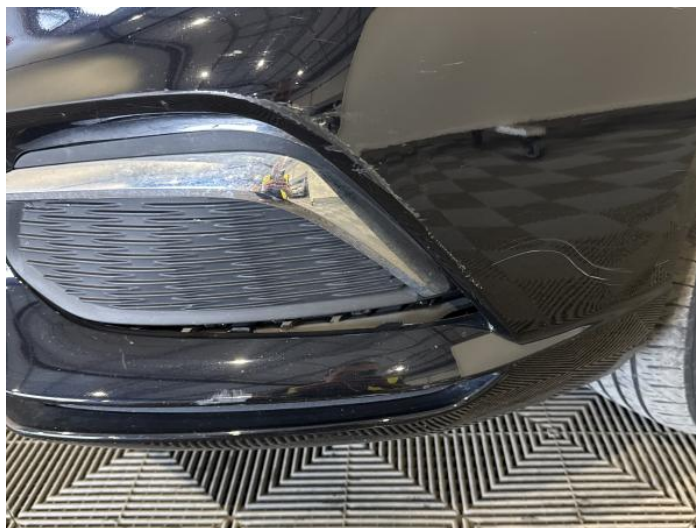
2: Bumper Front  
Scratched  
Over 100mm Thru Paint

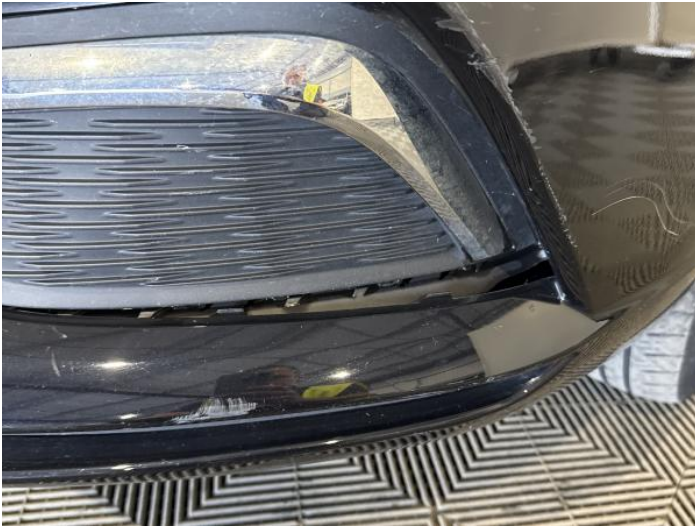
3: Bumper Front Moulding  
Scuffed (Unpainted)  
Over 100mm

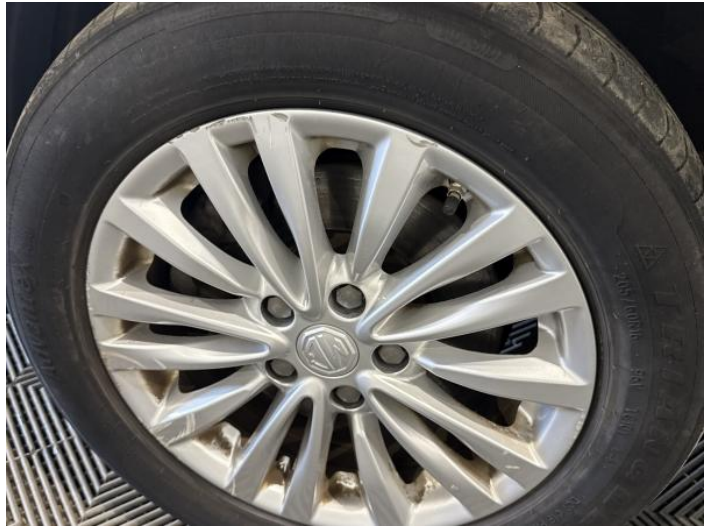
4: Wheel nsf  
Scratched  
Over 50mm

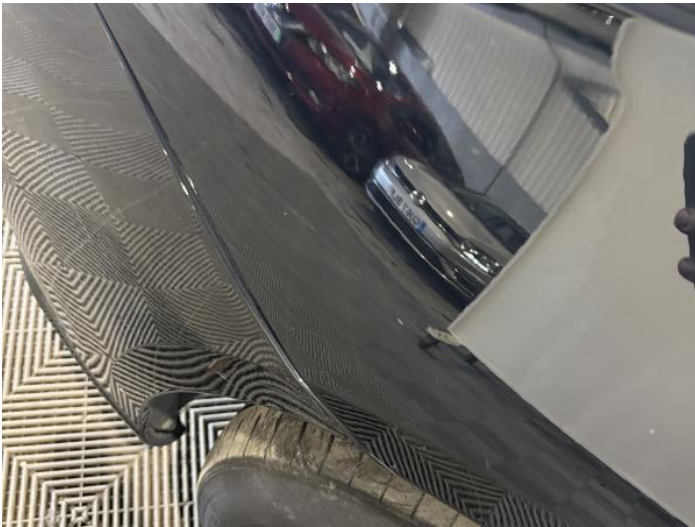
5: Wing nsf  
Scratched  
Over 25mm Thru Paint

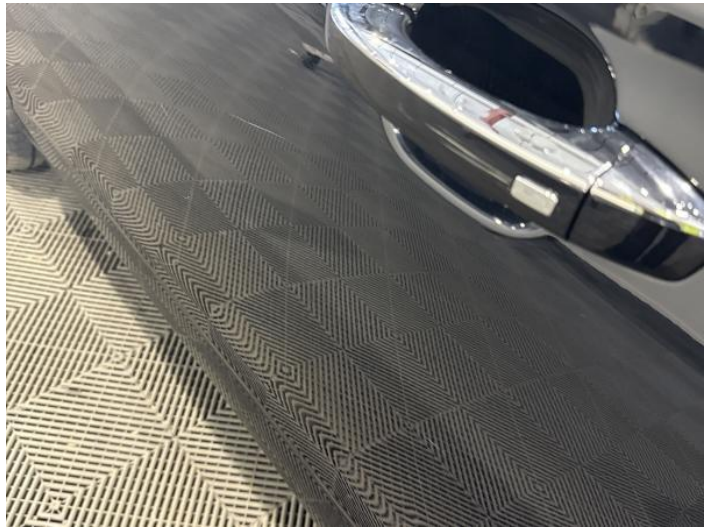
6: Door nsf  
Scratched  
Over 25mm Thru Paint

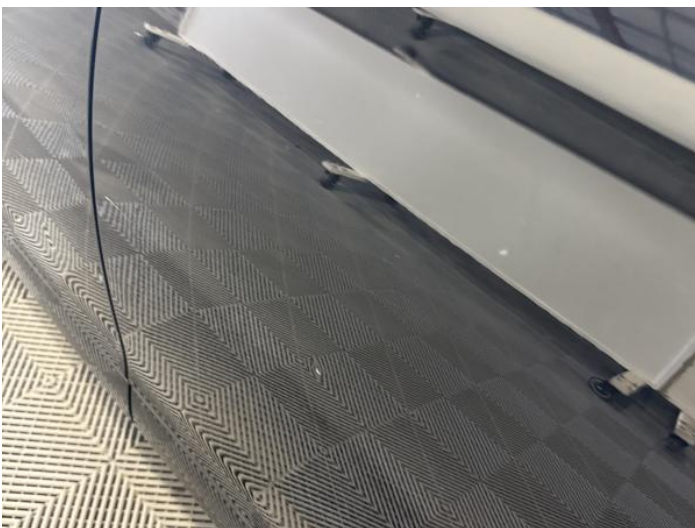
7: Door nsr  
Dented  
With Paint Damage

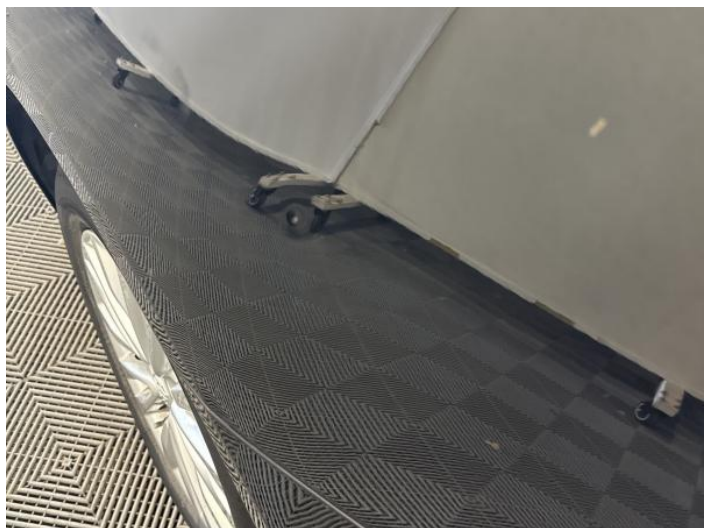
8: Qtr Panel nsr  
Dented  
Between 10mm + 30mm

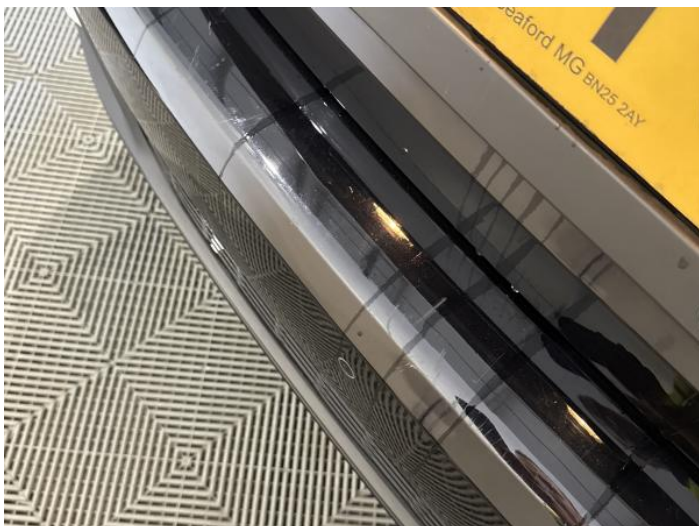
9: Bumper Rear  
Scratched  
25 to 100mm Thru Paint

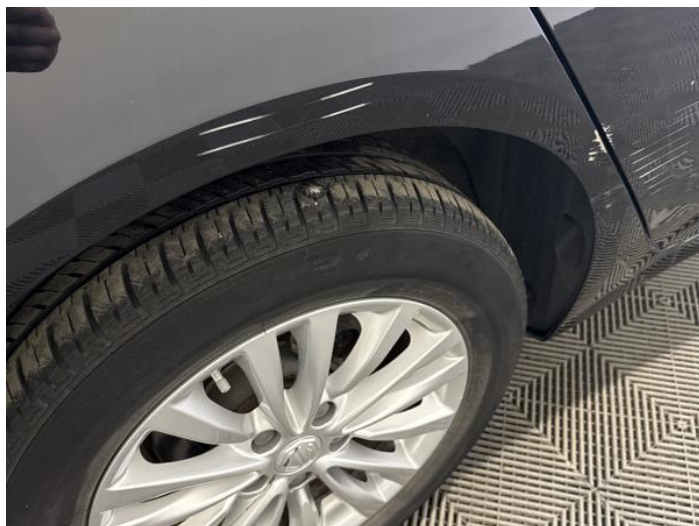
10: Qtr Panel osr  
Dented  
With Paint Damage

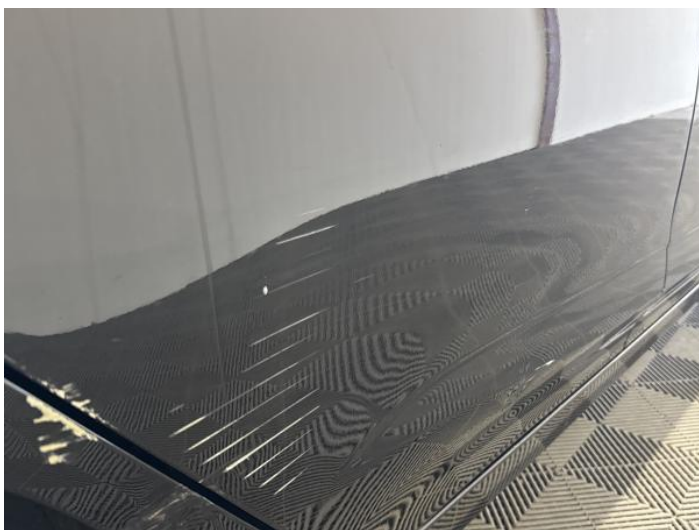
11: Door osr  
Dented  
With Paint Damage

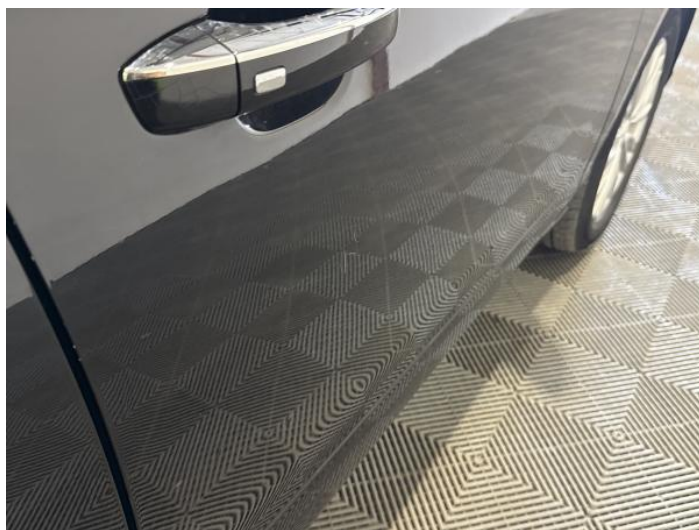
12: Door osf  
Dented  
Over 30mm

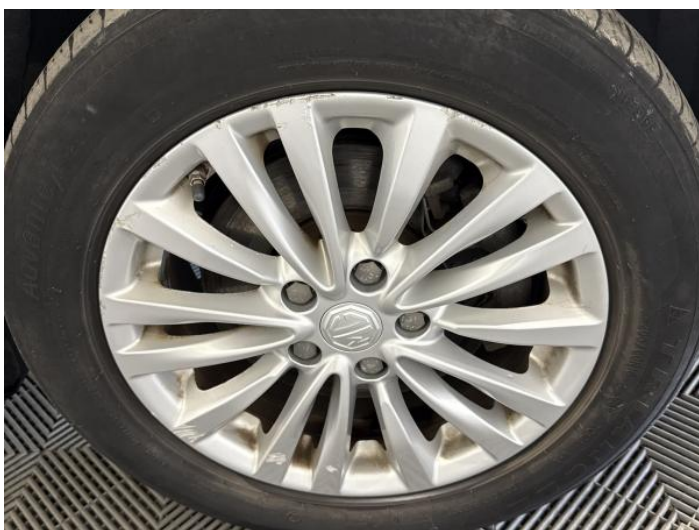
13: Wheel osf  
Scratched  
Over 50mm

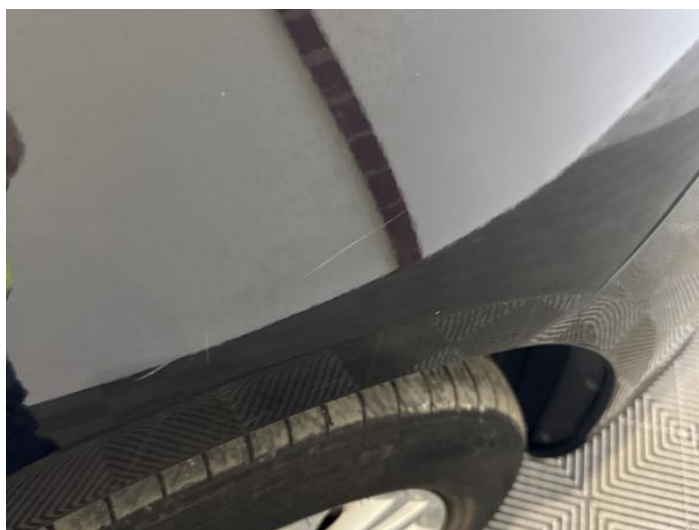
14: Wing osf  
Scratched  
Over 25mm Thru Paint

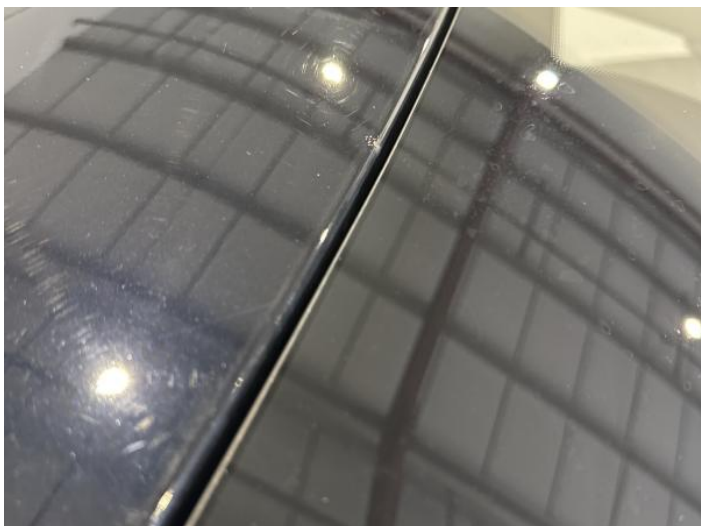
15: Roof  
Chipped  
Edge Chip
