VEHICLE INSPECTION REPORT

LN64DXR

Ford S-Max 2.2 TDCi 200 Titanium X Sport 5dr

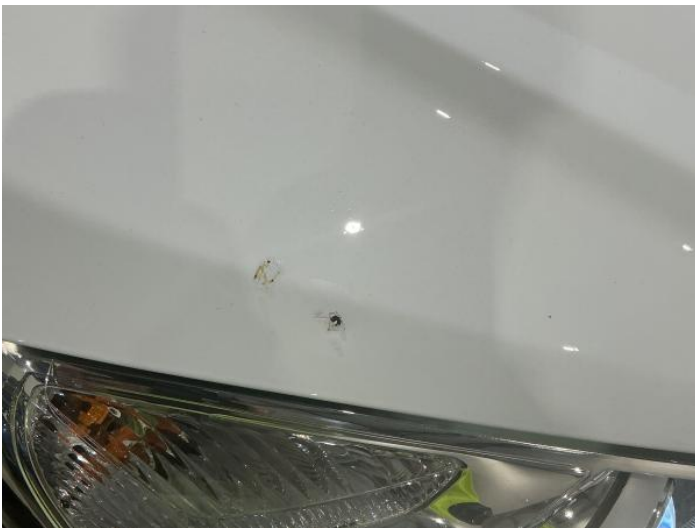
1: Bonnet
Chipped
Over 5mm

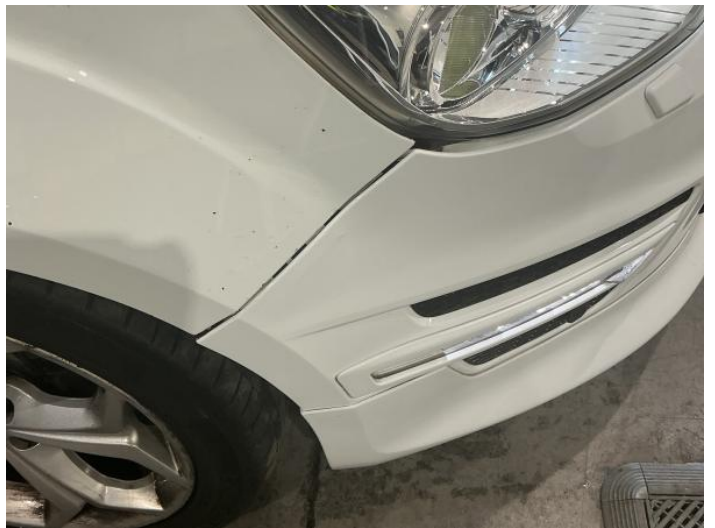
2: Bumper Front
Insecure
Action Required

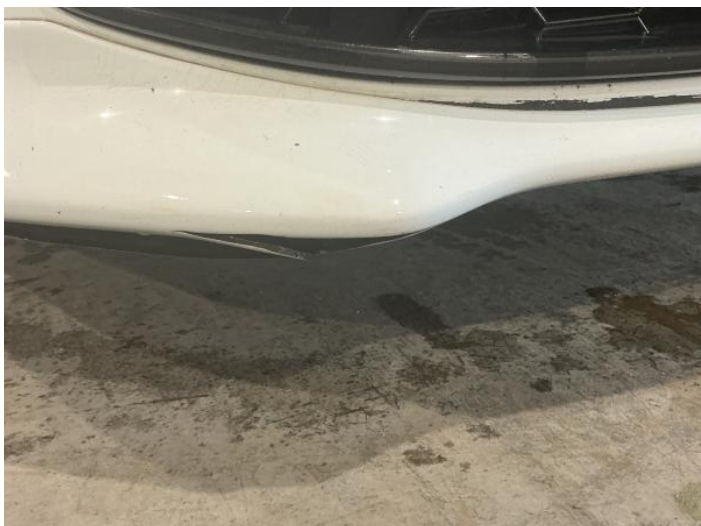
3: Bumper Front
Cracked
Over 25mm

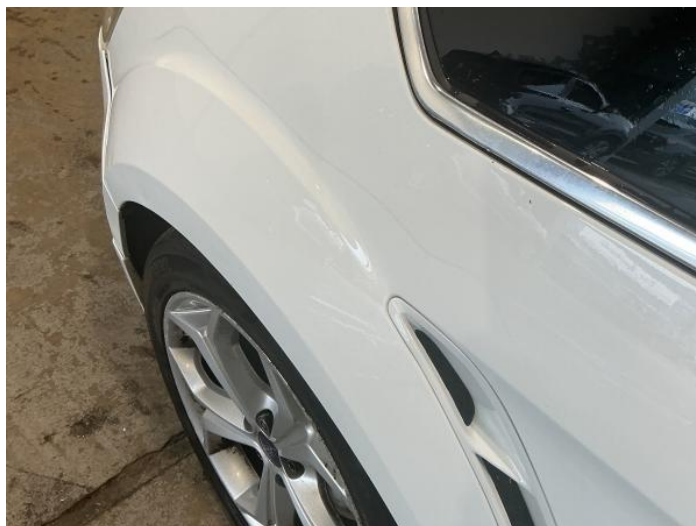
4: Wing nsf
Dented
With Paint Damage

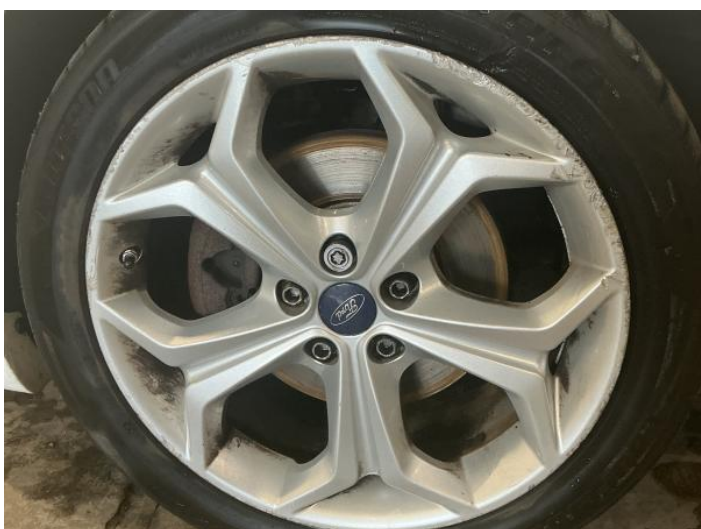
5: Wheel nsf
Scratched
Over 50mm

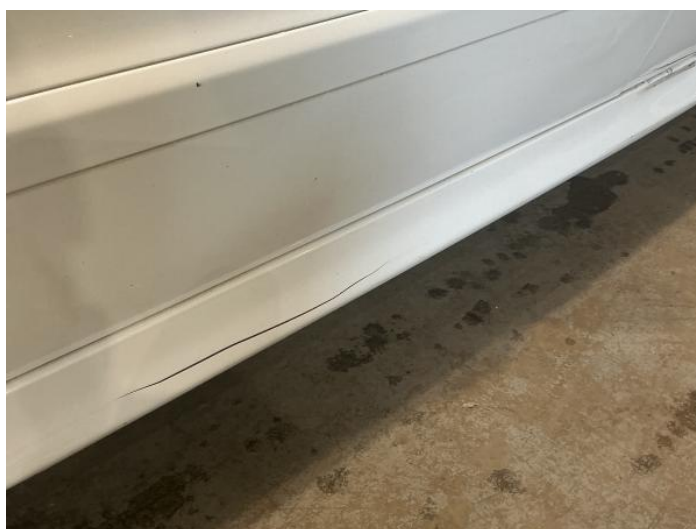
6: Sill Panel Trim ns
Broken
Replace

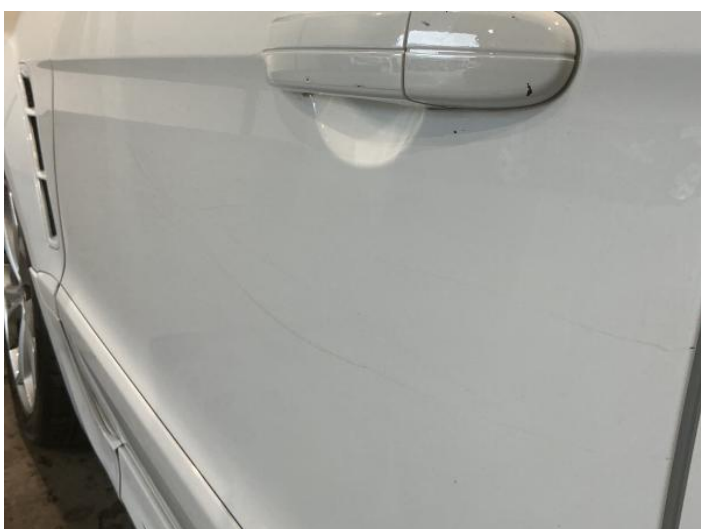
7: Door nsf
Scratched
Over 25mm Thru Paint

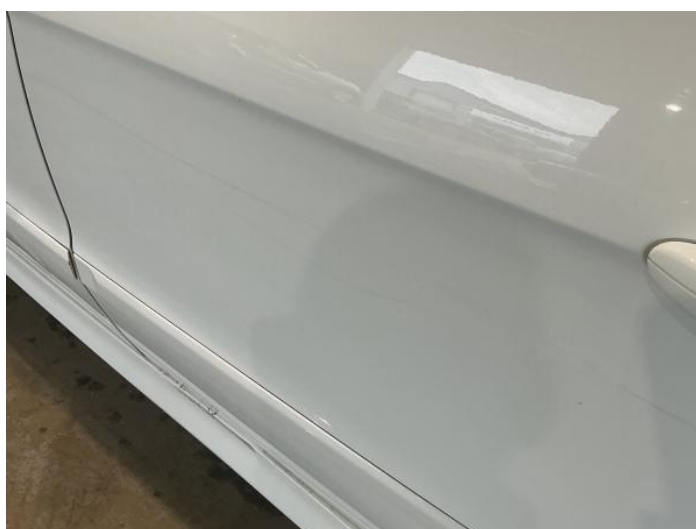
8: Door nsr
Scratched
Over 25mm Thru Paint

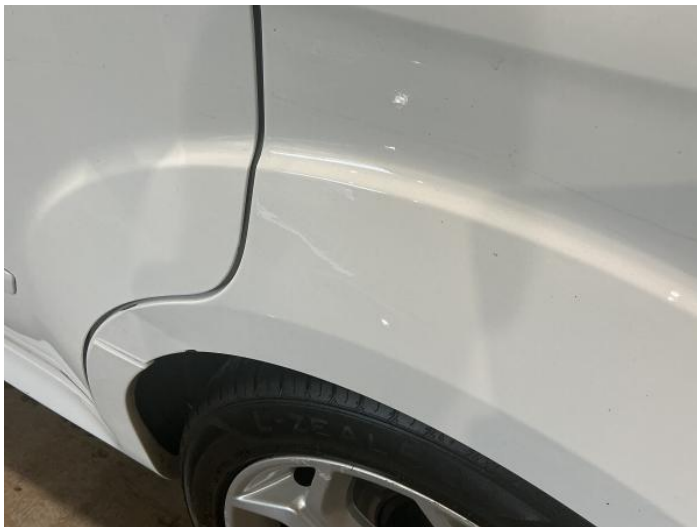
9: Qtr Panel nsr
Dented
With Paint Damage

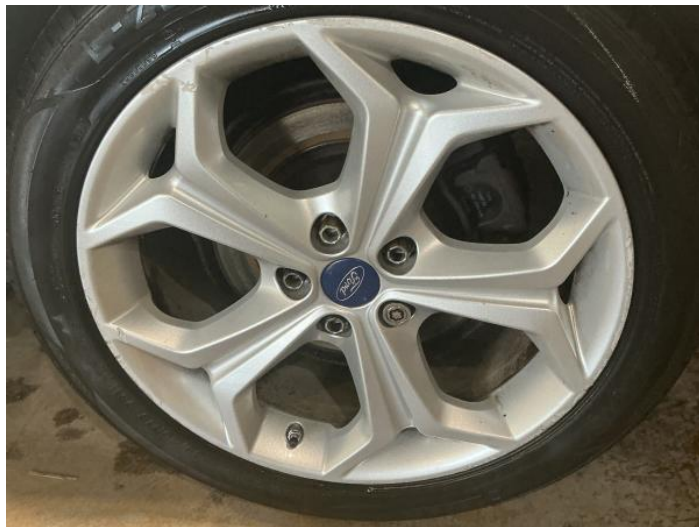
10: Wheel nsr
Scratched
Over 50mm

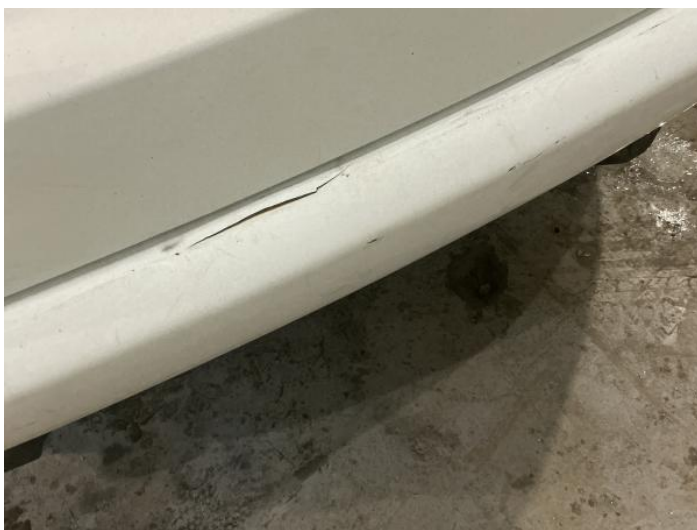
11: Bumper Rear
Cracked
Over 25mm

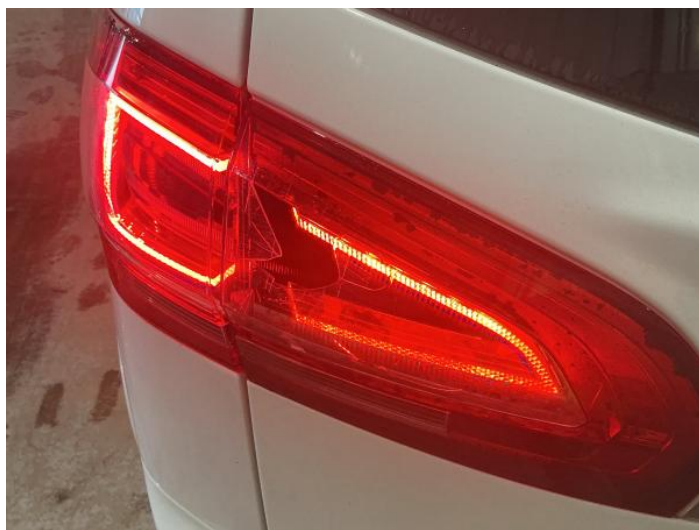
12: Lamp nsr
Broken
Replace

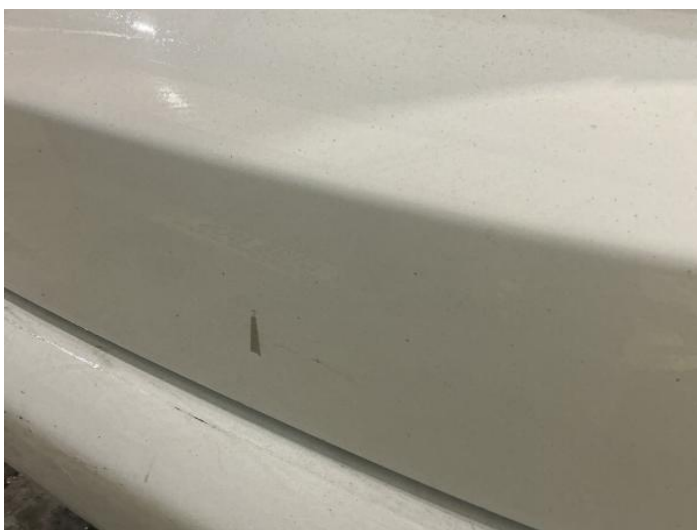
13: Tailgate
Dented
Between 10mm + 30mm

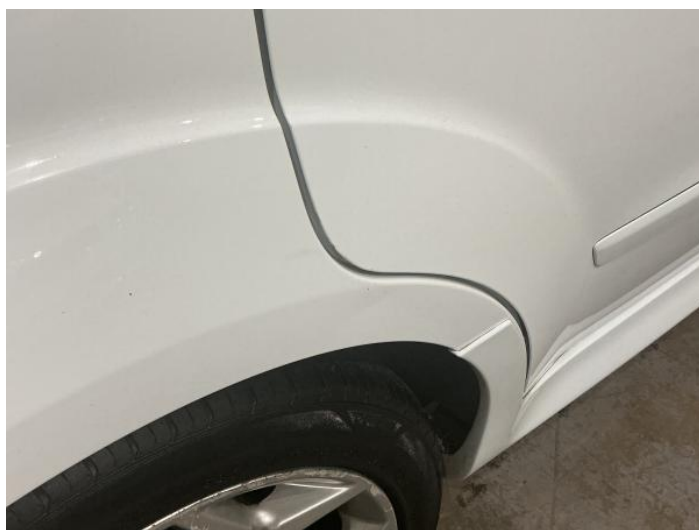
14: Qtr Panel osr
Dented
Between 10mm + 30mm

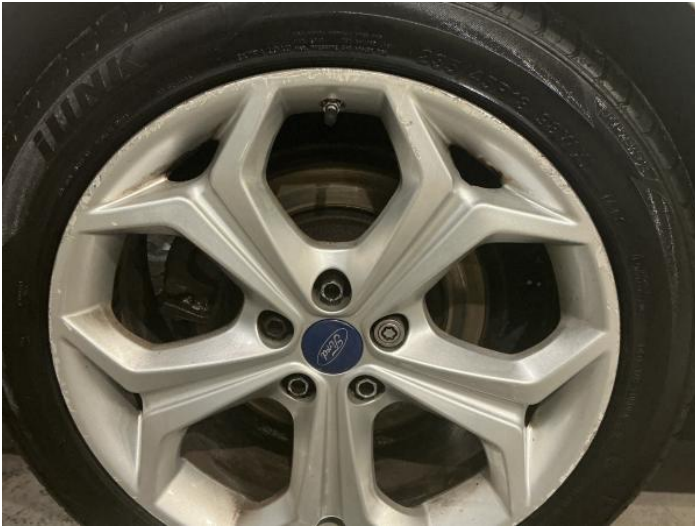
15: Wheel osr
Scratched
Over 50mm

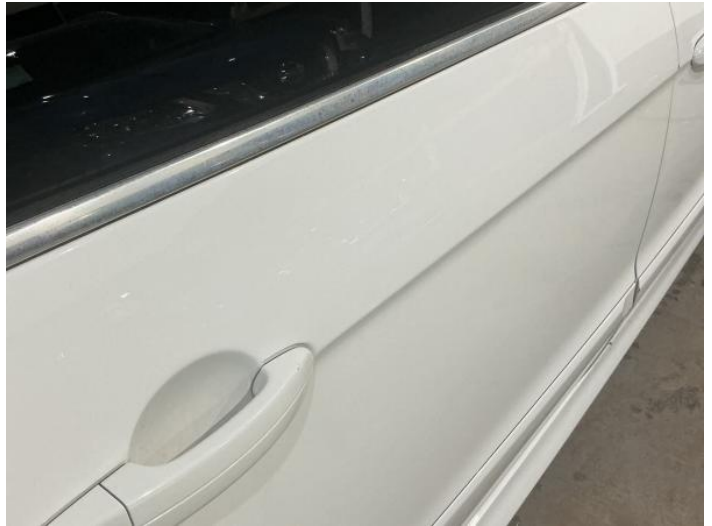
16: Door osr
Dented
Between 10mm + 30mm

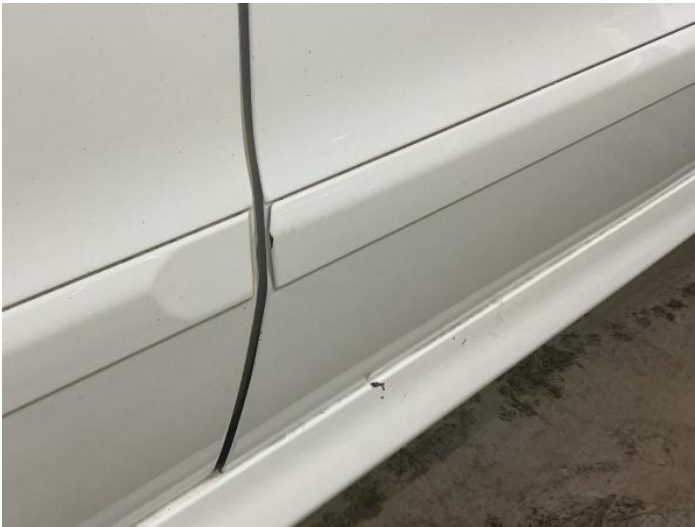
17: Door osf
Chipped
Edge Chip

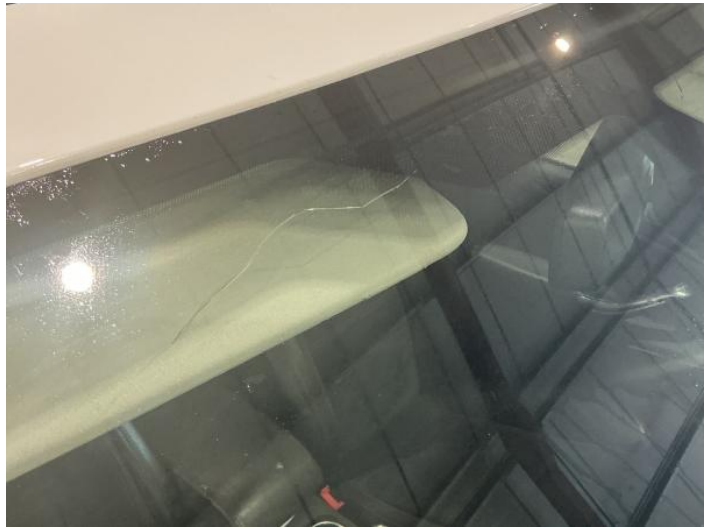
18: Screen Front
Cracked
Replace

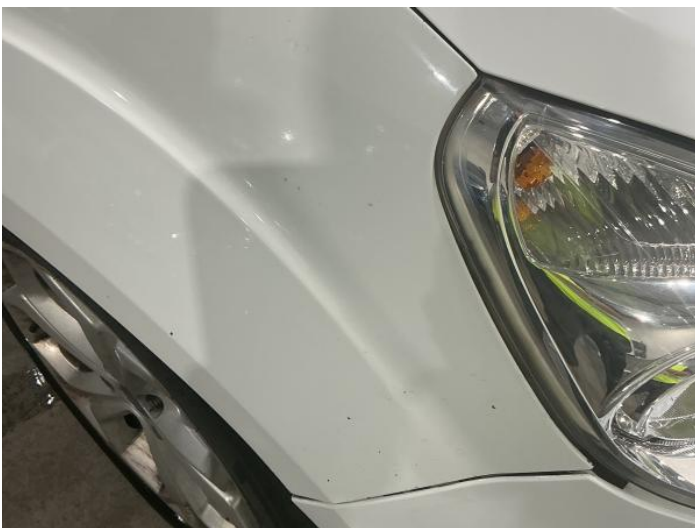
19: Wing osf
Chipped
Multiple Chips

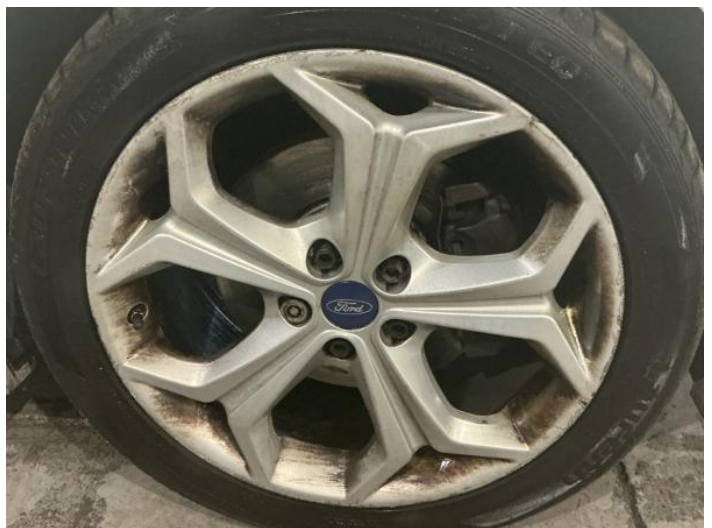
20: Wheel osf
Scratched
Over 50mm
