VEHICLE INSPECTION REPORT

GU70ULK

Audi A5 40 TFSI Edition 1 5dr S Tronic

nama
GRADE
4

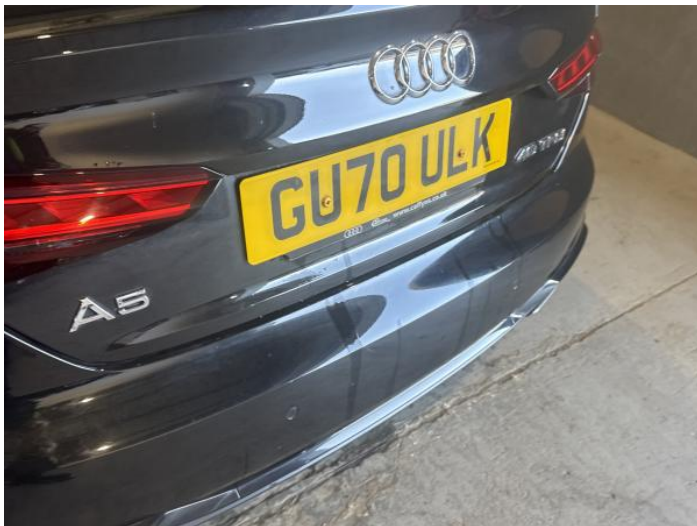
1: Bumper Rear
Chipped
Multiple Chips

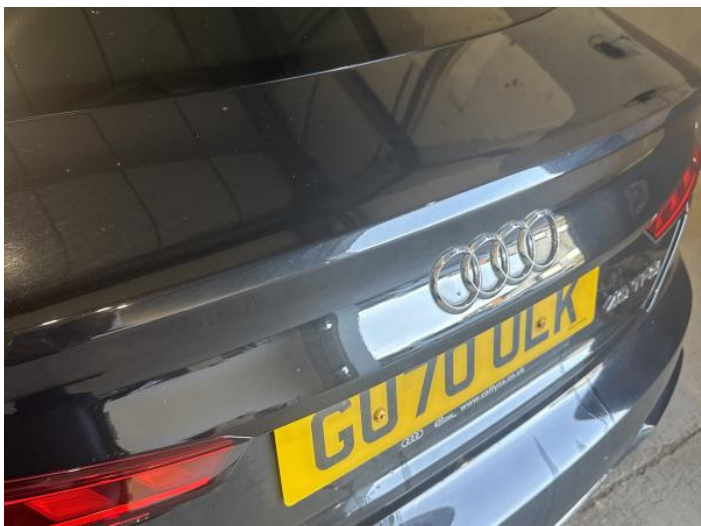
3: Boot Lid
Chipped
1 To 5

4: Boot Lid
Scratched
Over 25mm Not Thru Paint

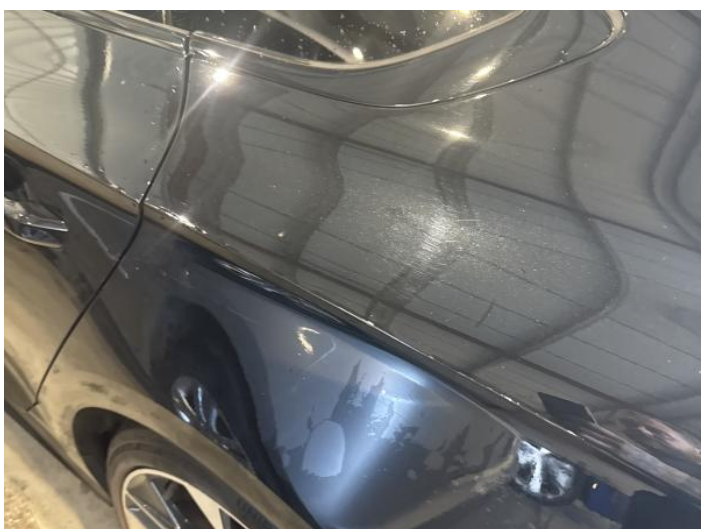
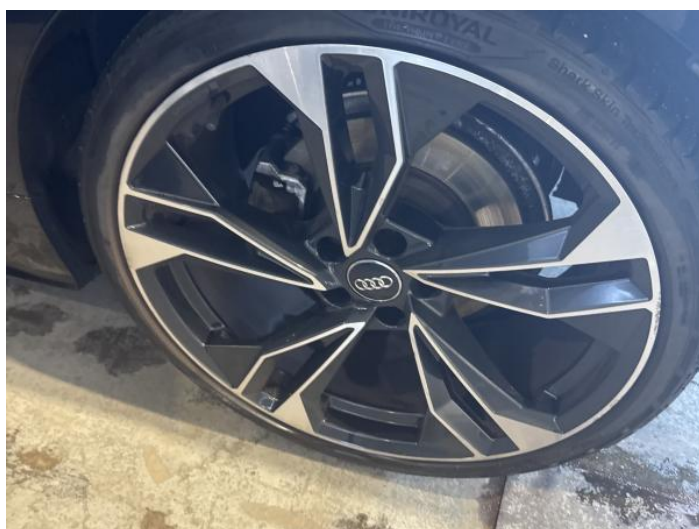
5: Qtr Panel nsr
Dented
With Paint Damage

6: Wheel nsr
Scratched
Over 50mm

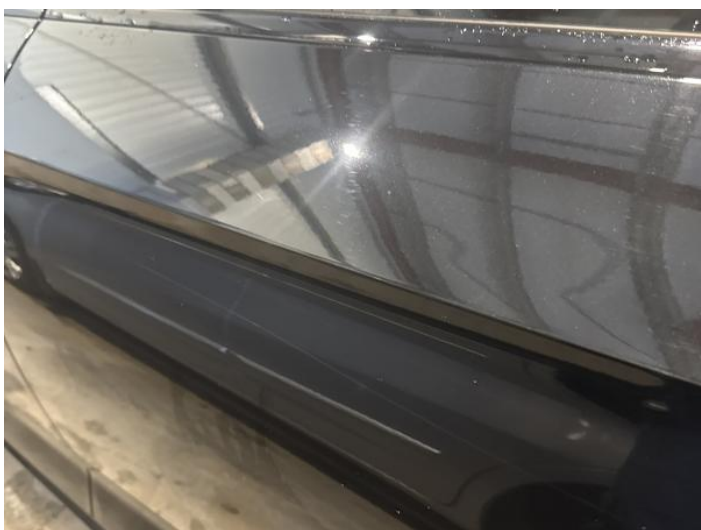
7: Door nsr
Chipped
1 To 5

8: Door nsr
Scratched
Over 25mm Not Thru Paint

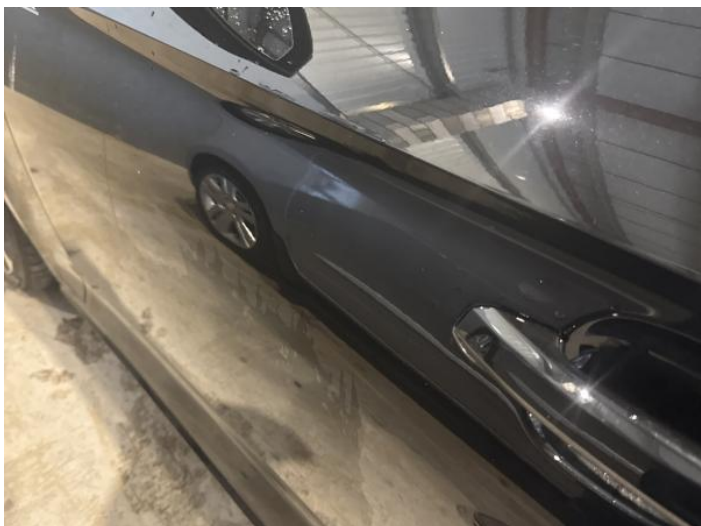
9: Door nsf
Dented
Over 2 UpTo 10mm

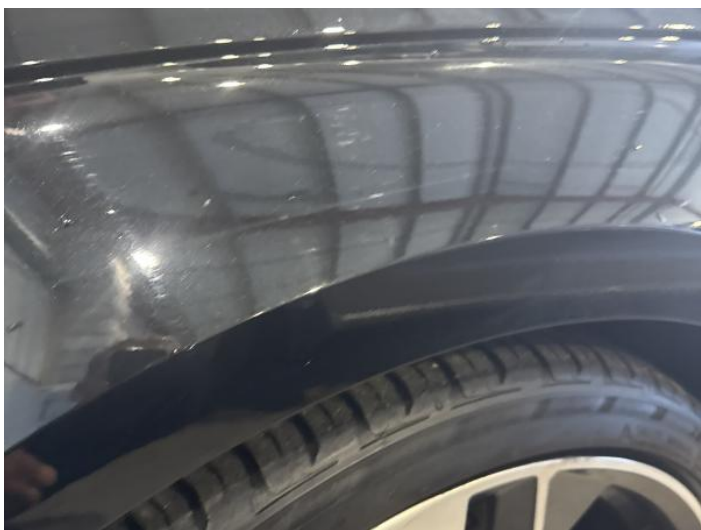
11: Wing nsf
Chipped
1 To 5

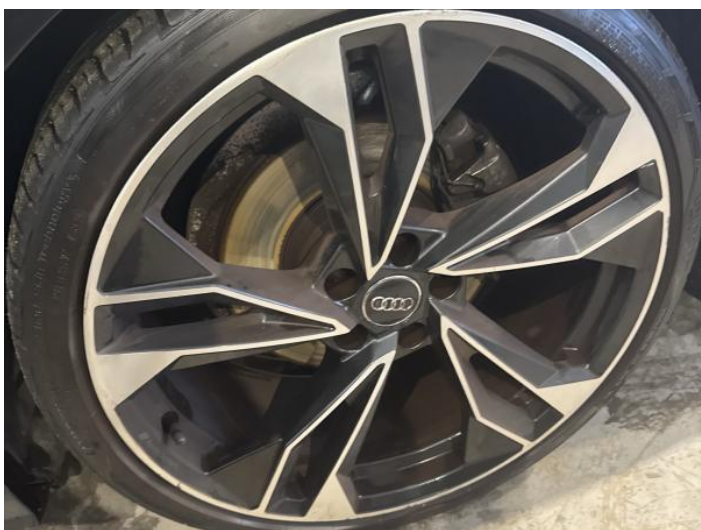
13: Wheel nsf
Scratched
Over 50mm

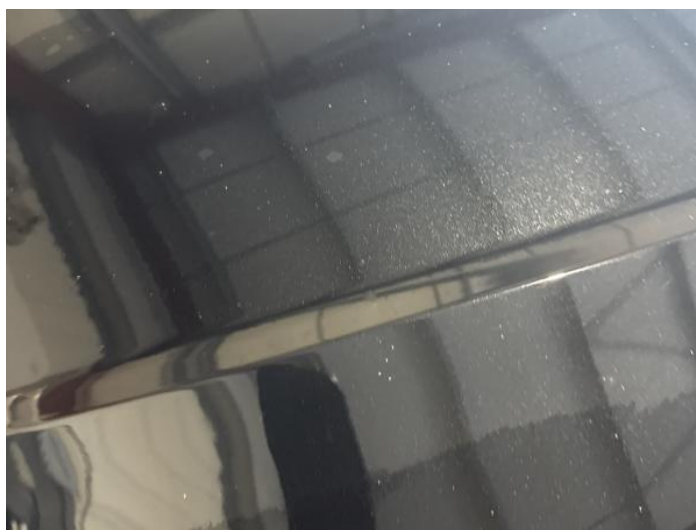
14: Bonnet
Chipped
Multiple Chips

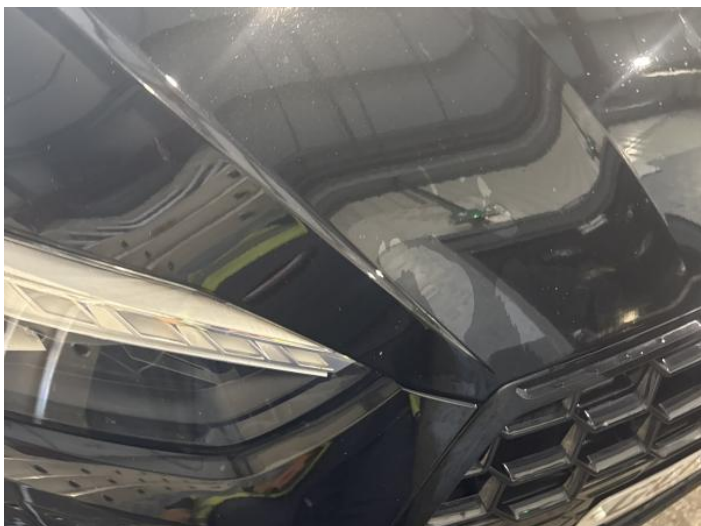
15: Bumper Front
Chipped
Multiple Chips

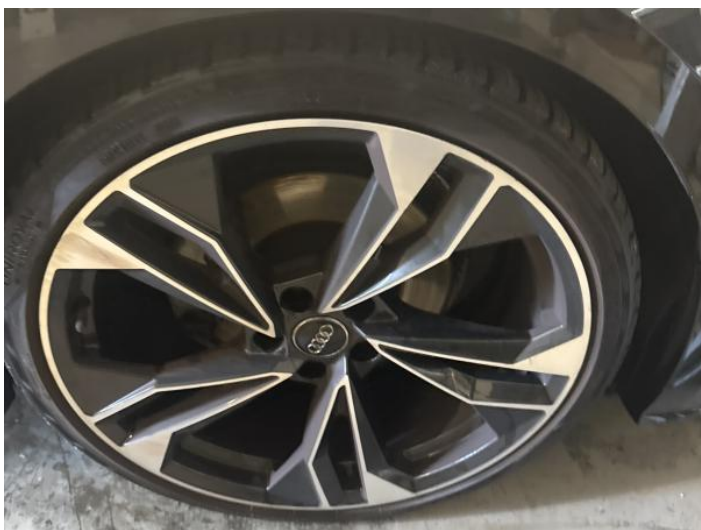
17: Wheel osf
Scratched
Up To 50mm

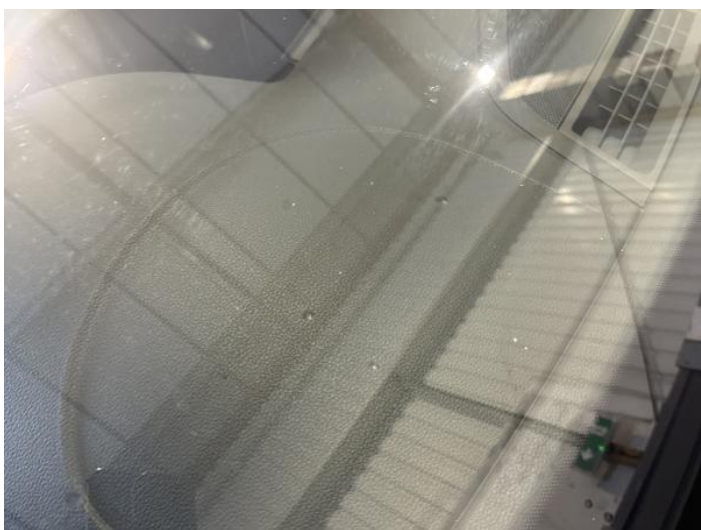
19: Screen Front
Chipped
UpTo 10mm

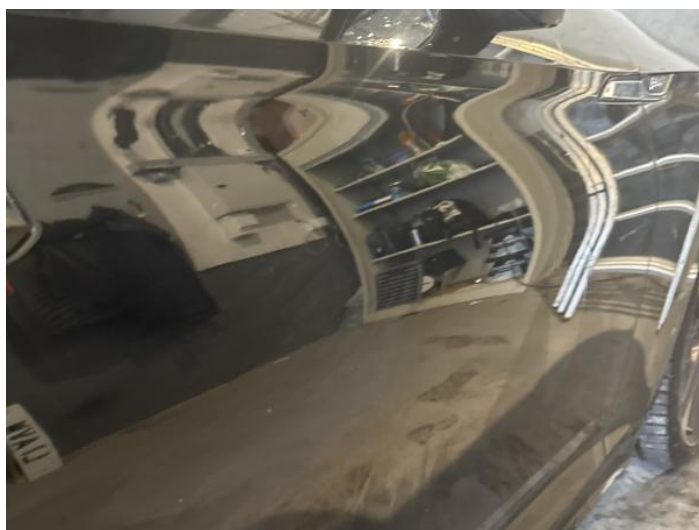
20: Door osf
Chipped
1 To 5

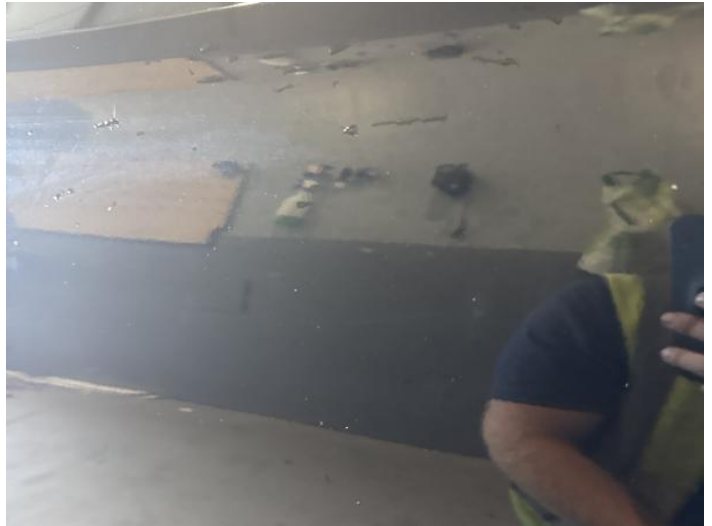
21: Door osf
Scratched
Over 25mm Not Thru Paint

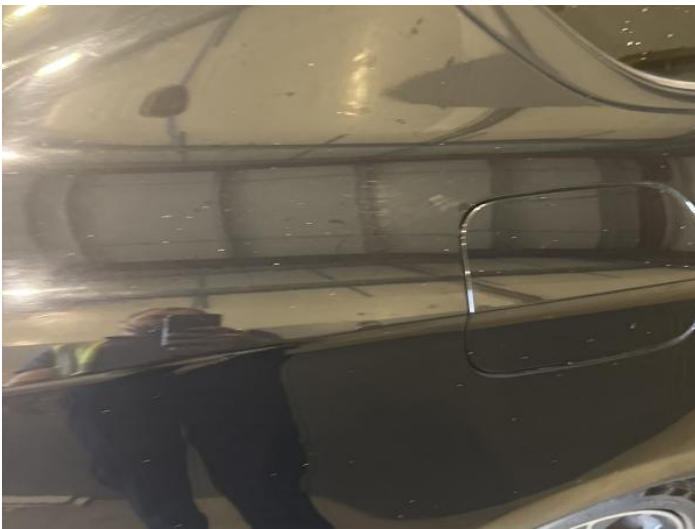
23: Qtr Panel osr
Chipped
Multiple Chips

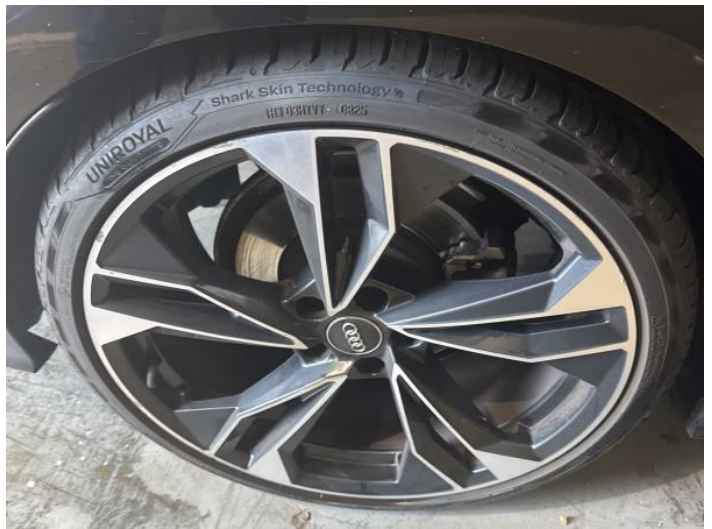
24: Wheel osr
Scratched
Over 50mm
