VEHICLE INSPECTION REPORT

HV62GCU

Hyundai I20 1.2 Style 5dr

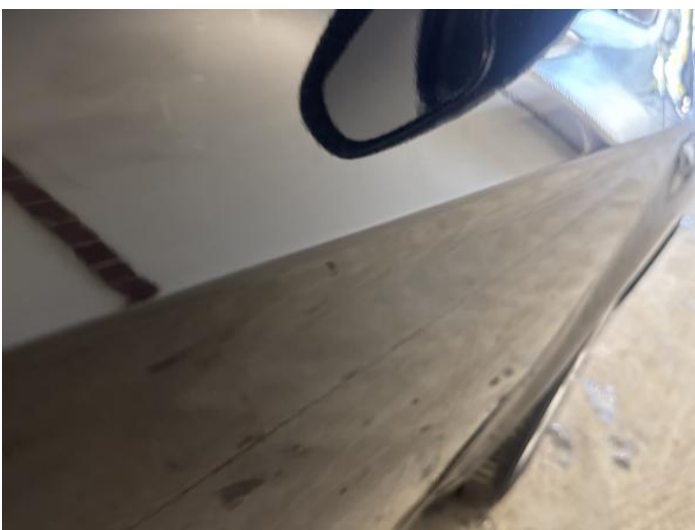
7: Door osf
Dented
Between 10mm + 30mm

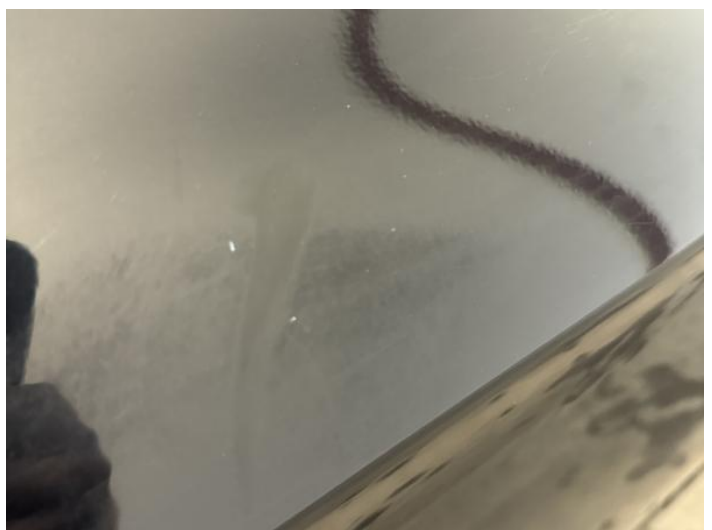
8: Door osr
Poor Previous Repair
Poor Paint

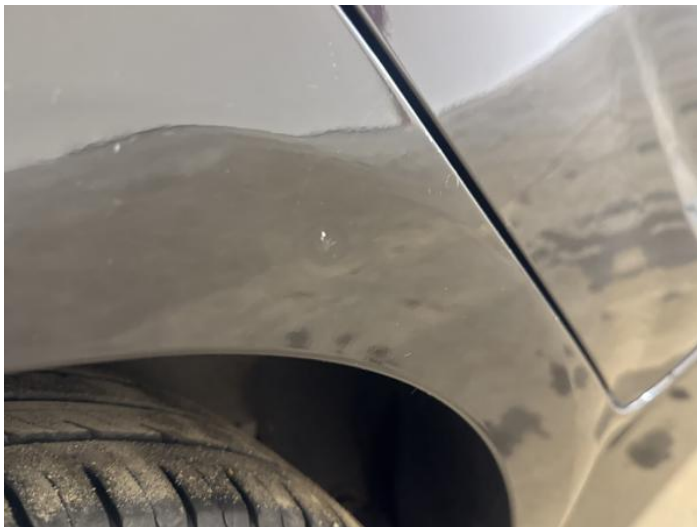
9: Qtr Panel osr
Dented
With Paint Damage

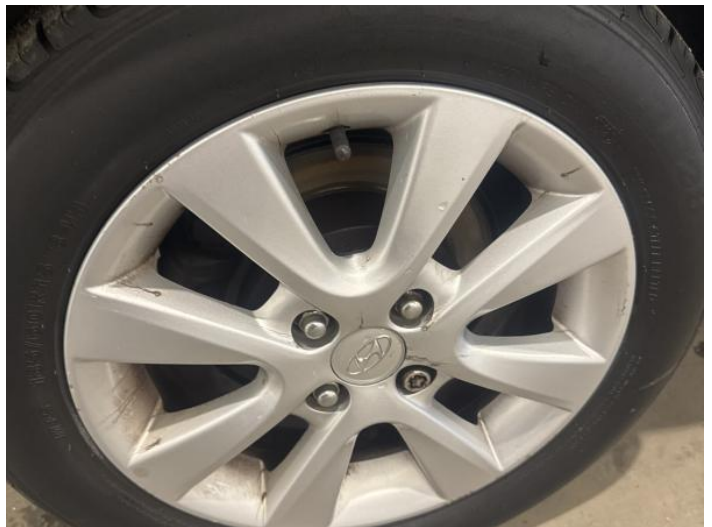
10: Wheel osr
Scratched
Over 50mm

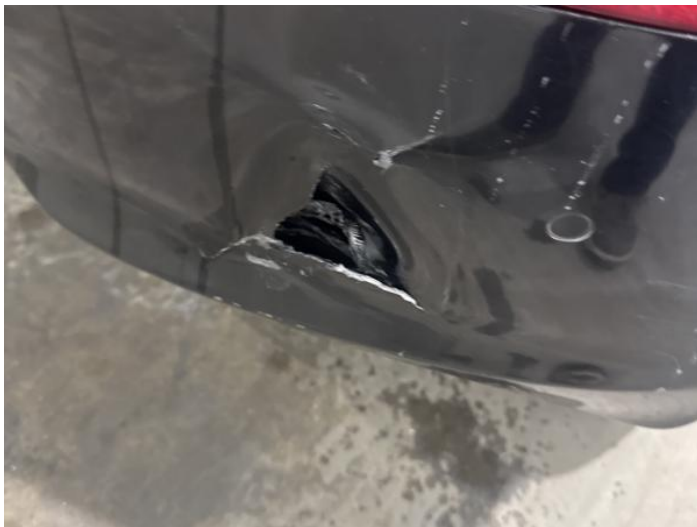
11: Bumper Rear
Hole
Over 25mm

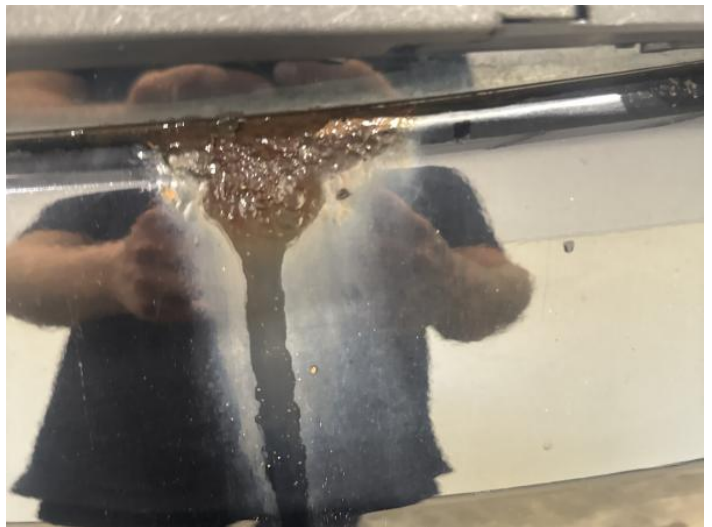
12: Boot Lid
Rusted
Over 5mm

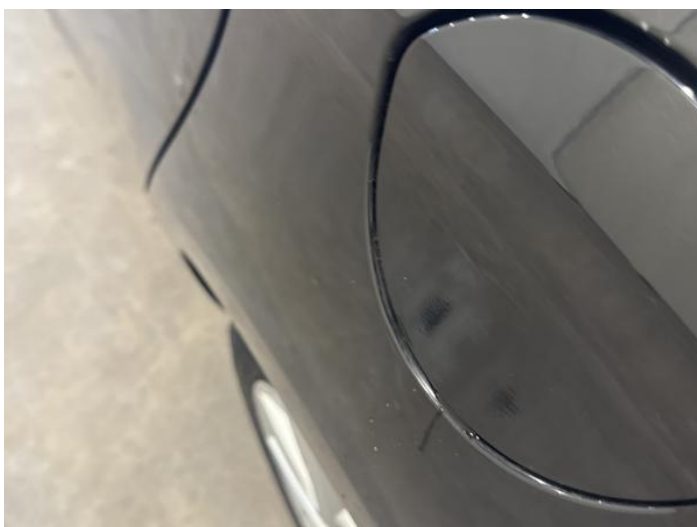
13: Qtr Panel nsr
Dented
With Paint Damage

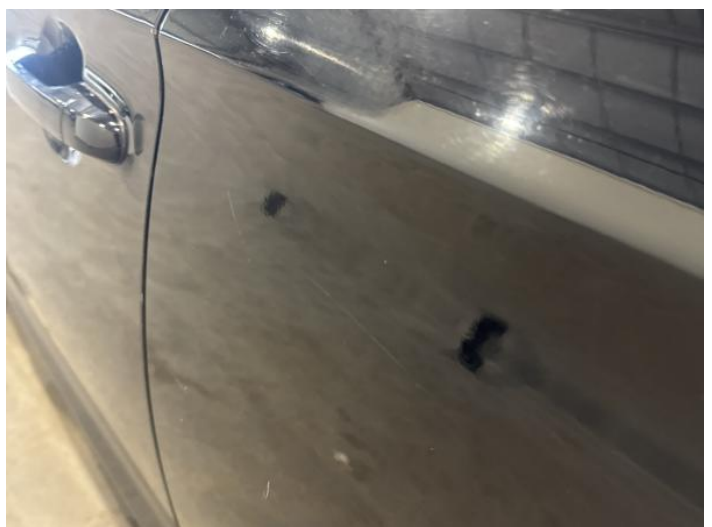
14: Door nsr
Dented
With Paint Damage

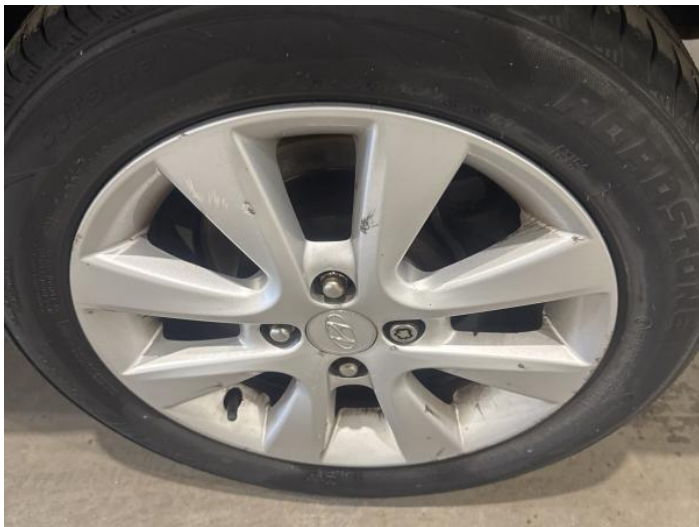
15: Wheel nsf
Scratched
Over 50mm

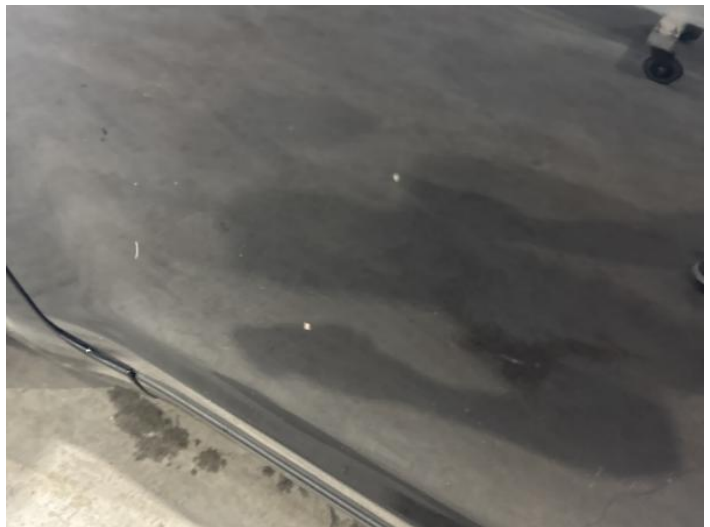
16: Door nsf
Chipped
Multiple Chips

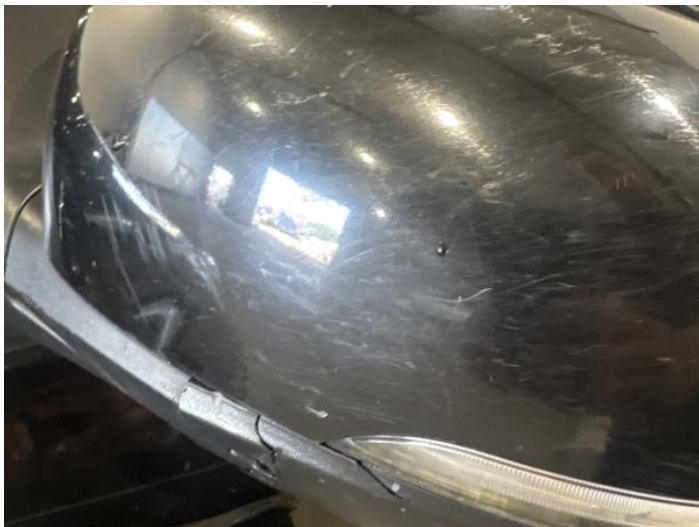
17: Door Mirror Assy nsf
Broken
Replace

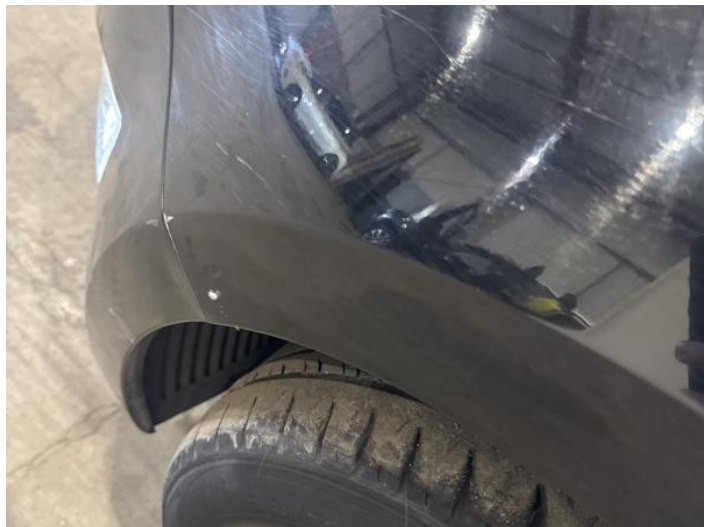
18: Wing nsf
Scratched
Over 25mm Thru Paint

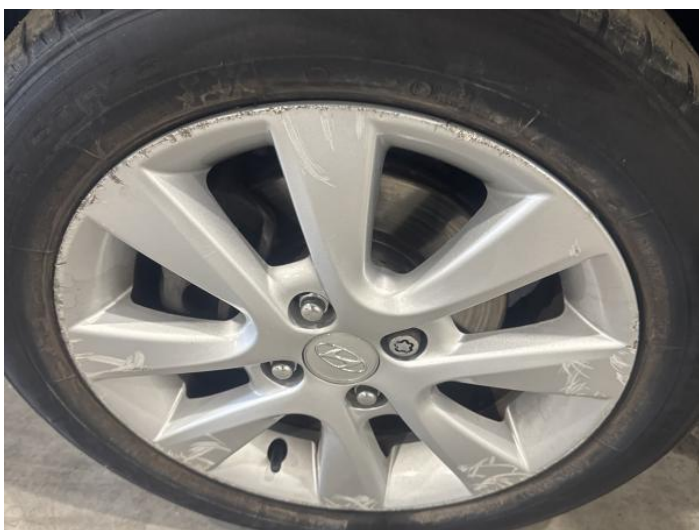
19: Wheel nsf
Scratched
Over 50mm
