# VEHICLE INSPECTION REPORT

**LD19FKL**

## Ford Focus 1.0 EcoBoost 125 Titanium 5dr

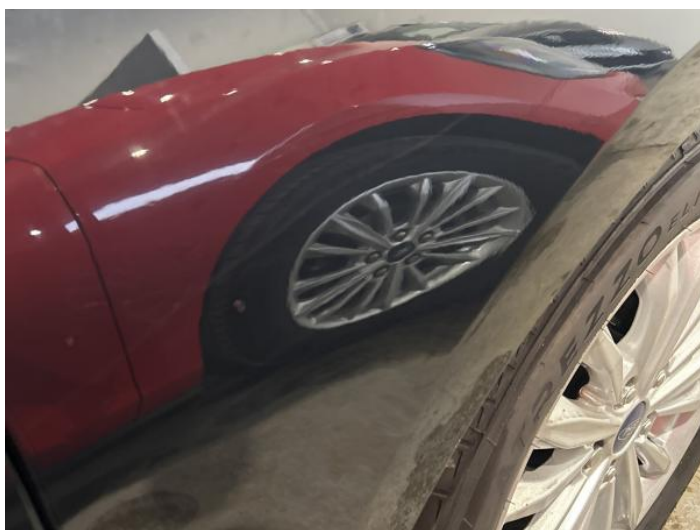
1: Wing osf  
Scratched  
Over 25mm Not Thru Paint

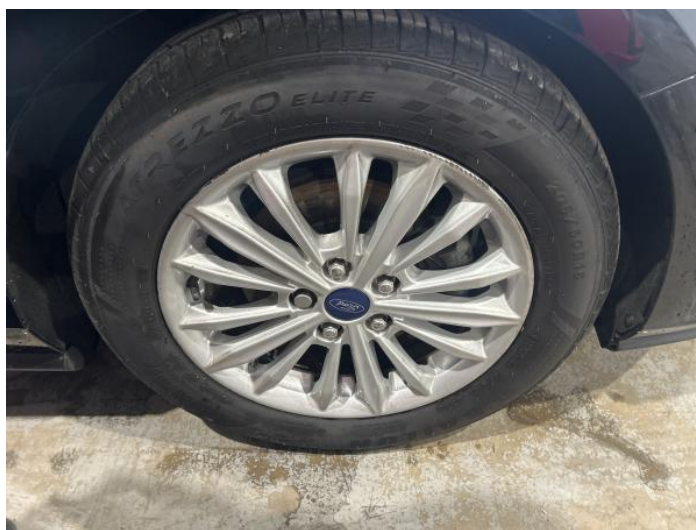
2: Wheel osf  
Scratched  
Over 50mm

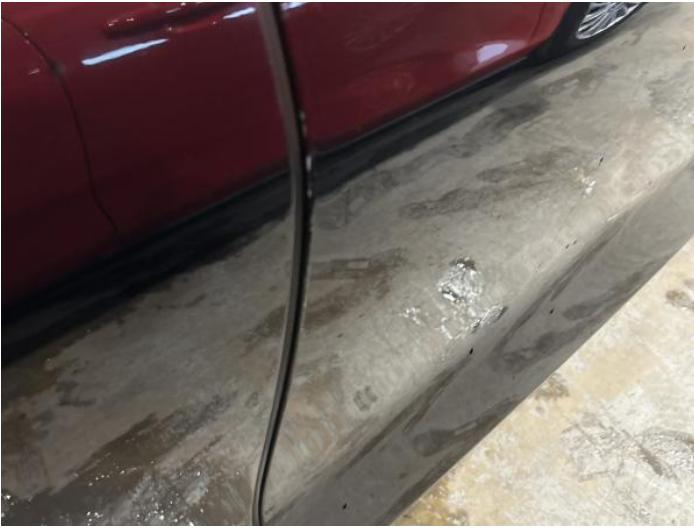
3: Door osf  
Chipped  
Edge Chip

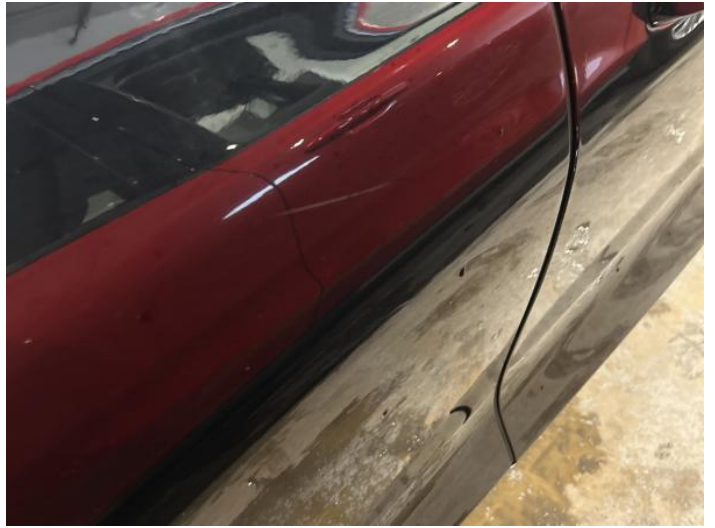
4: Door osr  
Scratched  
Over 25mm Not Thru Paint

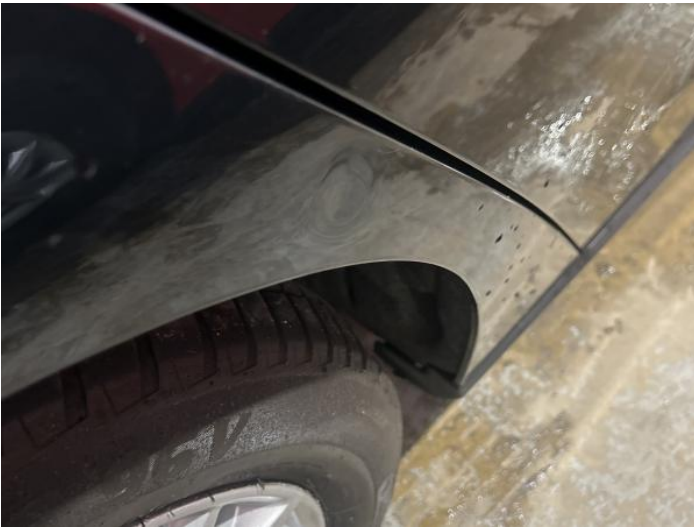
5: Qtr Panel osr  
Dented  
Between 10mm + 30mm

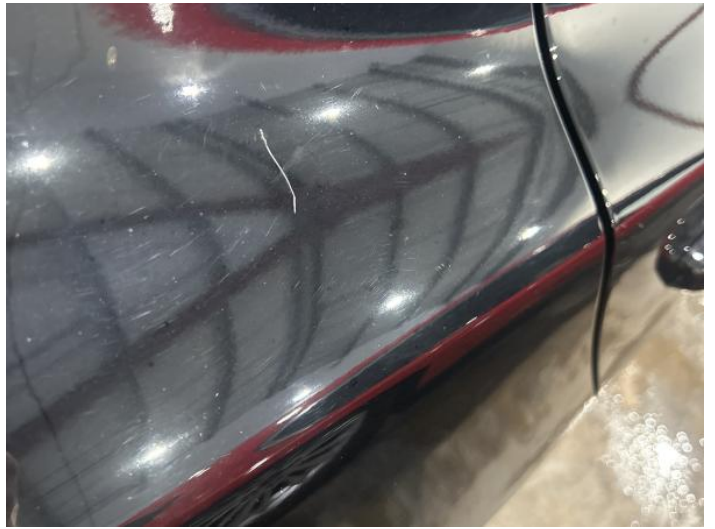
6: Qtr Panel osr  
Scratched  
UpTo 25mm Thru Paint

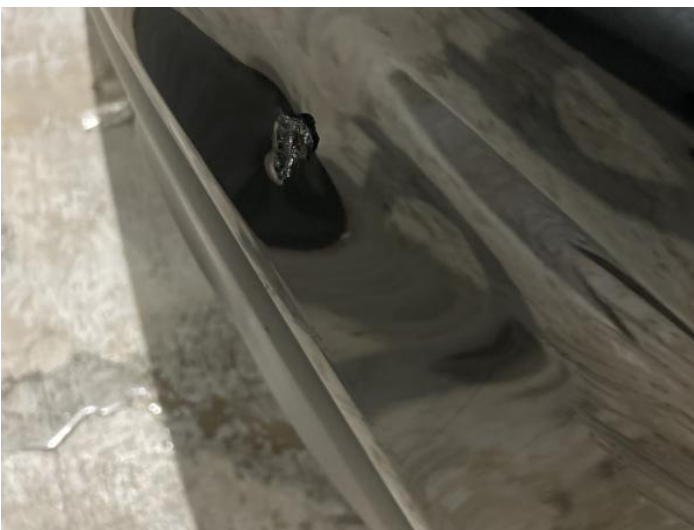
7: Bumper Rear  
Hole  
UpTo 25mm

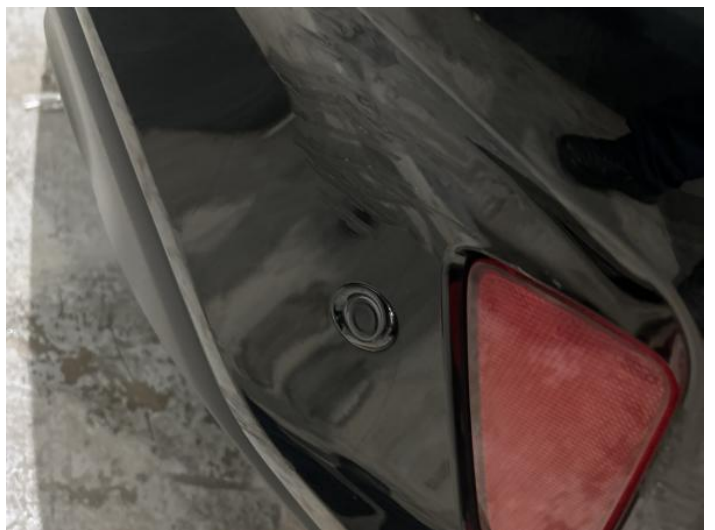
8: Bumper Rear  
Scratched  
25 to 100mm Thru Paint
