VEHICLE INSPECTION REPORT

GY21LMO

Jeep Renegade 1.0 T3 GSE Night Eagle II 5dr

Inspection		Vehicle	
Serious Damage?	No	VAT	Margin
		V5	Present

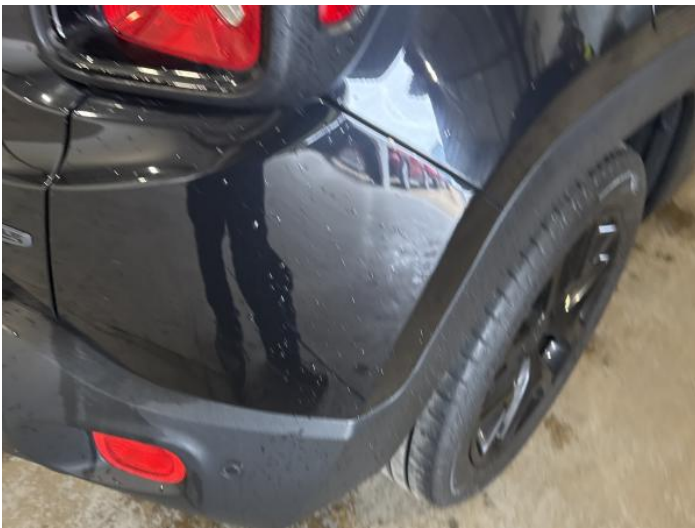
1: Bumper Rear
Chipped
Multiple Chips

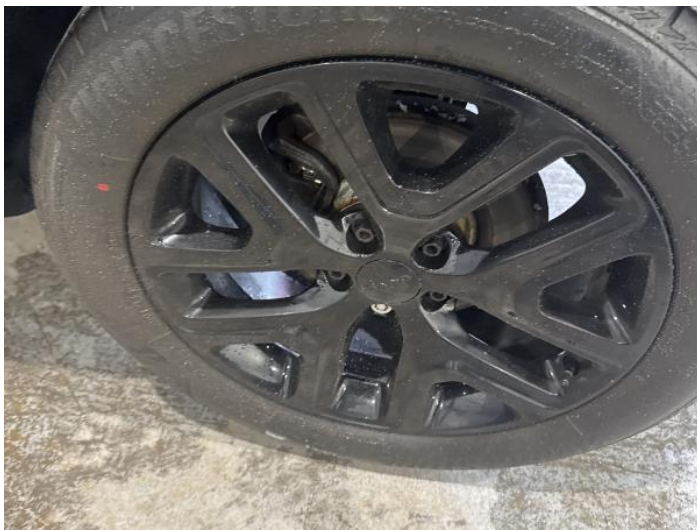
5: Wheel nsr
Scratched
Up To 50mm

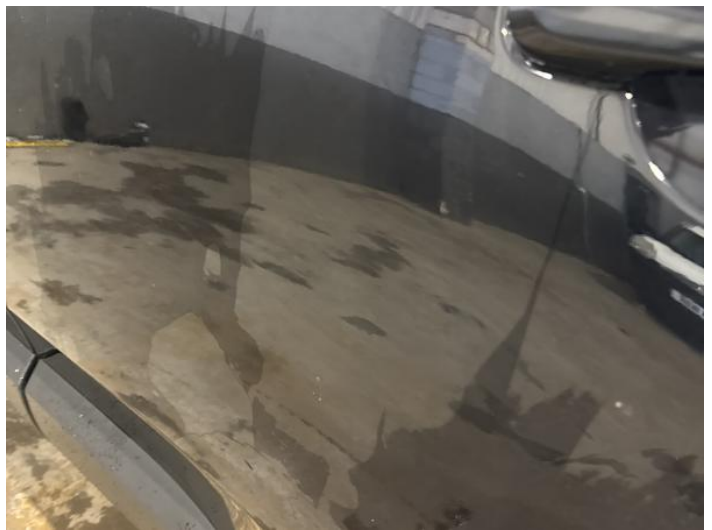
6: Door nsr
Chipped
1 To 5

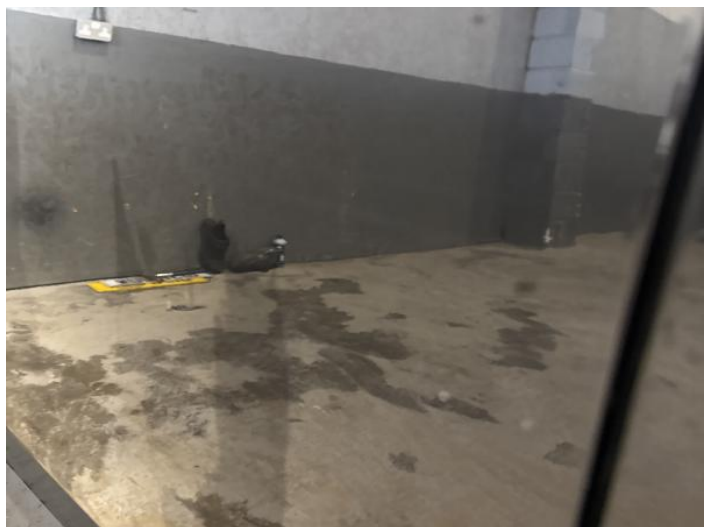
8: Door nsf
Chipped
1 To 5

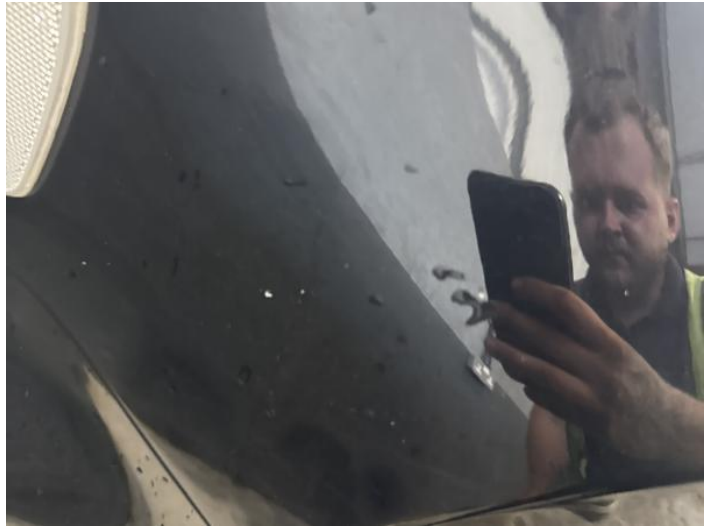
9: Door nsf
Scratched
Over 25mm Not Thru Paint

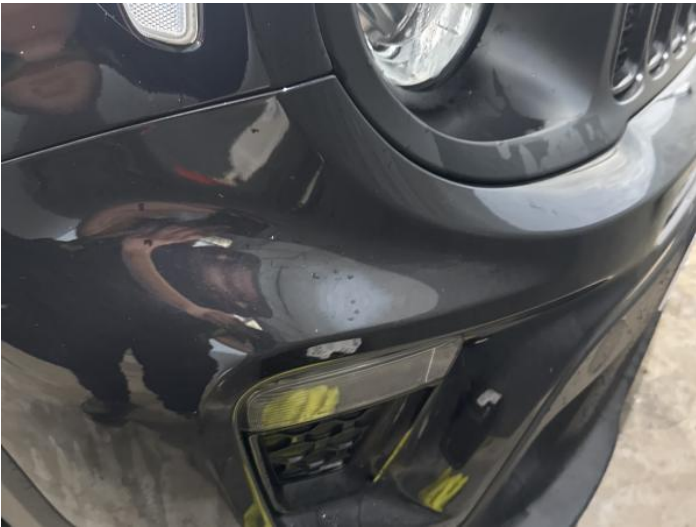
11: Bumper Front
Chipped
Multiple Chips

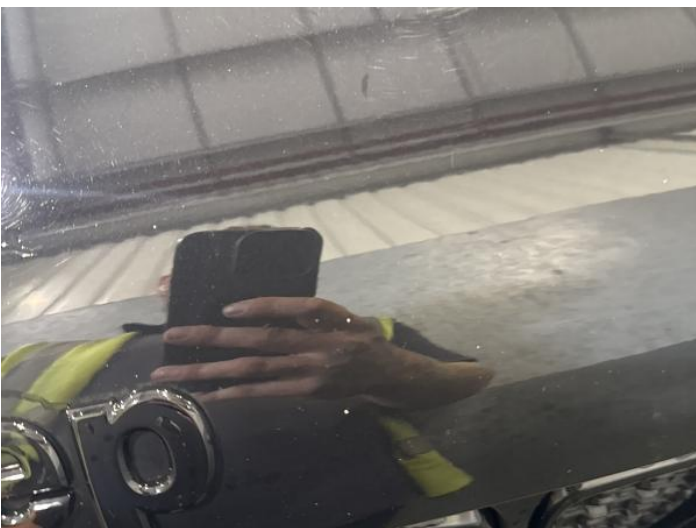
13: Bonnet
Chipped
1 To 5

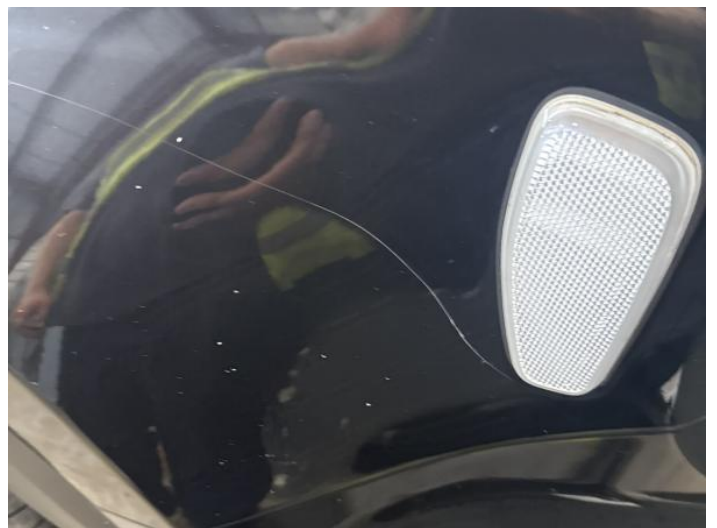
14: Wing osf
Scratched
Over 25mm Thru Paint

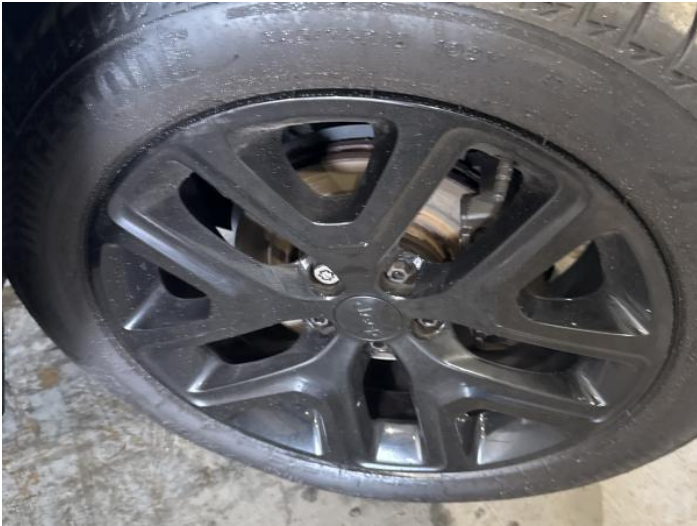
15: Wheel osf
Scratched
Up To 50mm

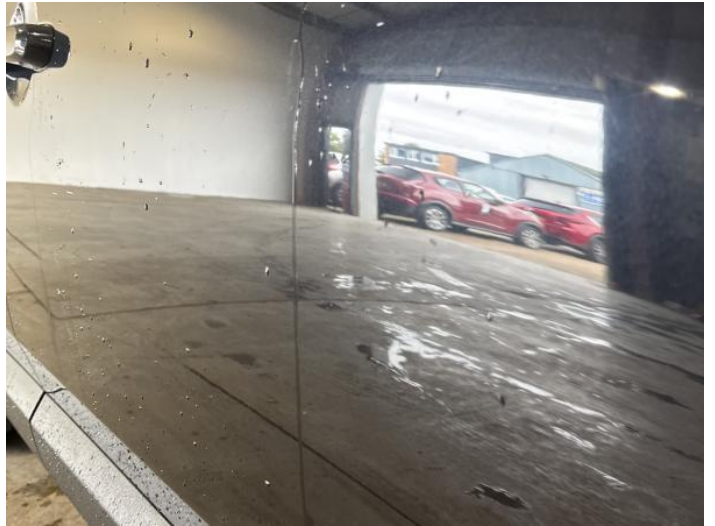
16: Door osf
Dented
2 Or Less UpTo 10mm

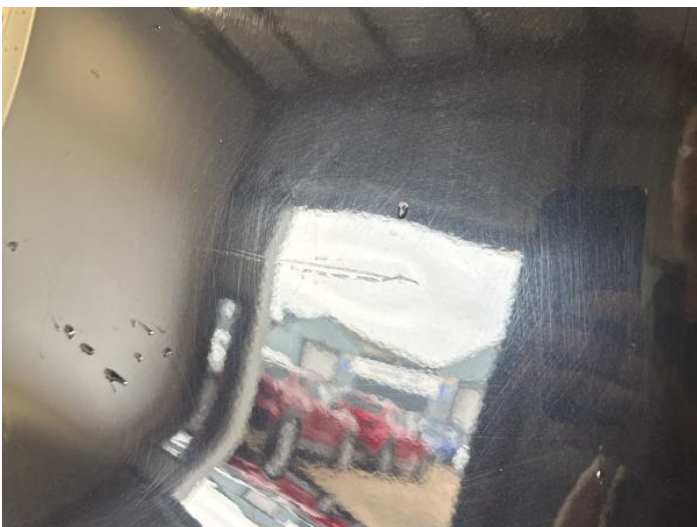
19: Qtr Panel osr
Dented
With Paint Damage
