VEHICLE INSPECTION REPORT

DT17UCH

Nissan Qashqai 1.5 dCi Tekna 5dr

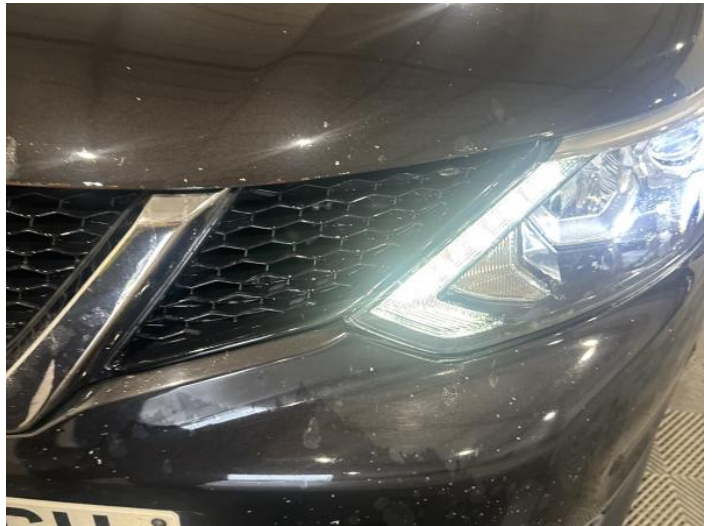
2: Bumper Front
Poor Previous Repair
Paint Flake

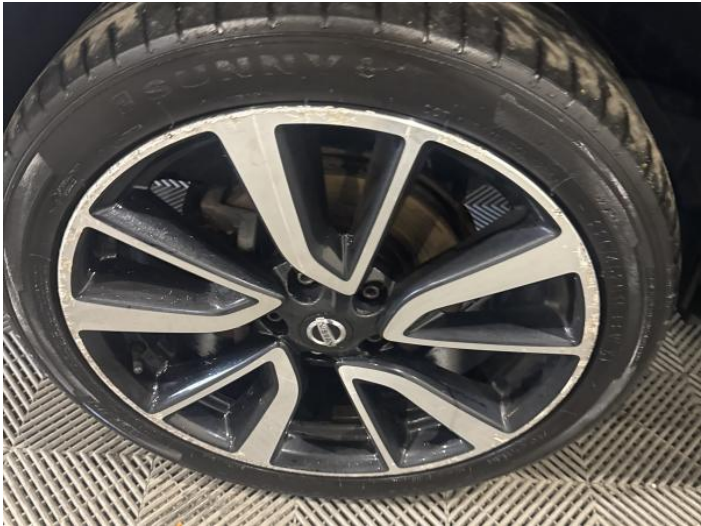
4: Wheel nsf
Scratched
Over 50mm

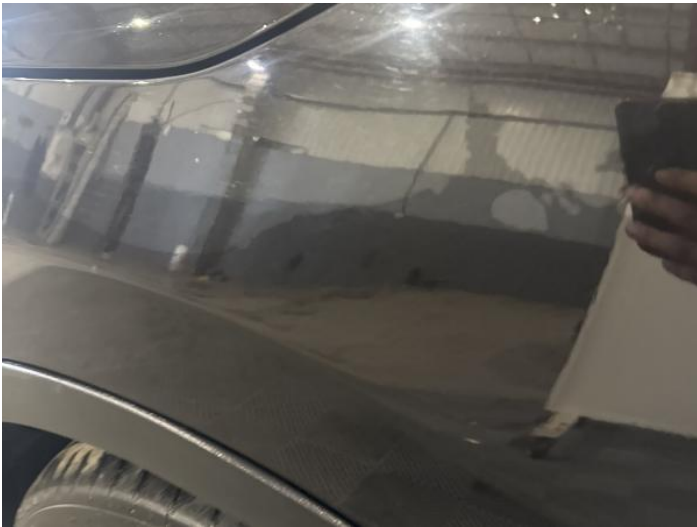
5: Wing nsf
Chipped
1 To 5

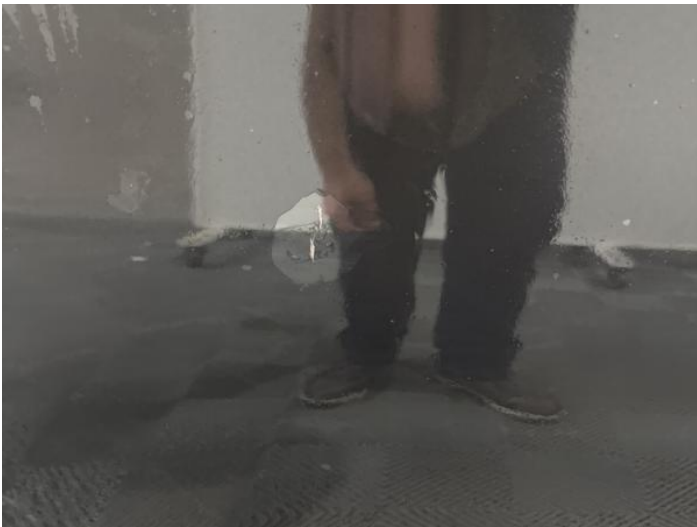
7: Door nsf
Scratched
UpTo 25mm Thru Paint

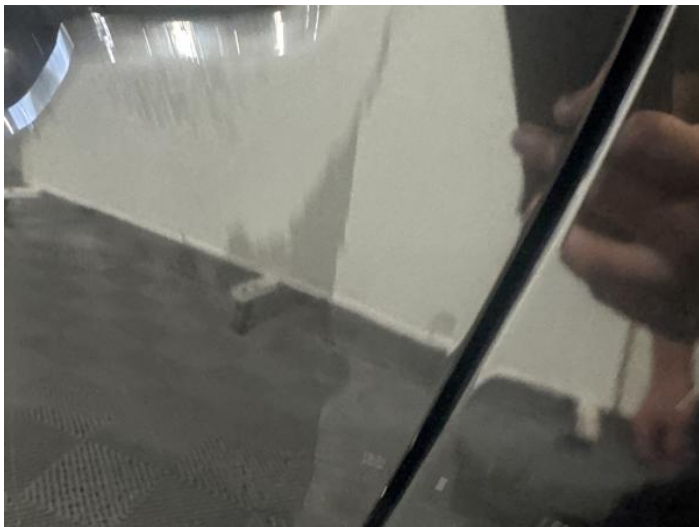
9: Door nsr
Scratched
UpTo 25mm Thru Paint

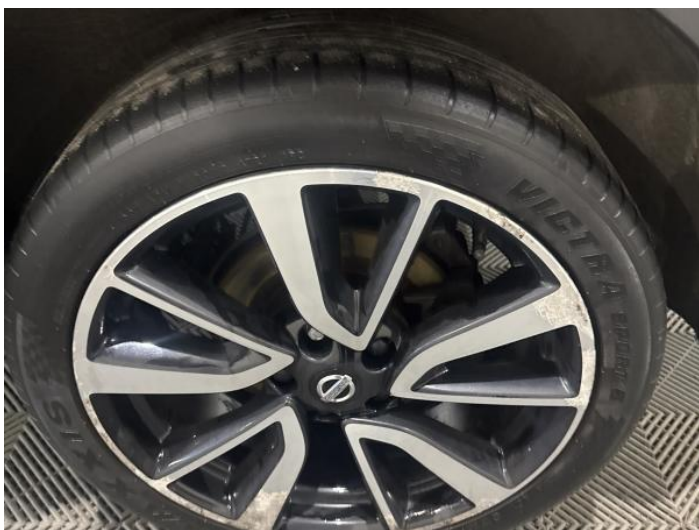
11: Wheel nsr
Scratched
Over 50mm

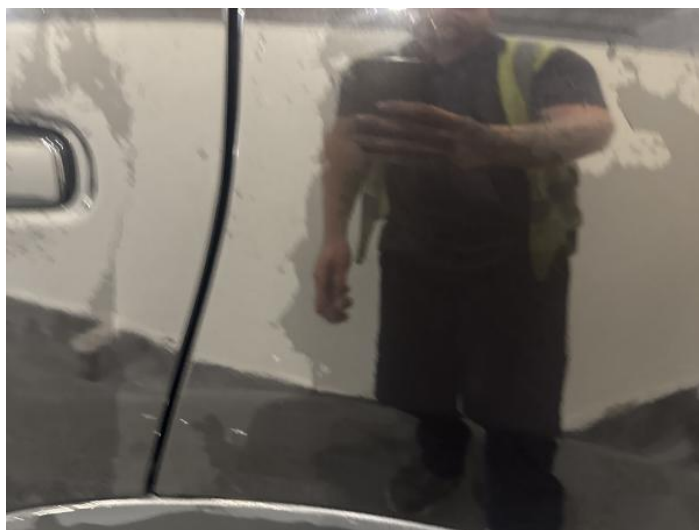
12: Qtr Panel nsr
Scratched
UpTo 25mm Thru Paint

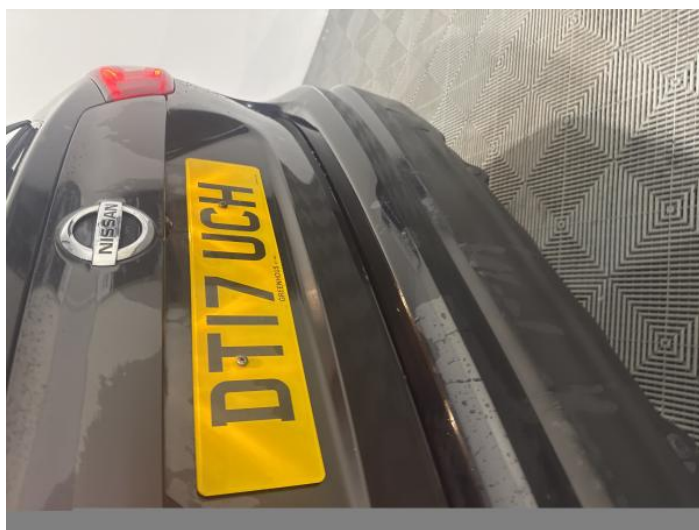
14: Bumper Rear
Chipped
Multiple Chips

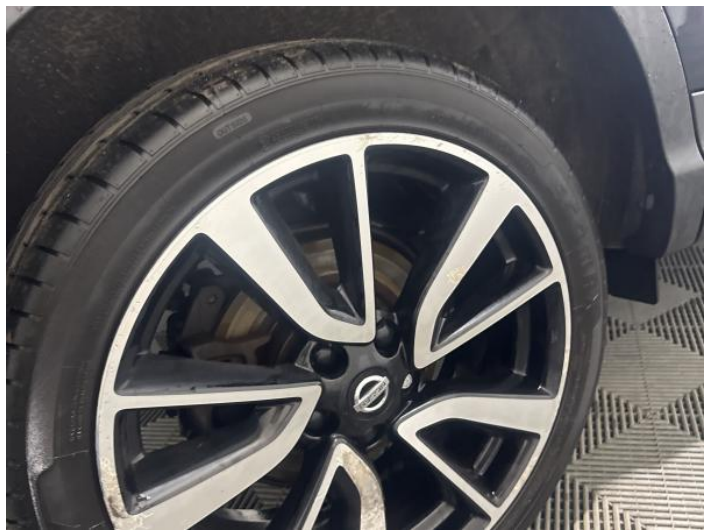
18: Wheel osr
Scratched
Over 50mm

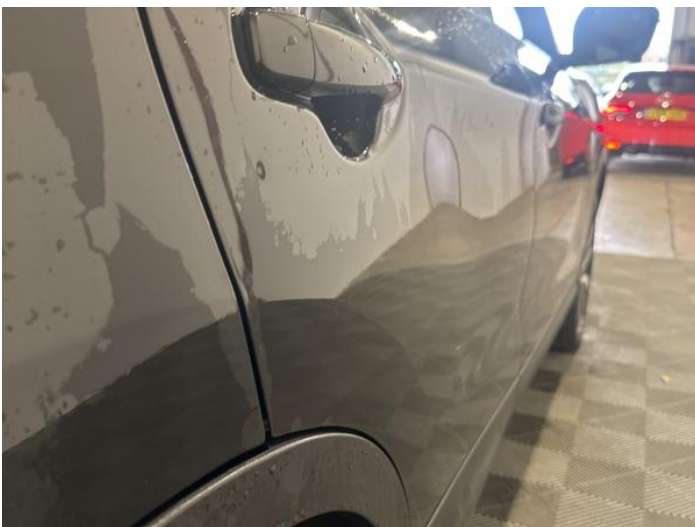
19: Door osr
Dented
Over 2 UpTo 10mm

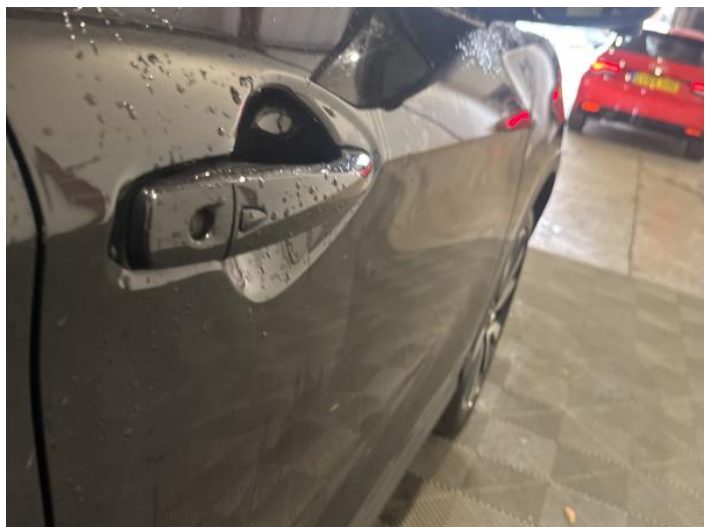
20: Door osf
Dented
Between 10mm + 30mm

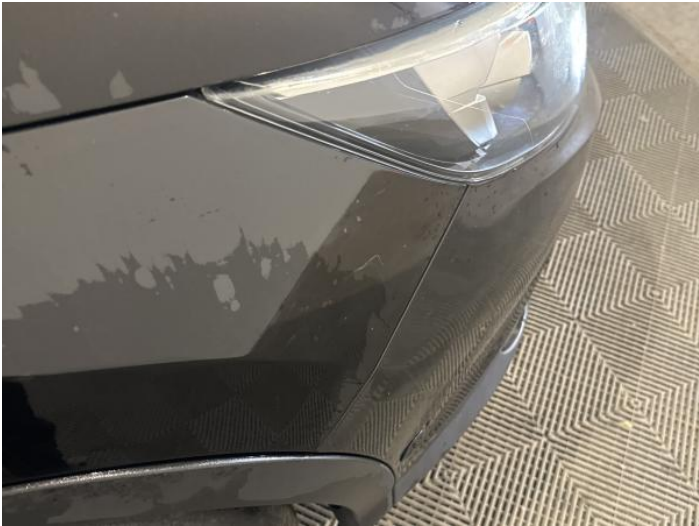
21: Wing osf
Chipped
1 To 5

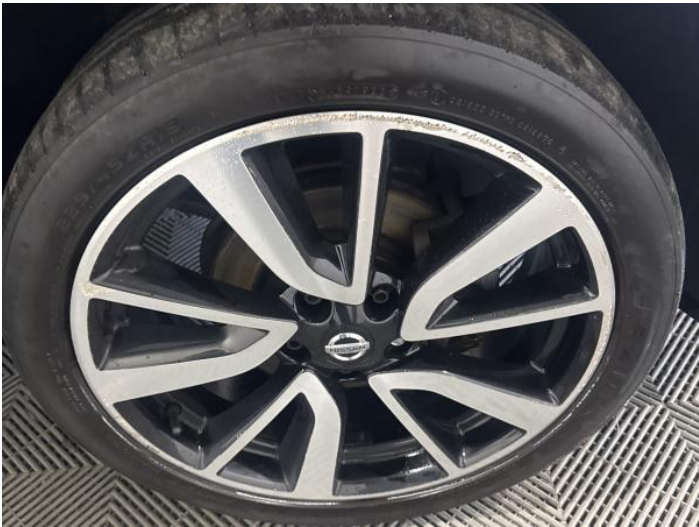
23: Wheel osf
Scratched
Up To 50mm
