VEHICLE INSPECTION REPORT

GU110OF

Honda Jazz 1.4 i-VTEC ES-T 5dr

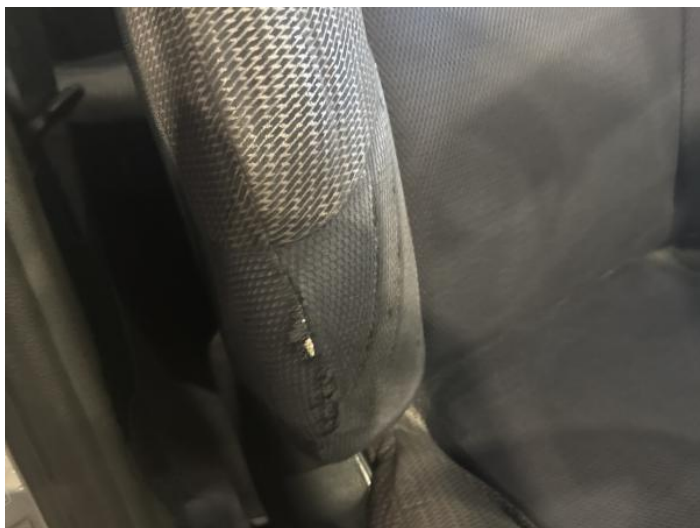
1: Seat Back Cover osf
Torn
Over 3mm

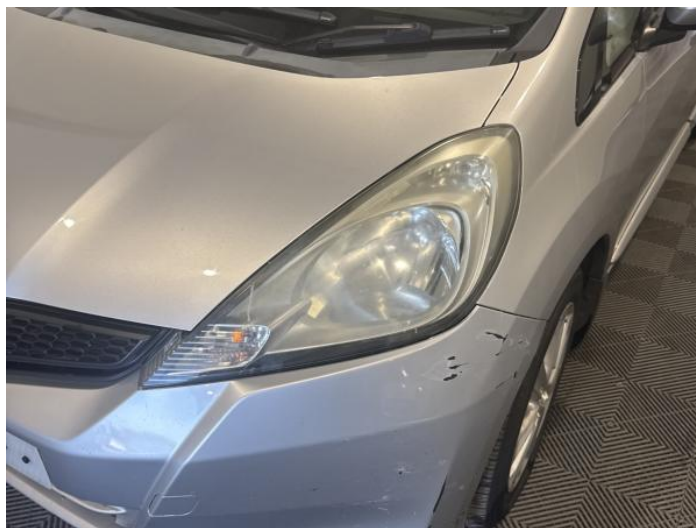
2: Bumper Front
Scratched
Over 100mm Thru Paint

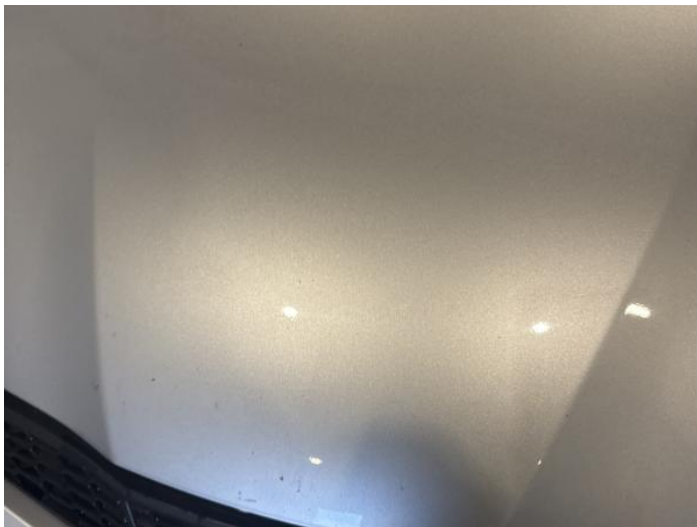
3: Bonnet
Chipped
Multiple Chips

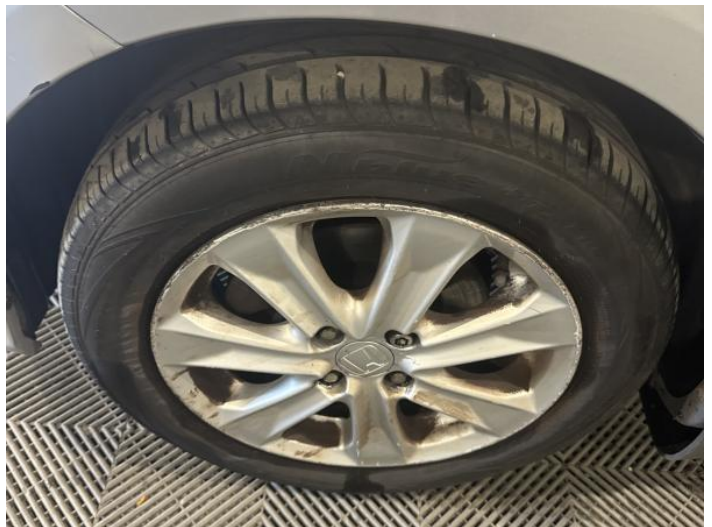
4: Wheel nsf
Scratched
Over 50mm

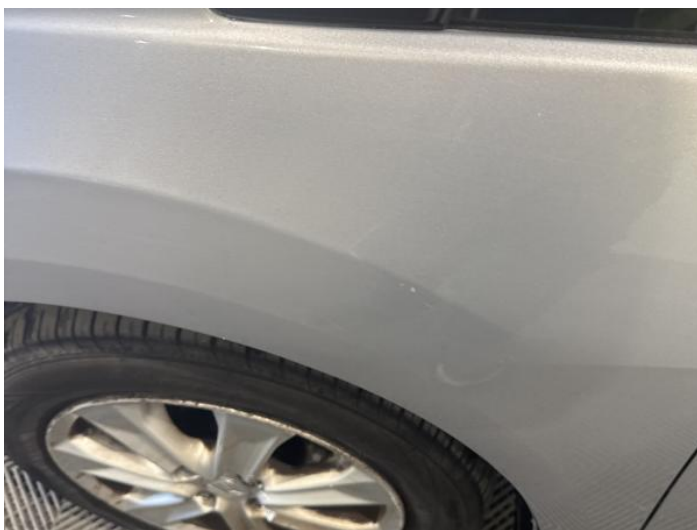
5: Wing nsf
Chipped
1 To 5

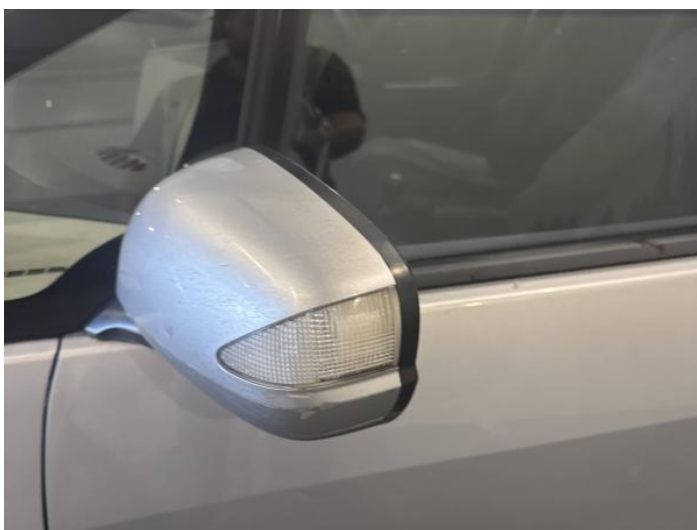
7: Door Mirror Assy nsf
Scratched (Painted)
Over 25mm Thru Paint

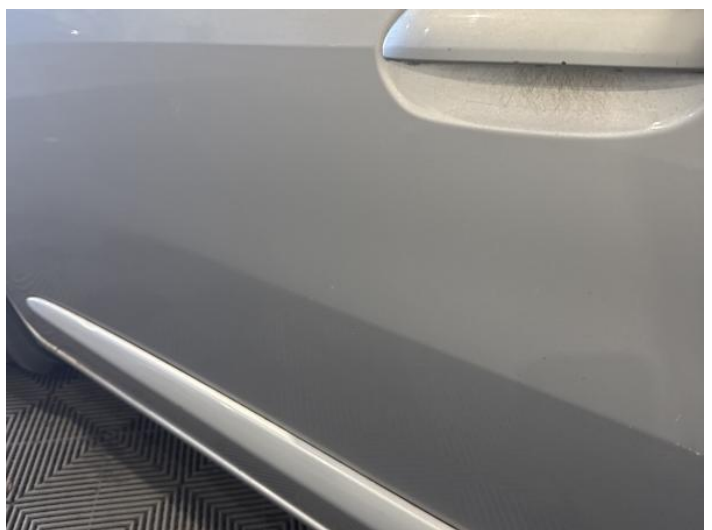
8: Door nsf
Poor Previous Repair
Poor Paint

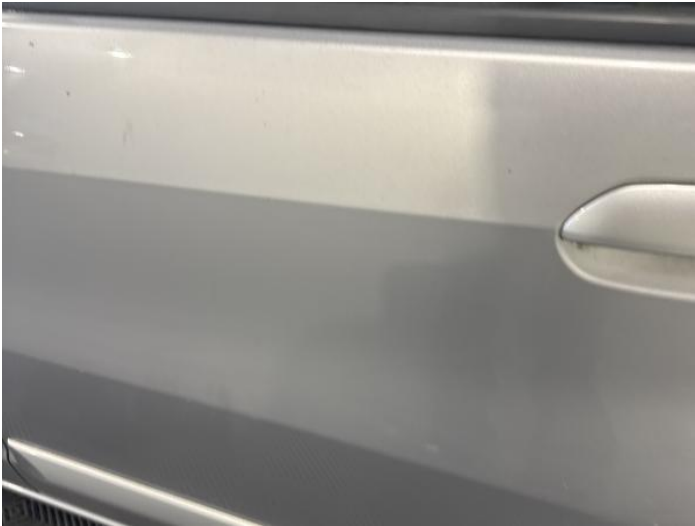
9: Door nsr
Chipped
Multiple Chips

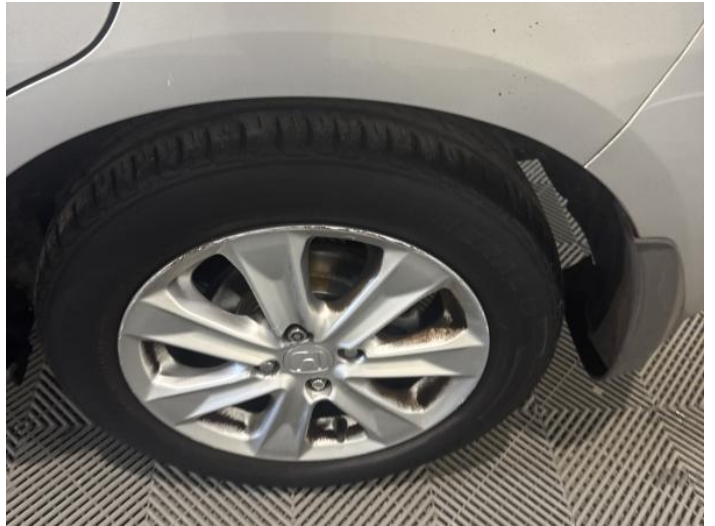
10: Wheel nsr
Scratched
Over 50mm

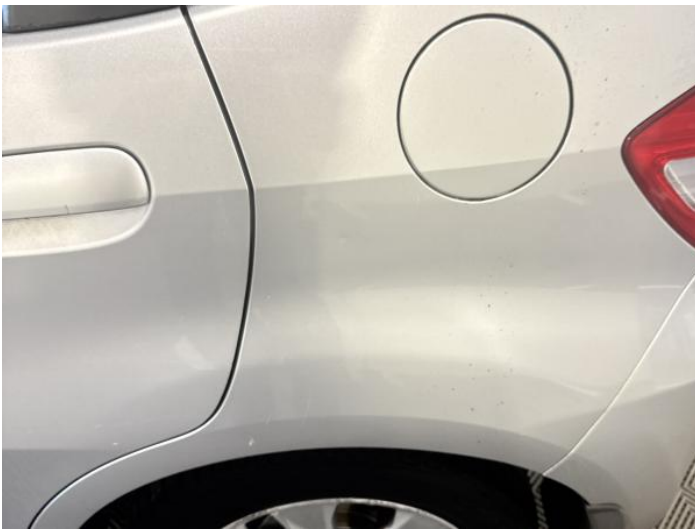
11: Qtr Panel nsr
Dented
With Paint Damage

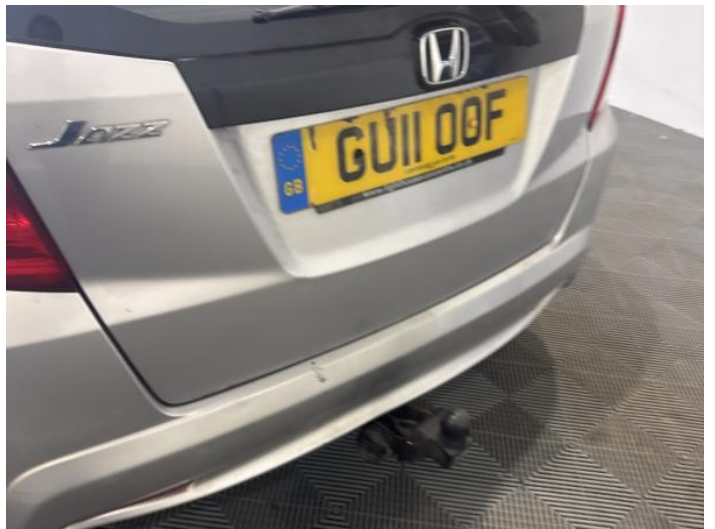
12: Bumper Rear
Poor Previous Repair
Poor Paint

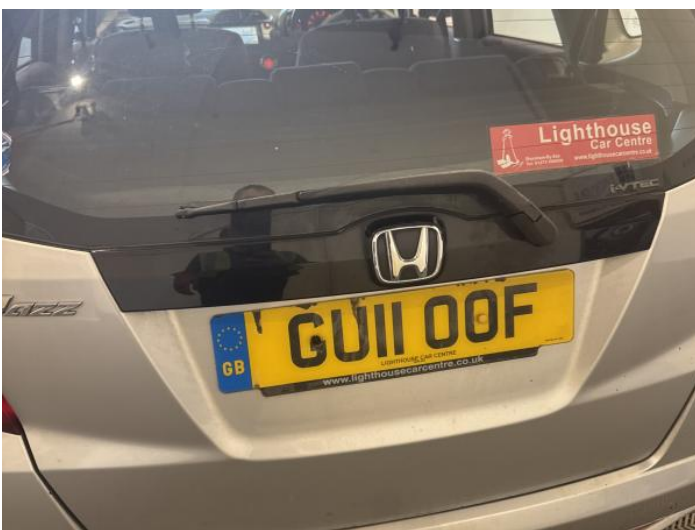
13: Boot Lid
Poor Previous Repair
Poor Paint

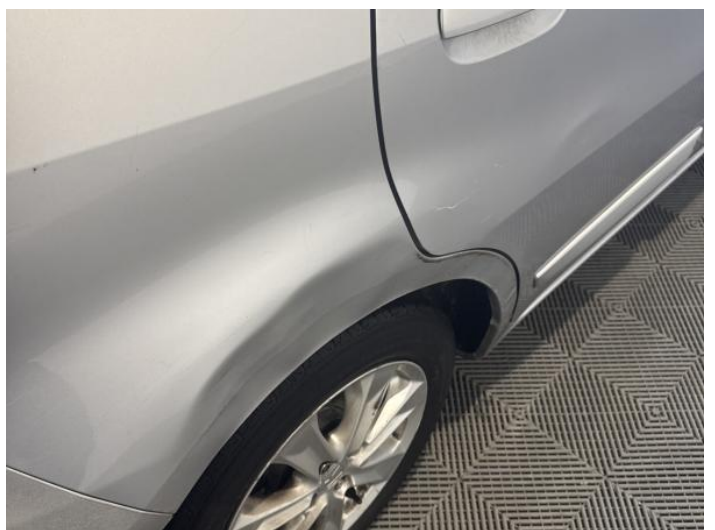
14: Qtr Panel osr
Dented
Over 30% Of Panel

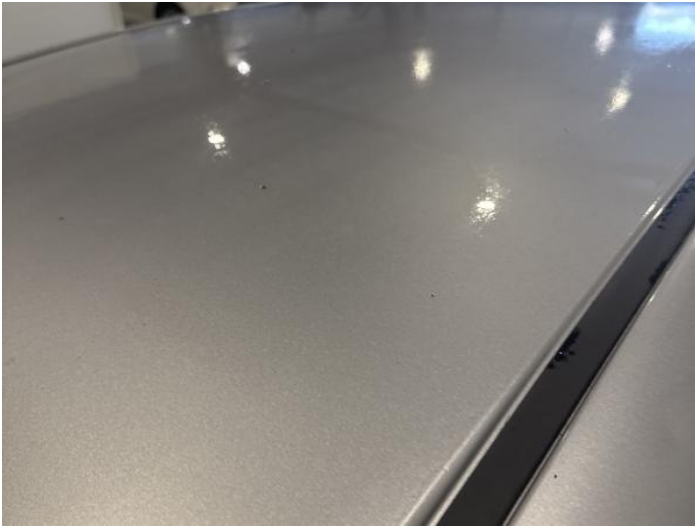
15: Roof
Dented
Over 30mm

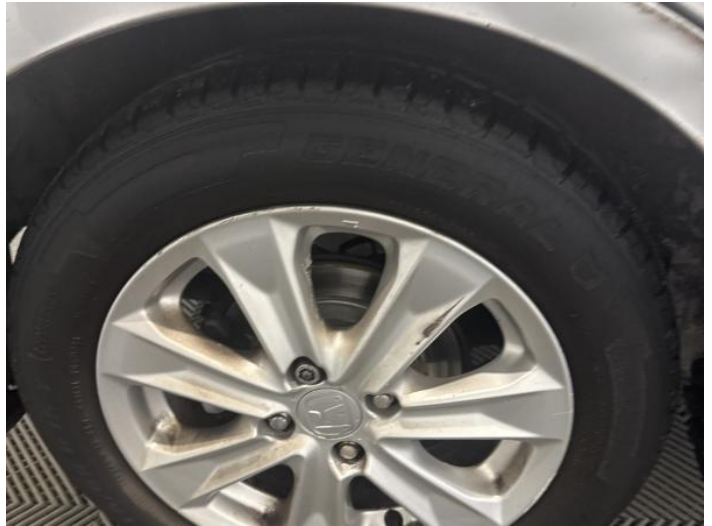
16: Wheel osr
Scratched
Over 50mm

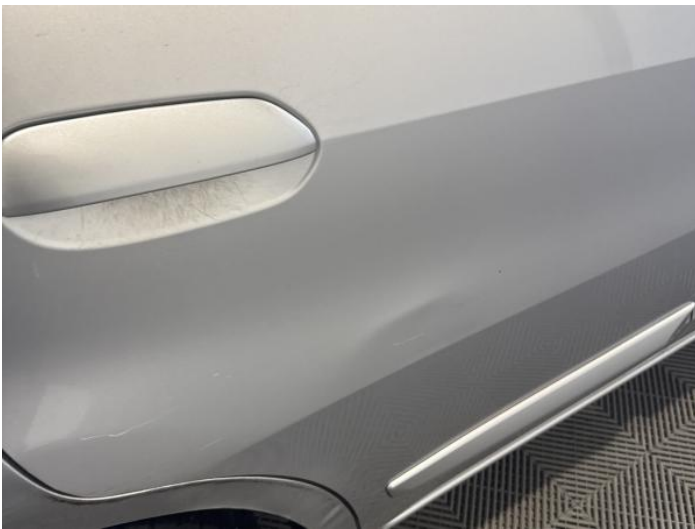
17: Door osr
Dented
With Paint Damage

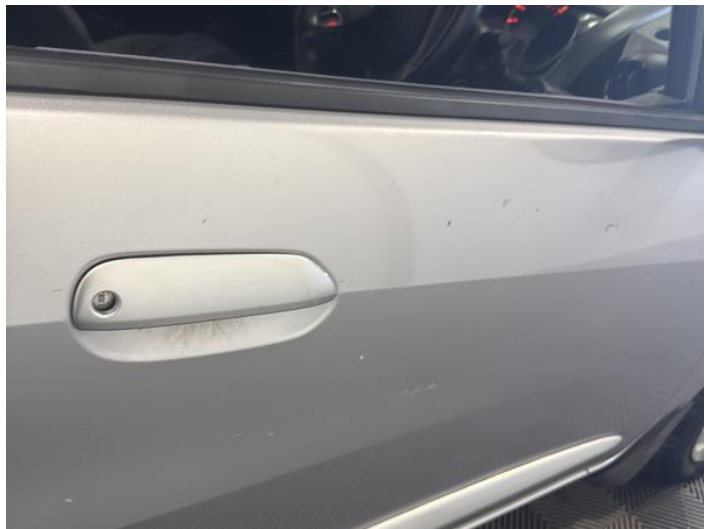
18: Door osf
Dented
With Paint Damage

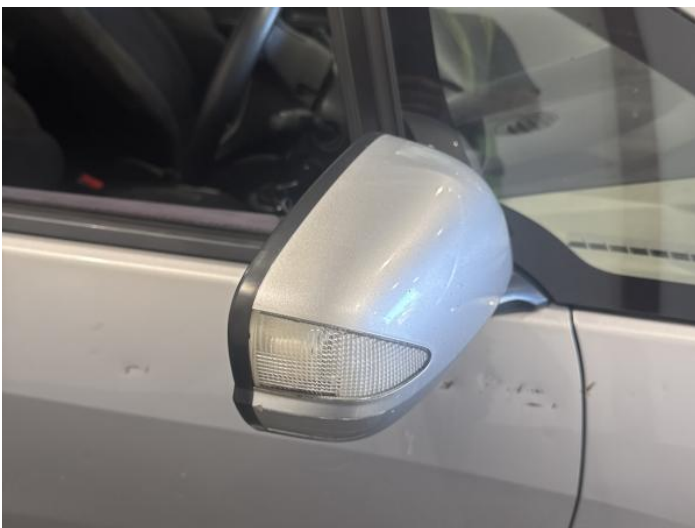
19: Door Mirror Assy osf
Scratched (Painted)
Over 25mm Thru Paint

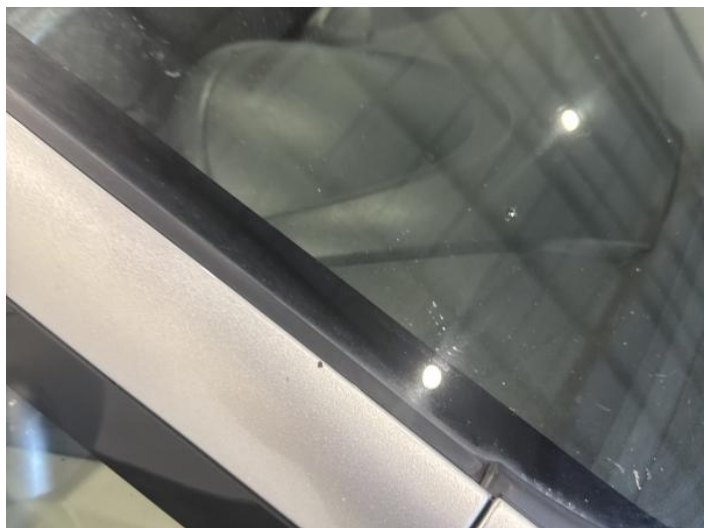
20: A Post os
Chipped
1 To 5

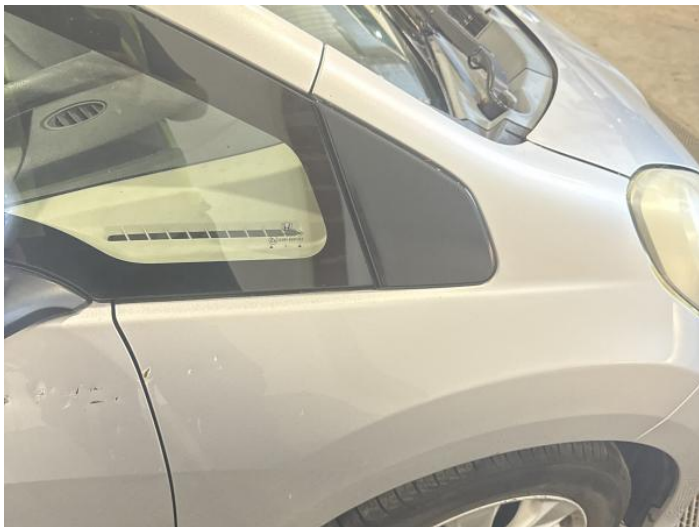
21: Wing osf
Dented
With Paint Damage

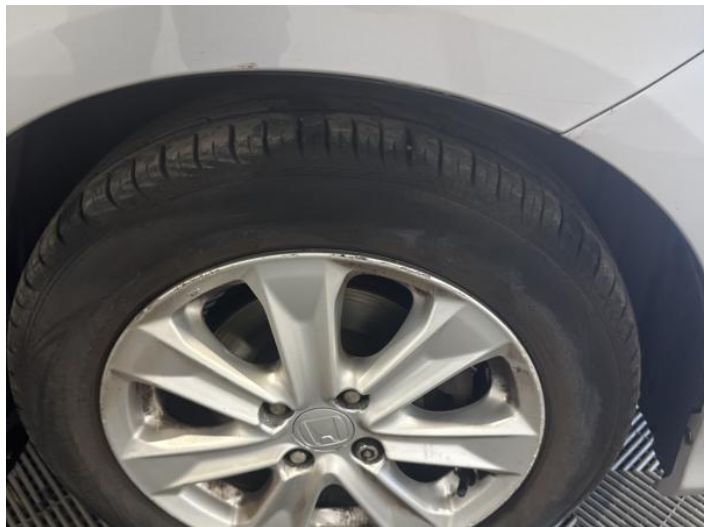
22: Wheel osf
Scratched
Over 50mm
