VEHICLE INSPECTION REPORT

BG62UTY

Mini Countryman 2.0 Cooper S D ALL4 5dr Auto

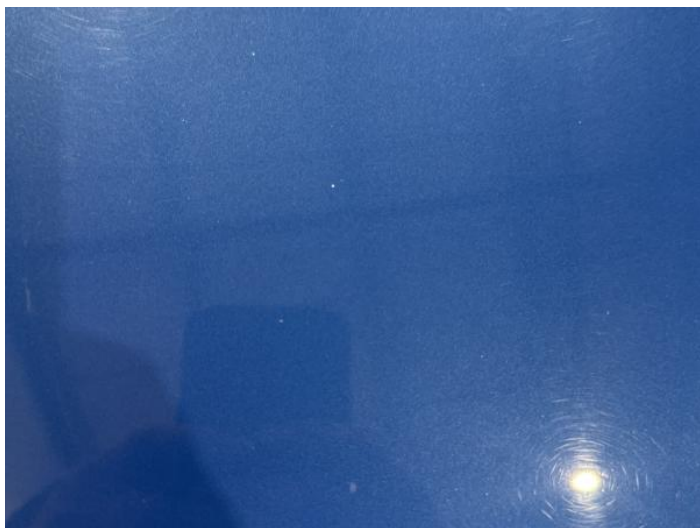
1: Bonnet
Chipped
1 To 5

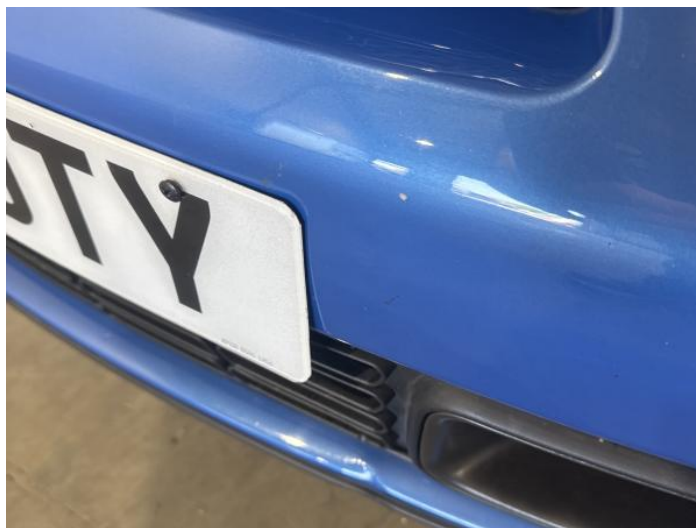
2: Bumper Front
Chipped
Multiple Chips

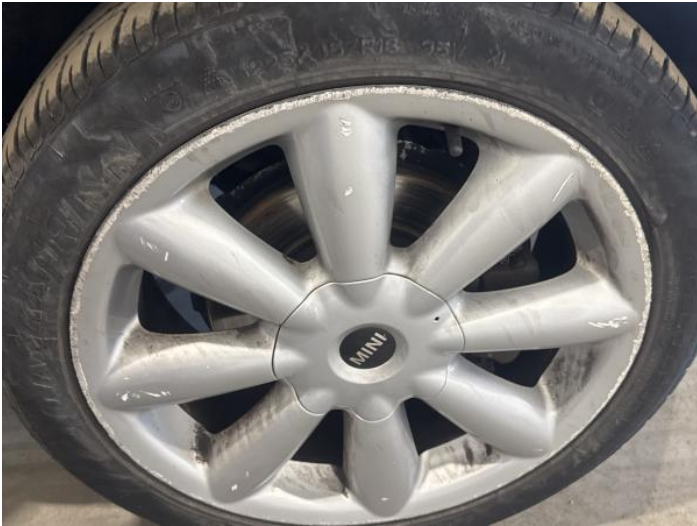
3: Wheel osf
Scratched
Over 50mm

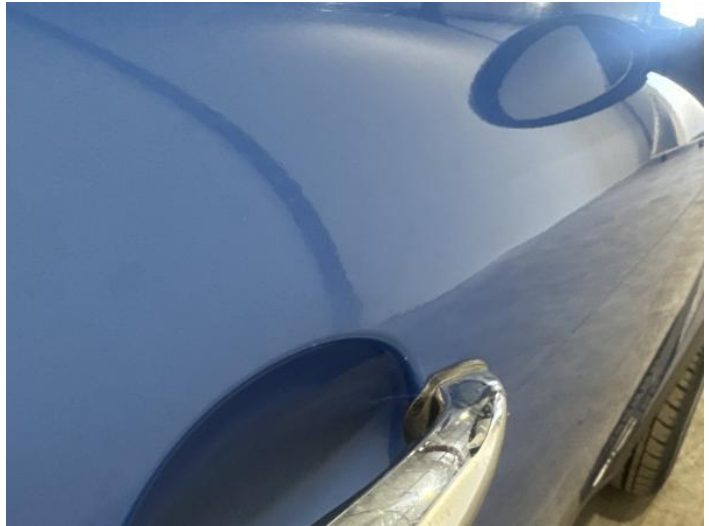
4: Door osf
Dented
Between 10mm + 30mm

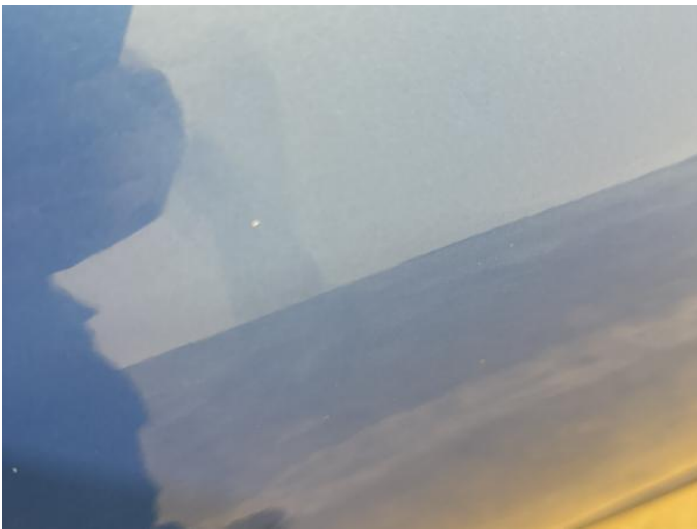
5: Door osr
Chipped
1 To 5

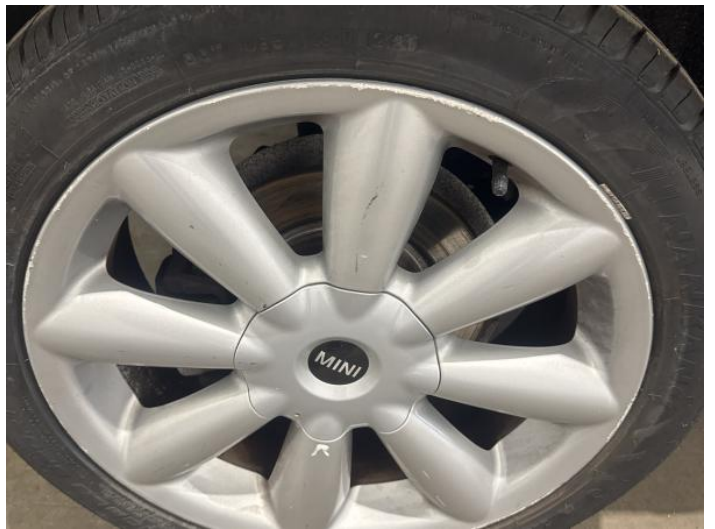
6: Wheel osr
Scratched
Over 50mm

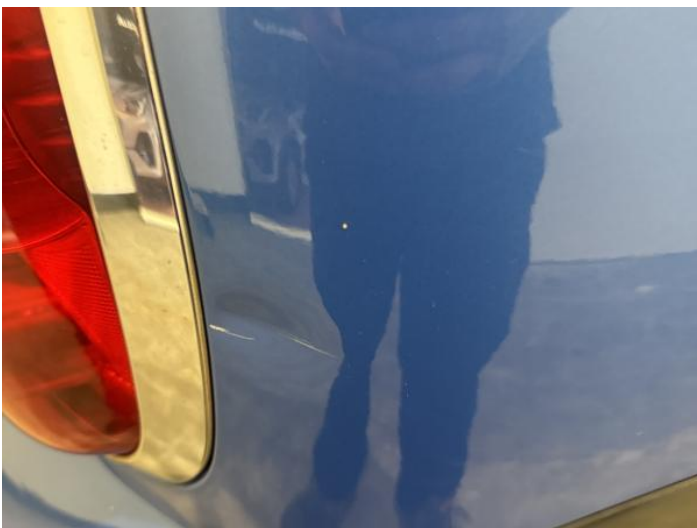
7: Qtr Panel osr
Dented
With Paint Damage

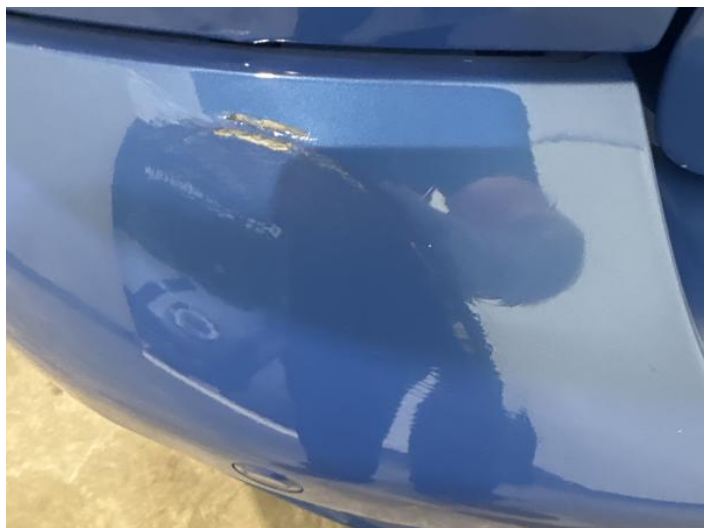
8: Bumper Rear
Poor Previous Repair
Poor Paint

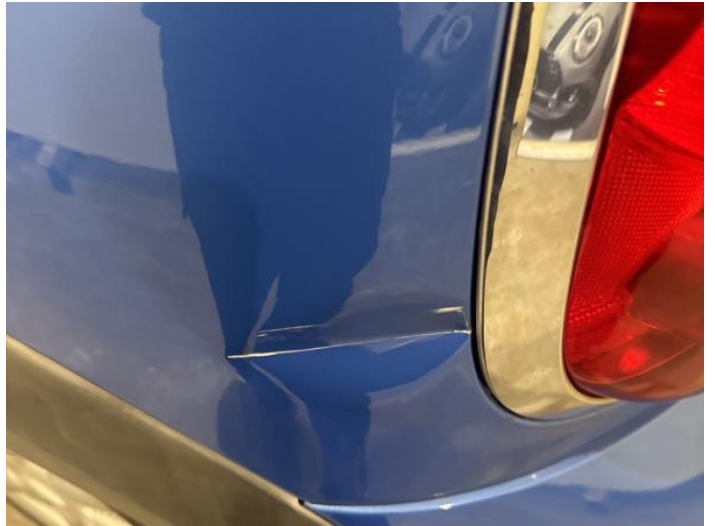
9: Boot Lid
Scratched
Over 25mm Not Thru Paint

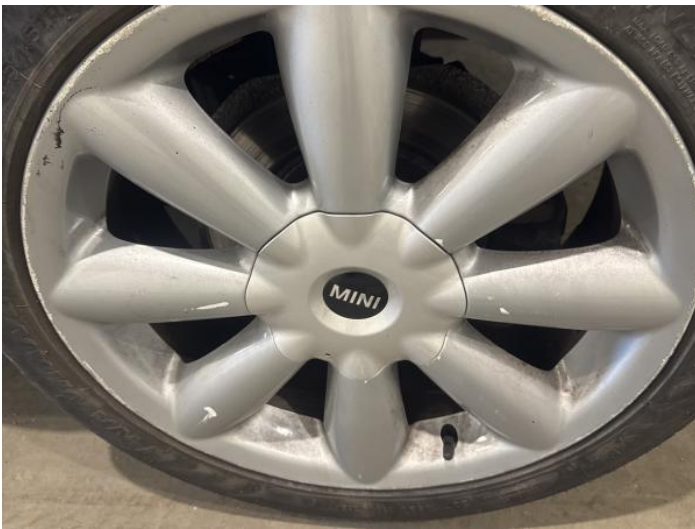
11: Wheel nsr
Scratched
Over 50mm

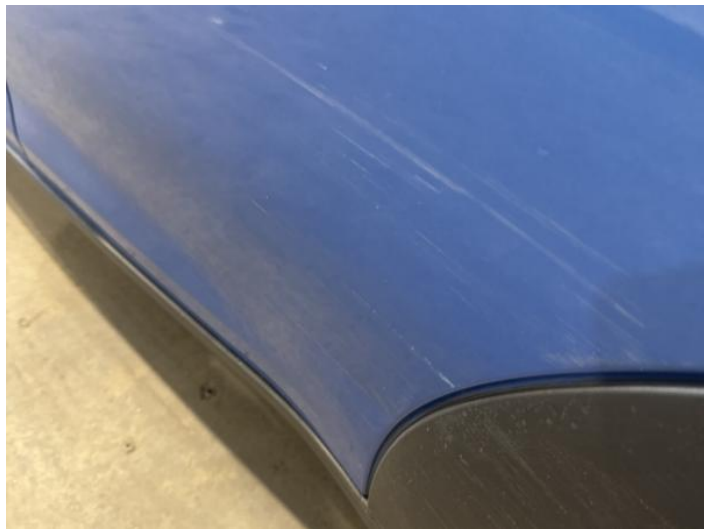
12: Door nsr
Dented
With Paint Damage

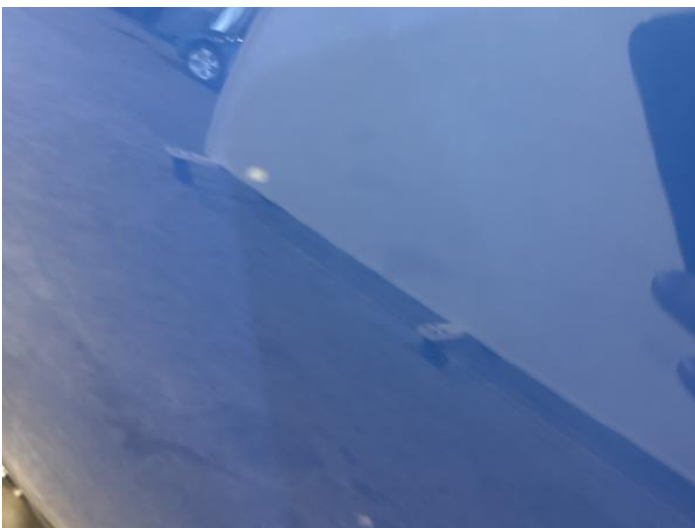
13: Door nsf
Chipped
1 To 5

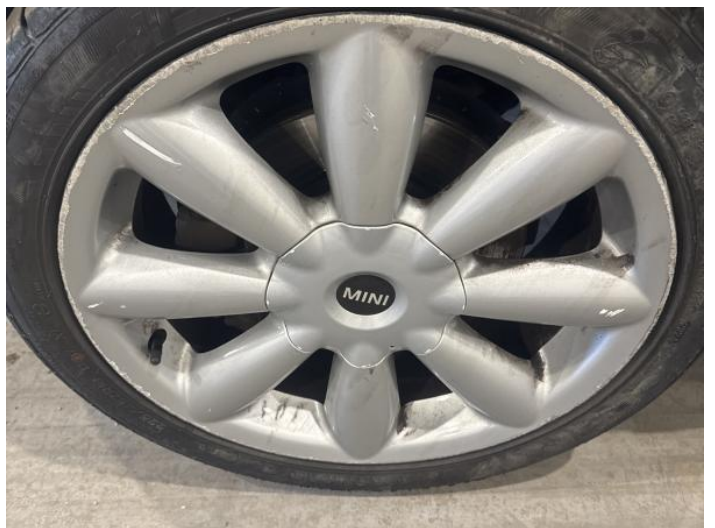
14: Wheel nsf
Scratched
Over 50mm

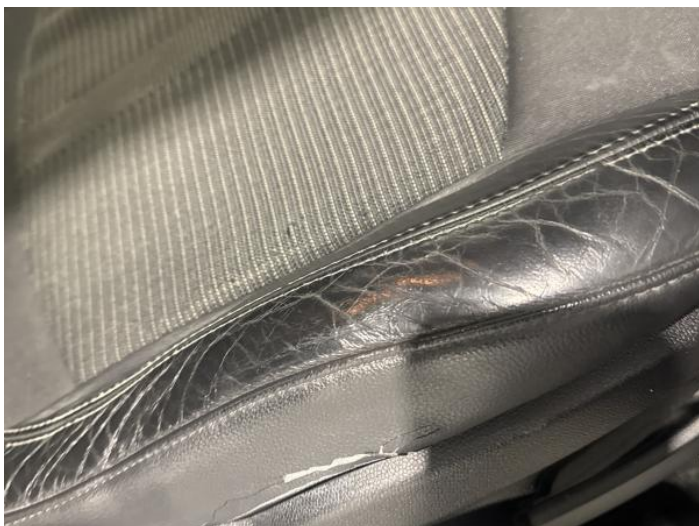
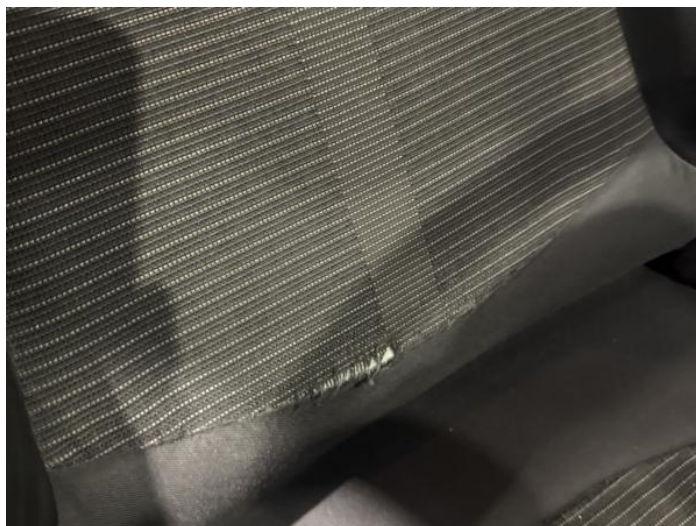
15: Seat Base Cover osf
Torn
Over 3mm

16: Seat Back Cover osf
Torn
Over 3mm
