# VEHICLE INSPECTION REPORT

**LN14HFA**

## Nissan Qashqai 1.2 DiG-T Acenta Premium 5dr

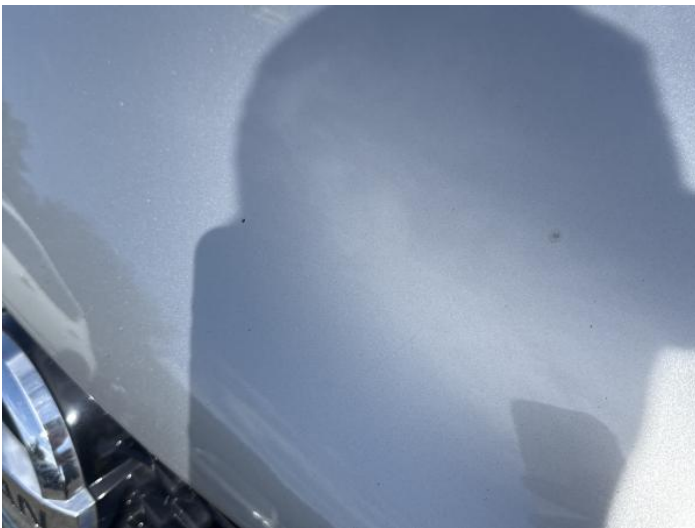
1: Bonnet  
Chipped  
Multiple Chips

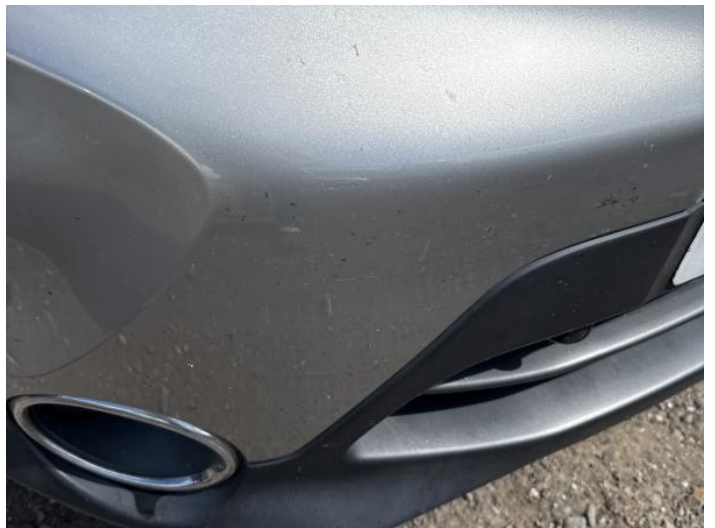
2: Bumper Front  
Scratched  
25 to 100mm Thru Paint

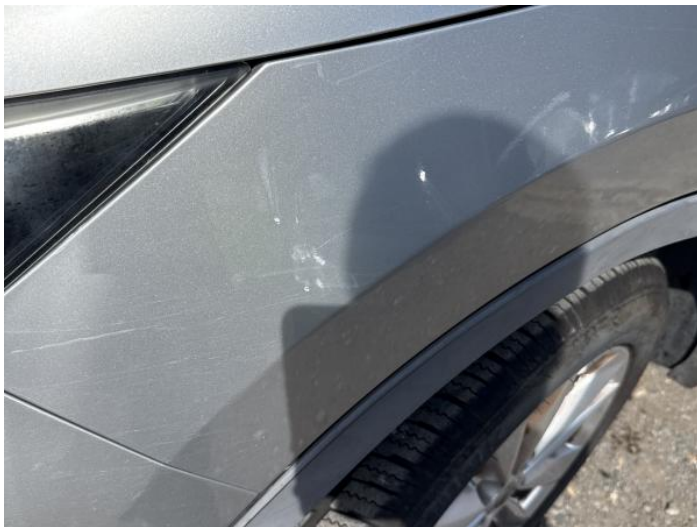
3: Wing nsf  
Scratched  
Over 25mm Thru Paint

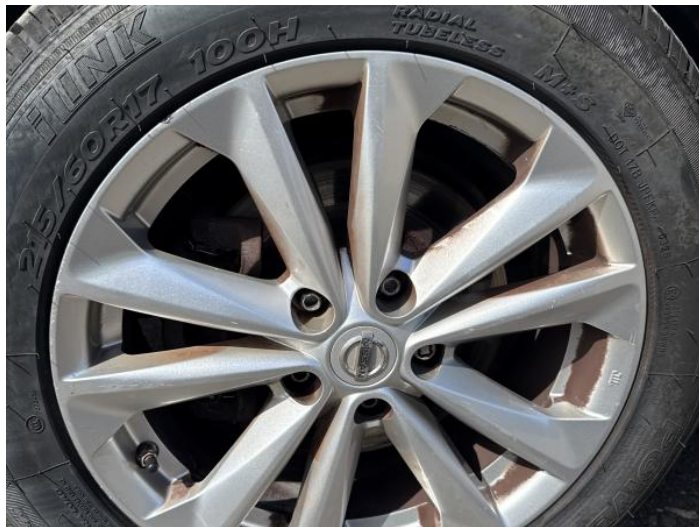
4: Wheel osf  
Scratched  
Over 50mm

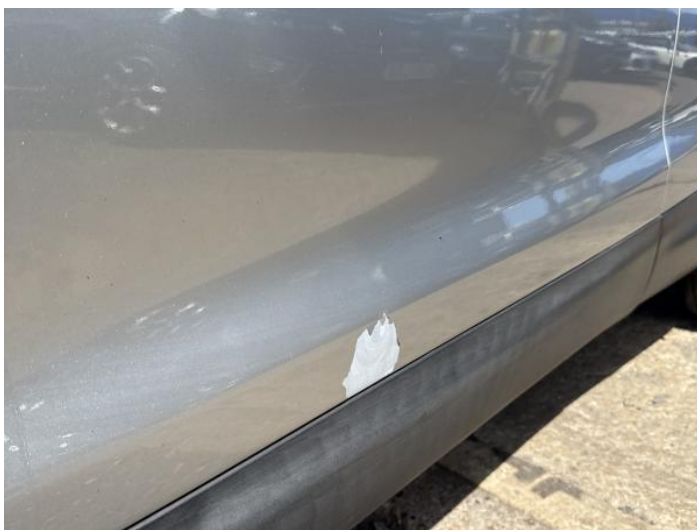
5: Door nsf  
Poor Previous Repair  
Paint Flake

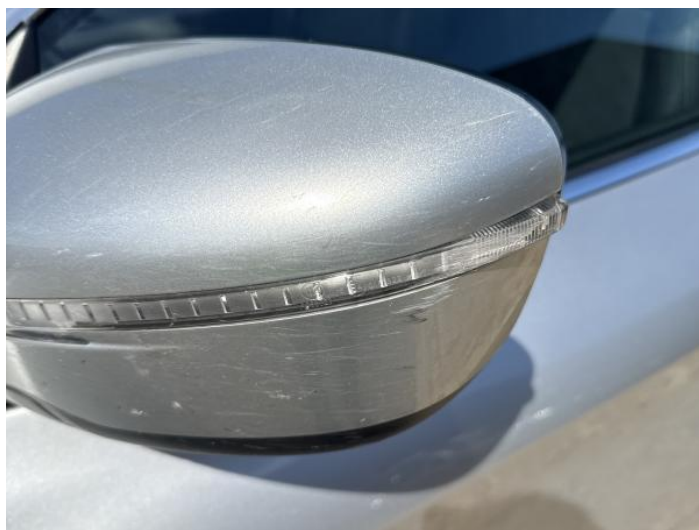
6: Door Mirror Assy nsf  
Scratched (Painted)  
Over 25mm Thru Paint

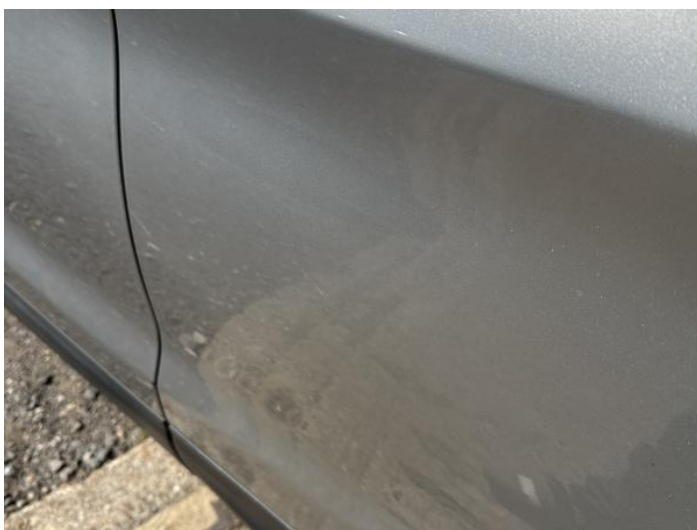
7: Door nsr  
Scratched  
Over 25mm Thru Paint

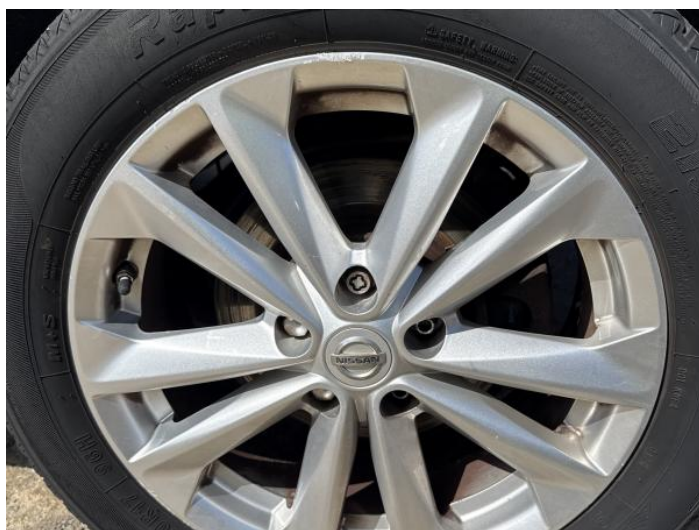
8: Wheel nsr  
Scratched  
Over 50mm

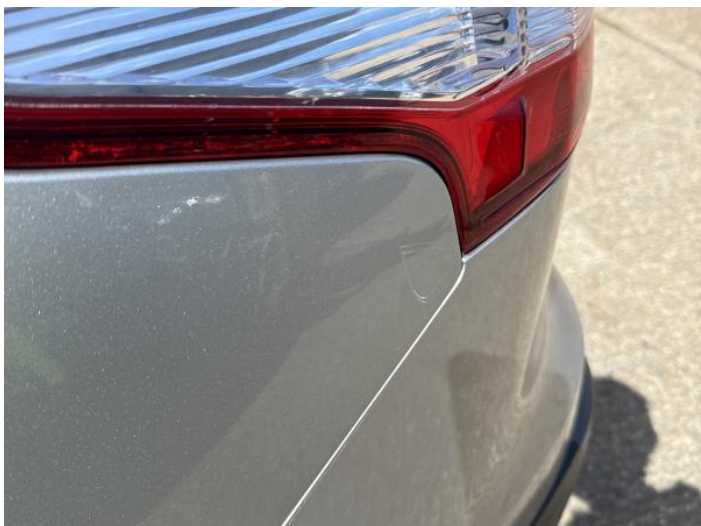
9: Qtr Panel nsr  
Scratched  
Over 25mm Thru Paint

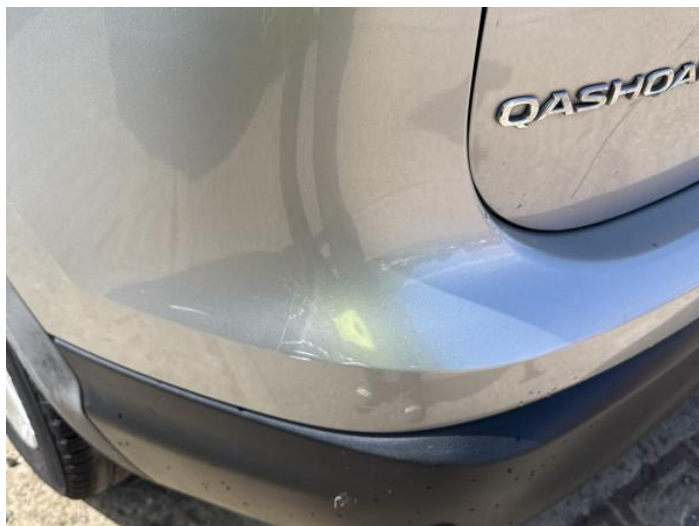
10: Bumper Rear  
Scratched  
Over 100mm Thru Paint

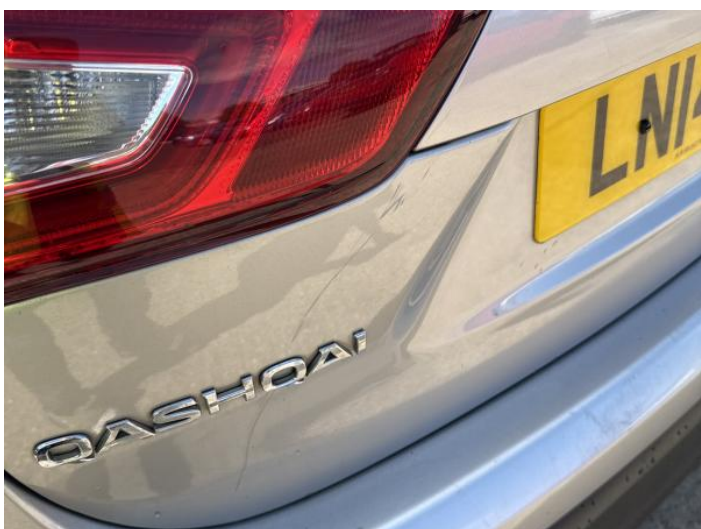
11: Tailgate  
Scratched  
Over 25mm Thru Paint

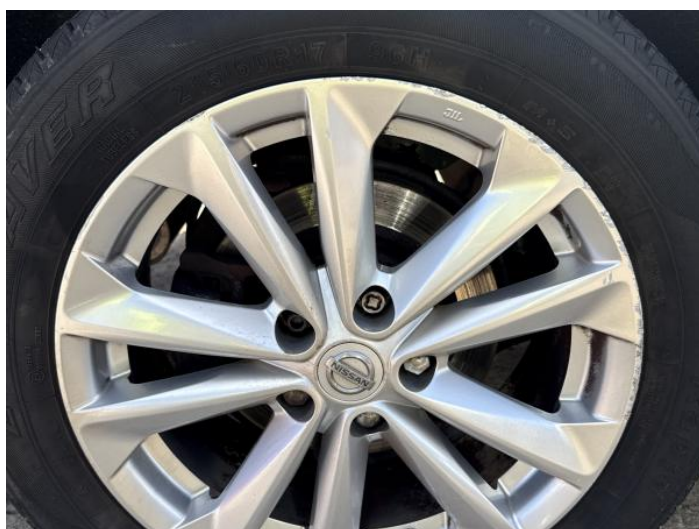
12: Wheel osr  
Scratched  
Over 50mm

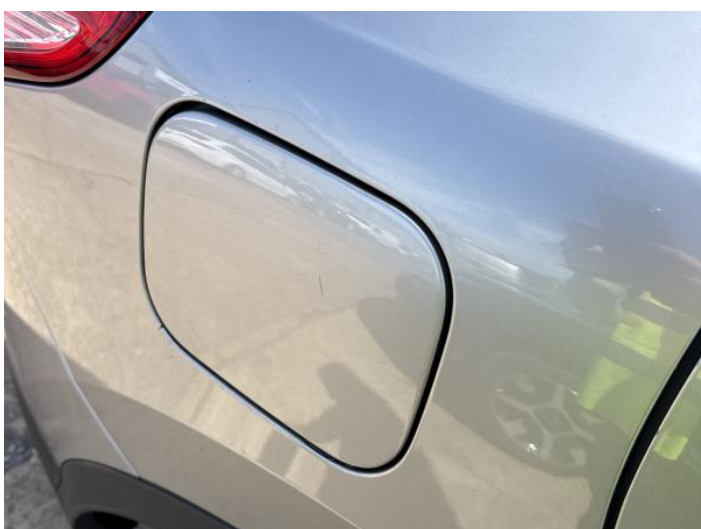
13: Qtr Panel osr  
Dented  
Over 30mm

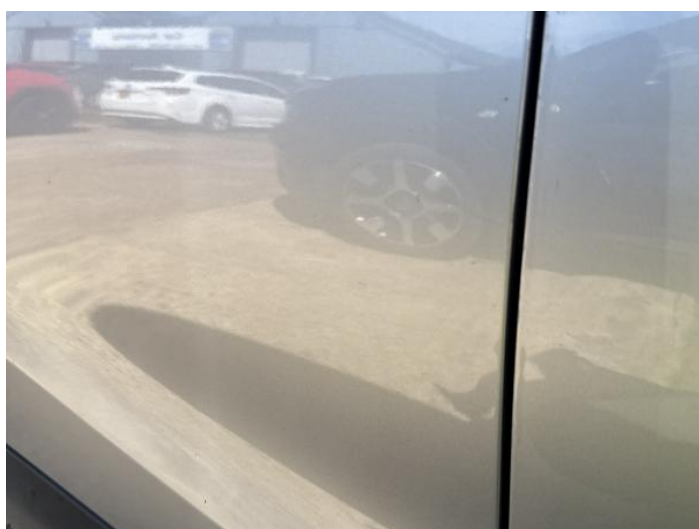
14: Door osr  
Scratched  
Over 25mm Thru Paint

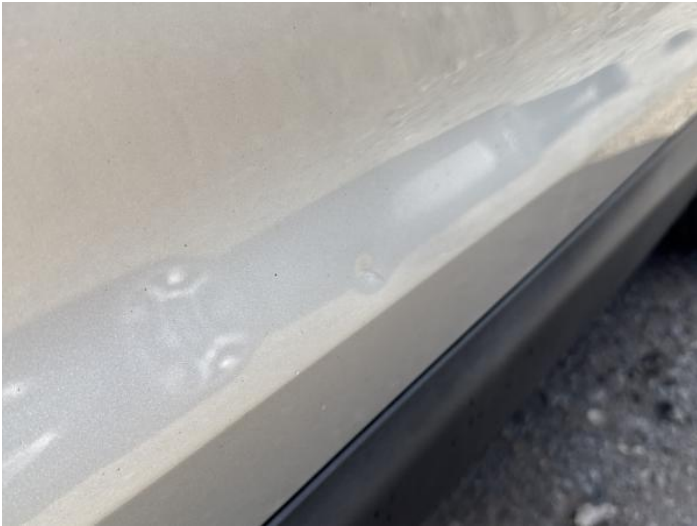
15: Door osf  
Dented  
2 Or Less UpTo 10mm

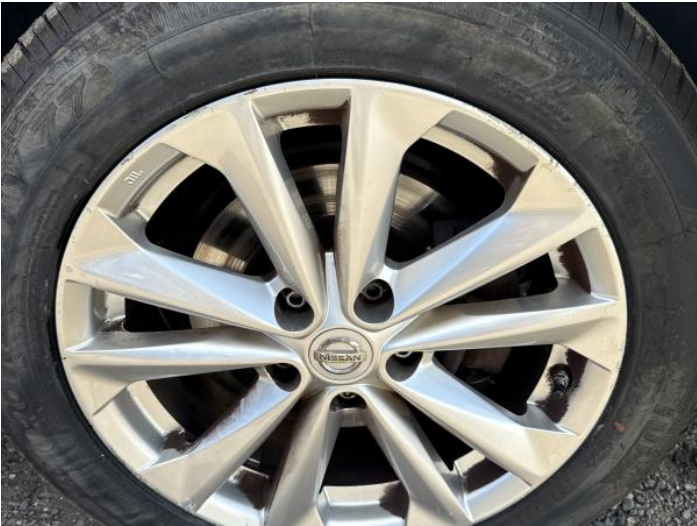
16: Wheel osf  
Scratched  
Over 50mm

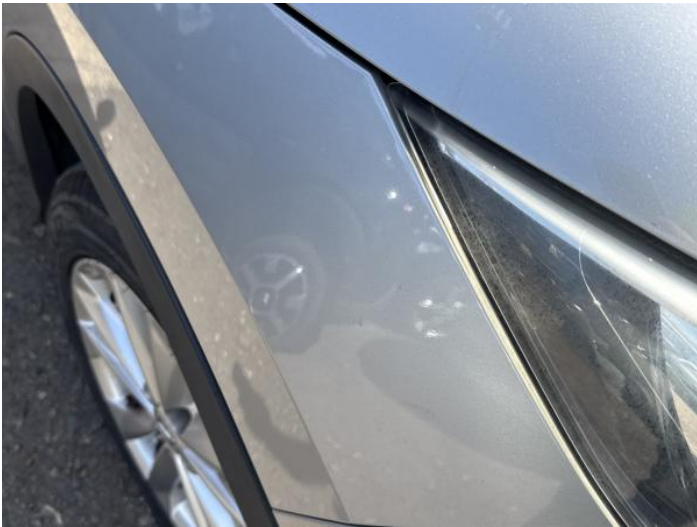
17: Wing osf  
Scratched  
UpTo 25mm Thru Paint
