VEHICLE INSPECTION REPORT

LV15SYZ

Mazda CX-3 1.5d Sport Nav 5dr AWD Auto

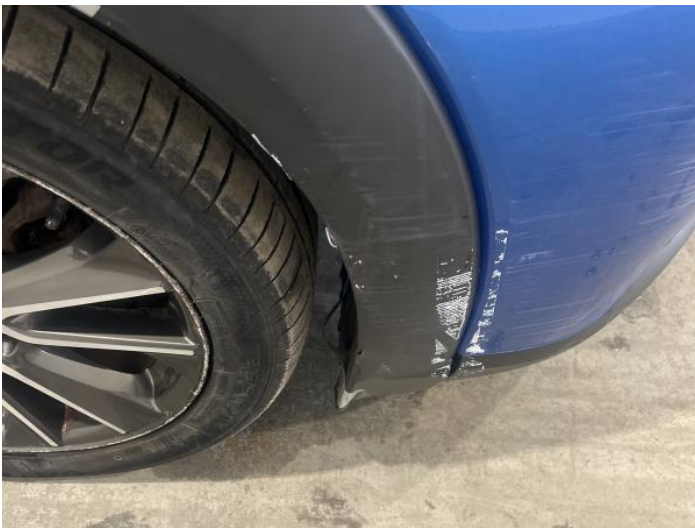
1: Qtr Panel Arch Extension os
Scuffed (Unpainted)
Over 100mm

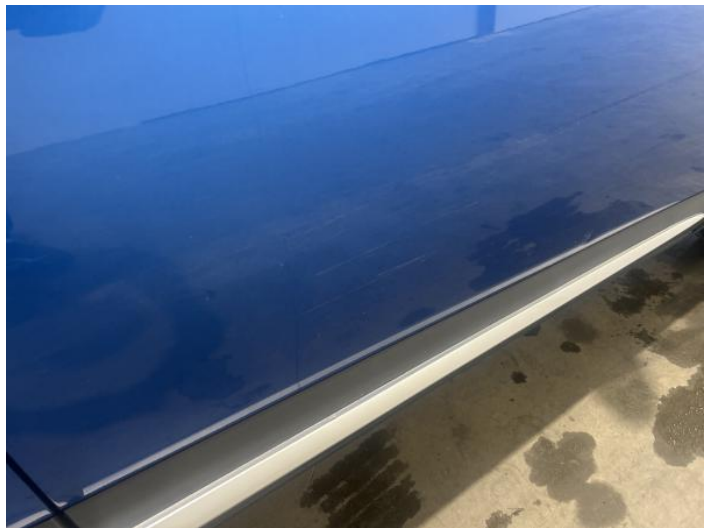
2: Door osf
Scratched
Over 25mm Thru Paint

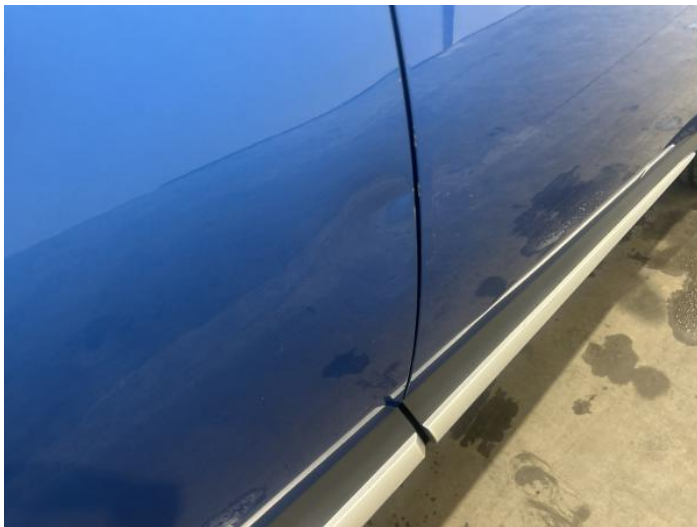
3: Door osr
Dented
Over 30mm

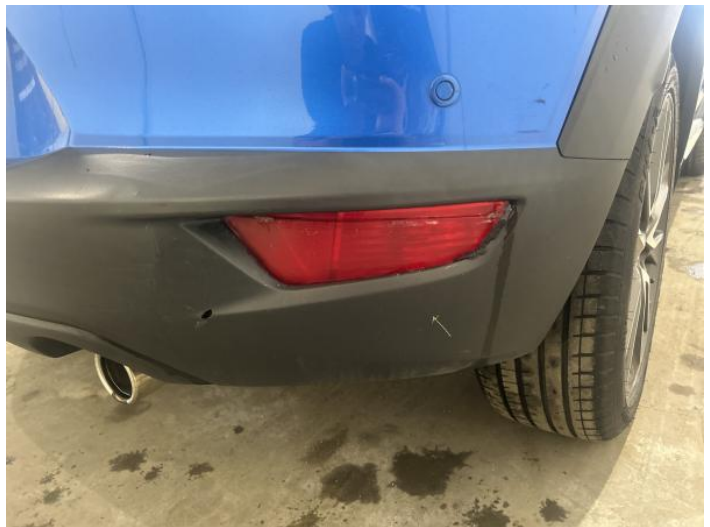
4: Reflector osr
Broken
Replace

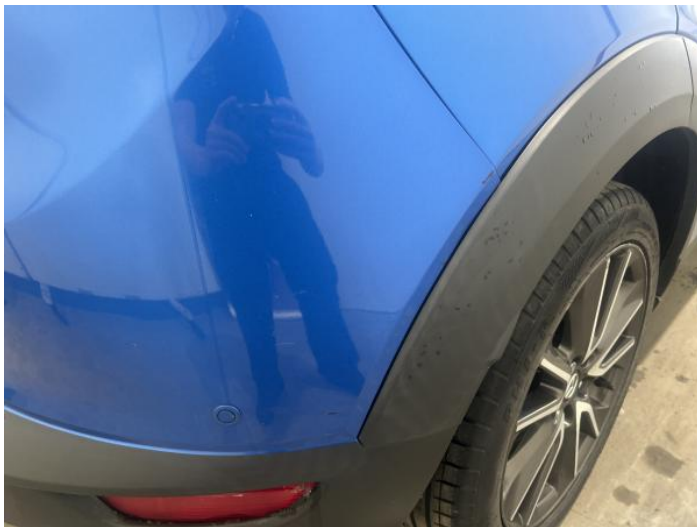
5: Bumper Rear
Scratched
25 to 100mm Thru Paint

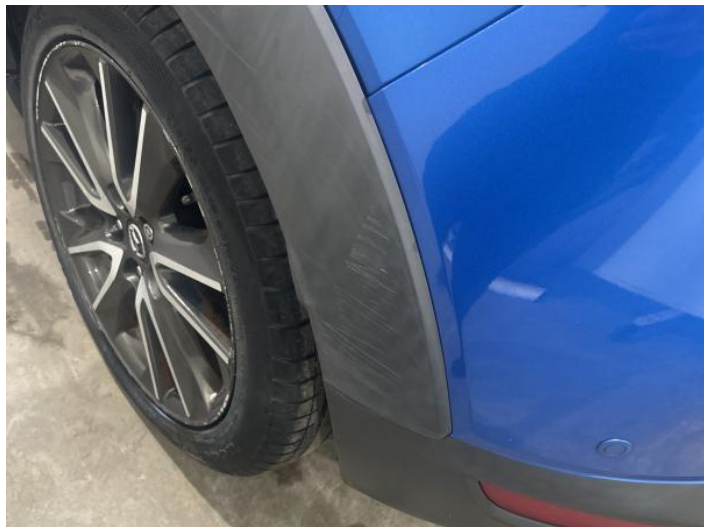
6: Qtr Panel Moulding ns
Scuffed (Unpainted)
Over 100mm

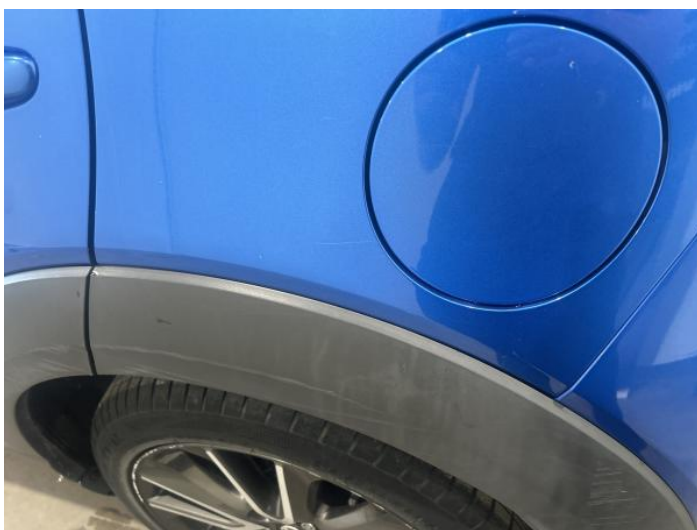
7: Qtr Panel nsr
Scratched
Over 25mm Thru Paint

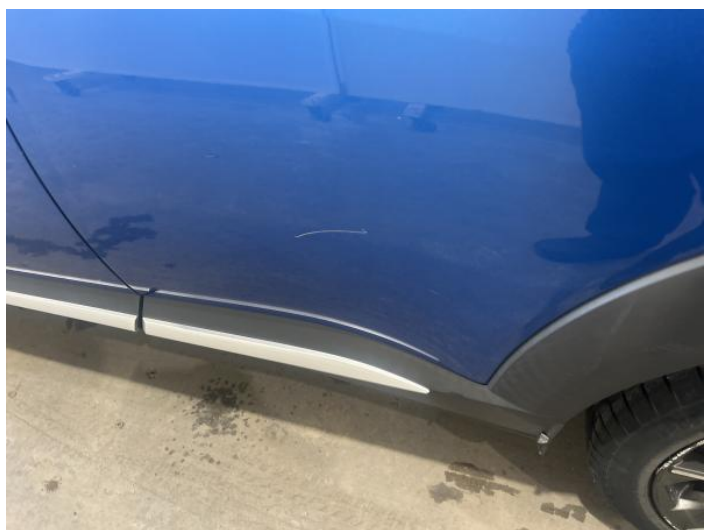
8: Door nsr
Scratched
Over 25mm Thru Paint

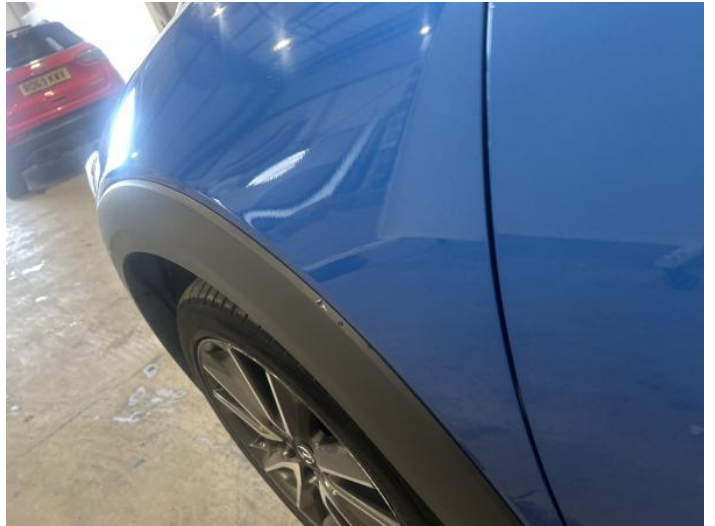
9: Door nsf
Scratched
Over 25mm Not Thru Paint

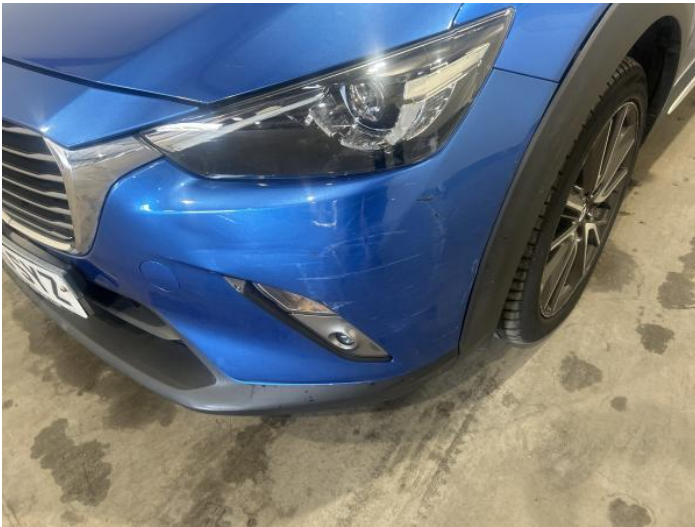
11: Bumper Front
Scratched
Over 100mm Thru Paint

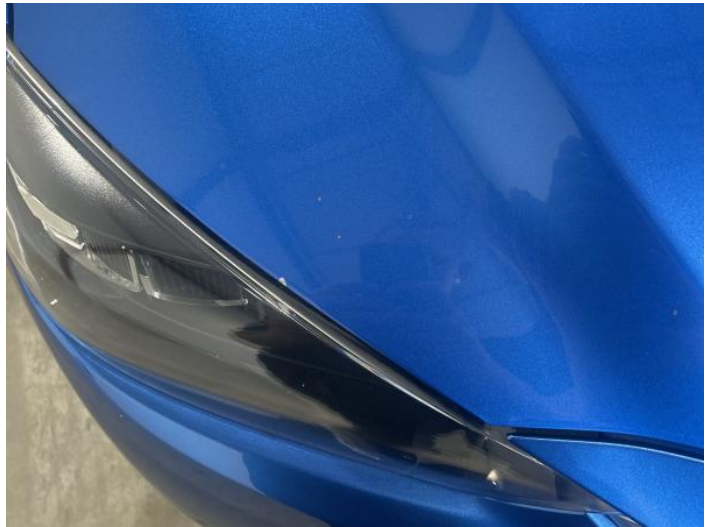
12: Bonnet
Chipped
1 To 5

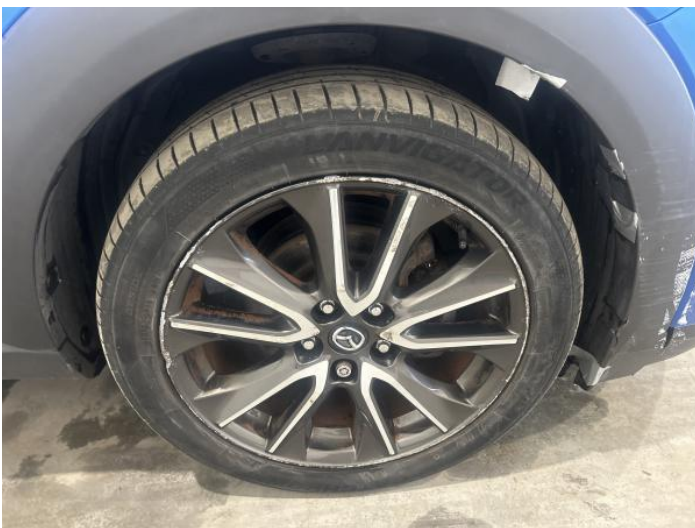
13: Wheel osf
Scratched
Over 50mm

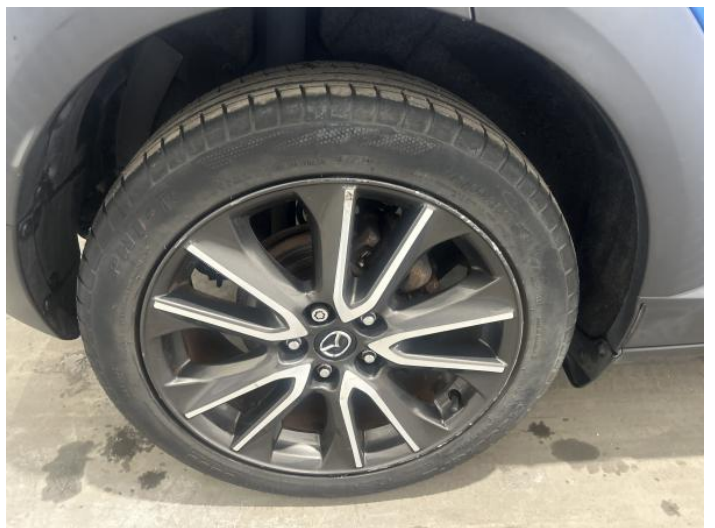
14: Wheel osr
Scratched
Over 50mm

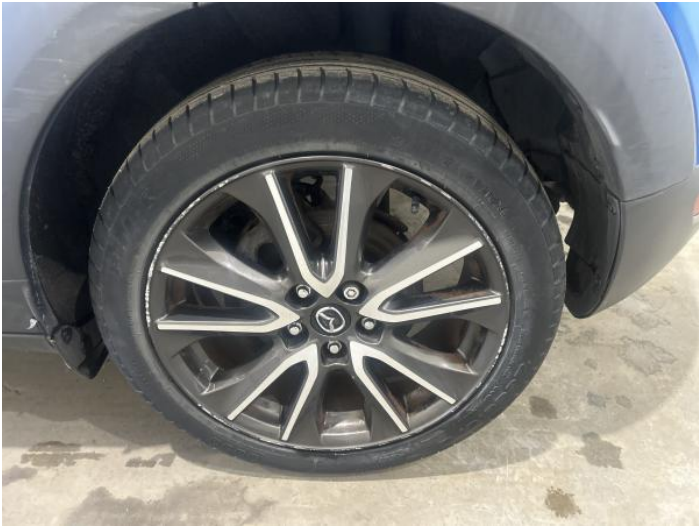
15: Wheel nsr
Scratched
Over 50mm

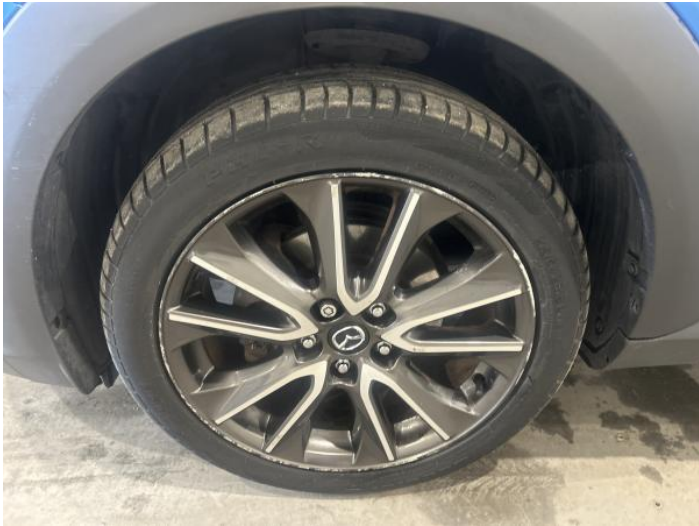
16: Wheel nsf
Scratched
Over 50mm
