# VEHICLE INSPECTION REPORT

**GY64XAF**

## Mini Hatchback 1.5 Cooper 5dr

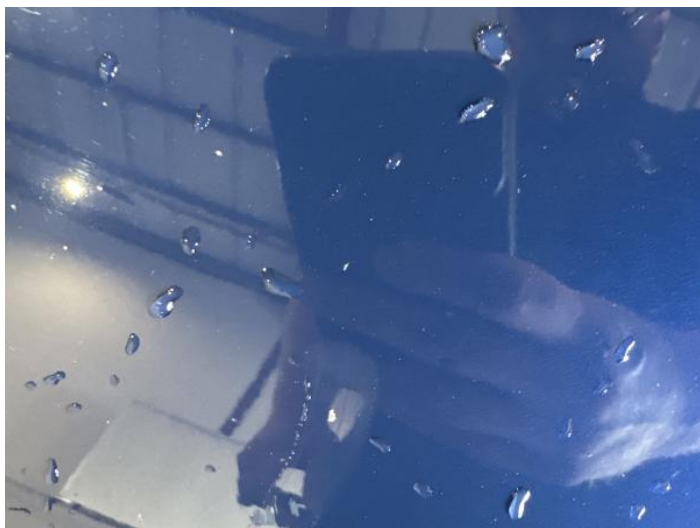
1: Bonnet  
Chipped  
1 To 5

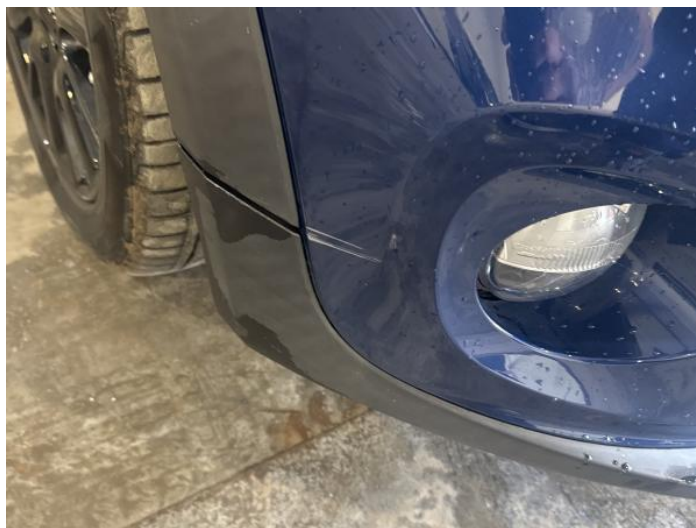
2: Bumper Front  
Scratched  
25 to 100mm Thru Paint

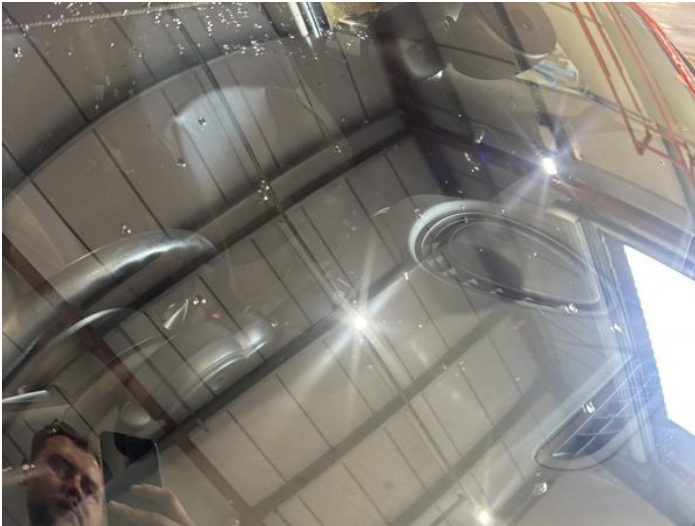
3: Screen Front  
Chipped  
UpTo 10mm

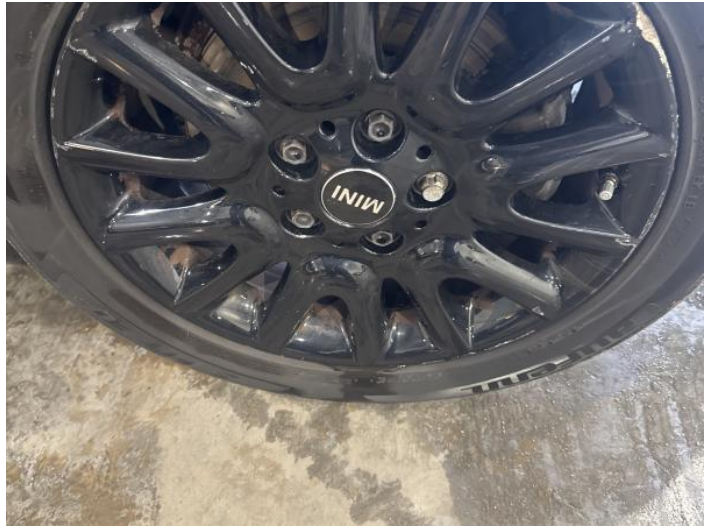
4: Wheel osf  
Scratched  
Over 50mm

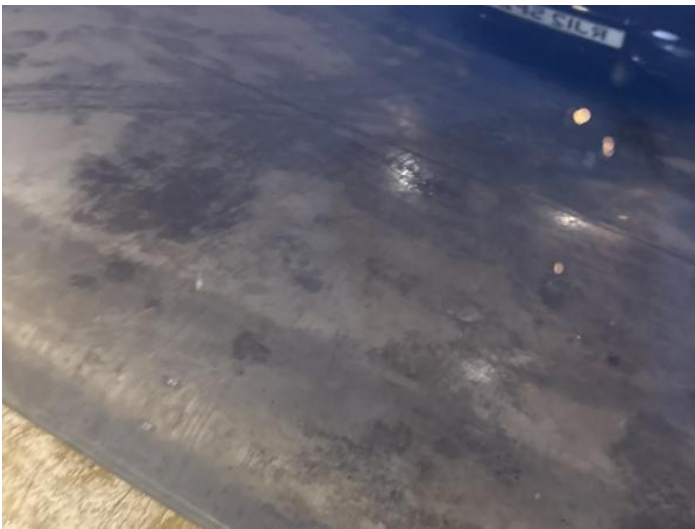
5: Door osf  
Chipped  
1 To 5

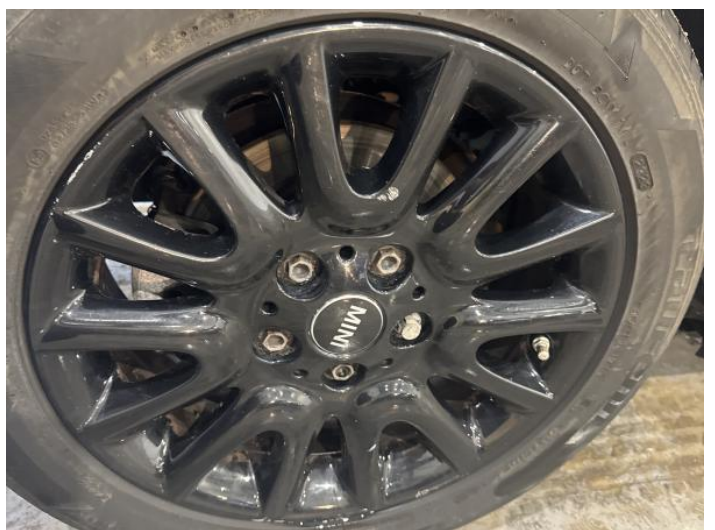
8: Wheel osr  
Scratched  
Over 50mm

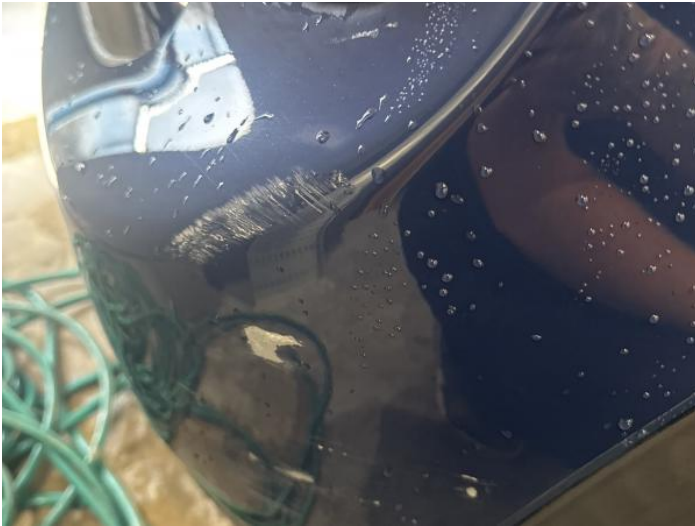
9: Bumper Rear  
 Scratched  
 Over 100mm Thru Paint

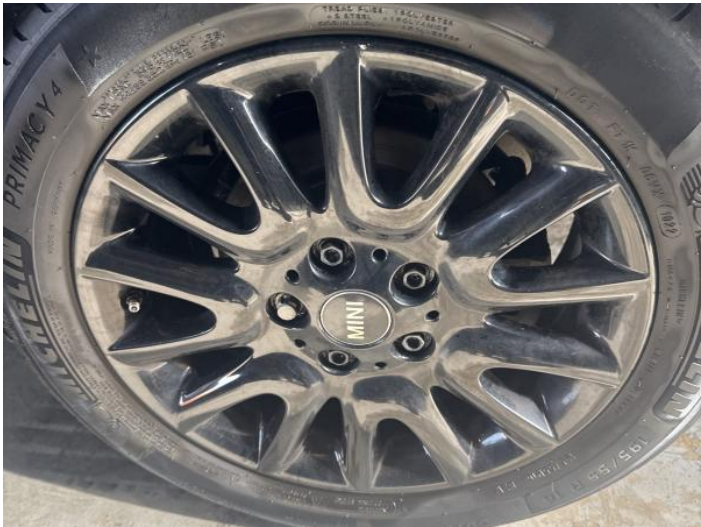
12: Wheel nsr  
 Scratched  
 Up To 50mm

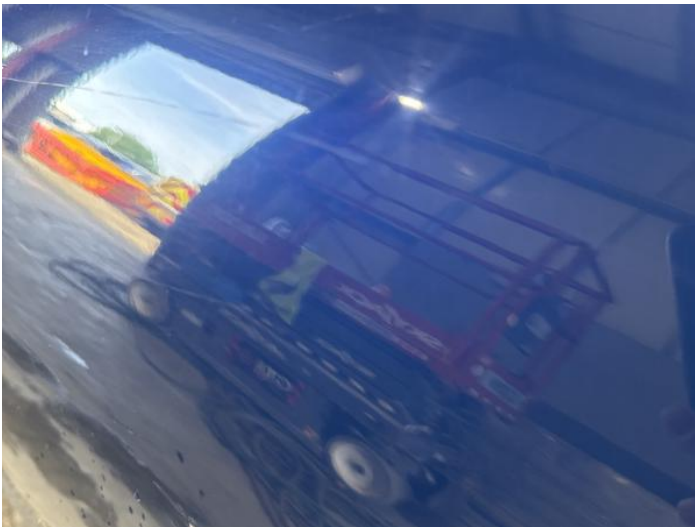
13: Door nsr  
 Scratched  
 Over 25mm Not Thru Paint

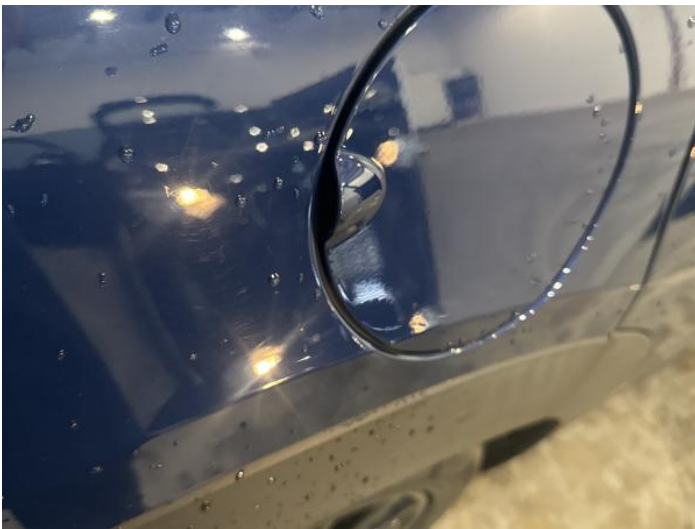
17: Qtr Panel osr  
Dented  
Over 30mm
