## VEHICLE INSPECTION REPORT

**LO63TYD**

### Hyundai IX35 1.7 CRDi Blue Drive Premium Panorama 5dr 2WD

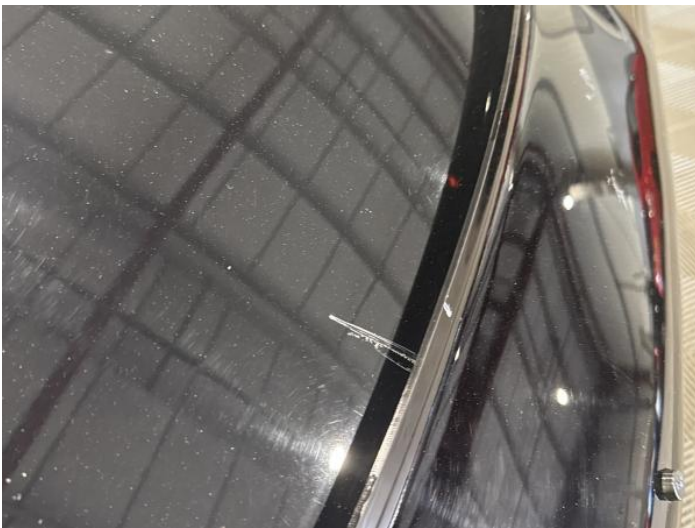
1: Bonnet  
Scratched  
Over 25mm Thru Paint

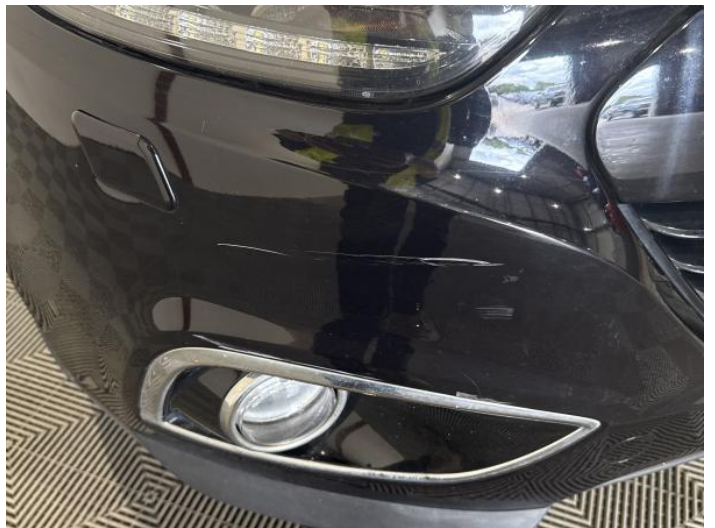
2: Bumper Front  
Scratched  
Over 100mm Thru Paint

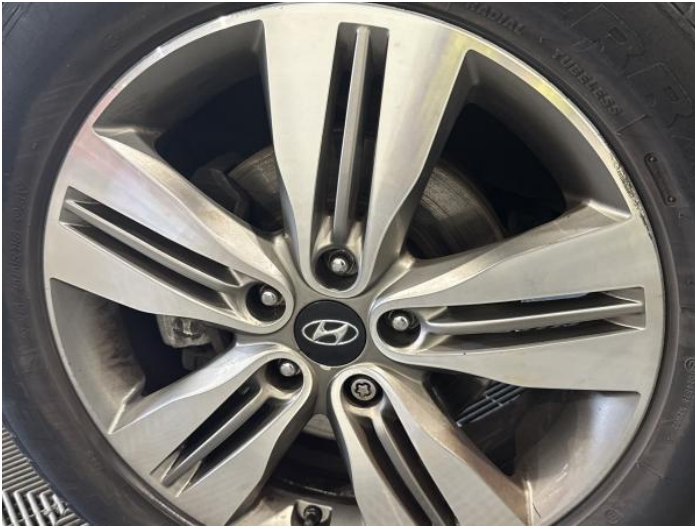
3: Wheel nsf  
Scratched  
Up To 50mm

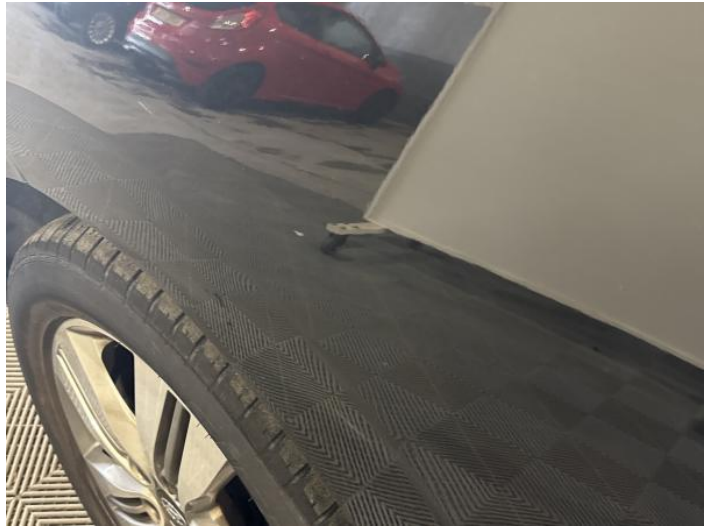
4: Wing nsf  
Scratched  
Over 25mm Thru Paint

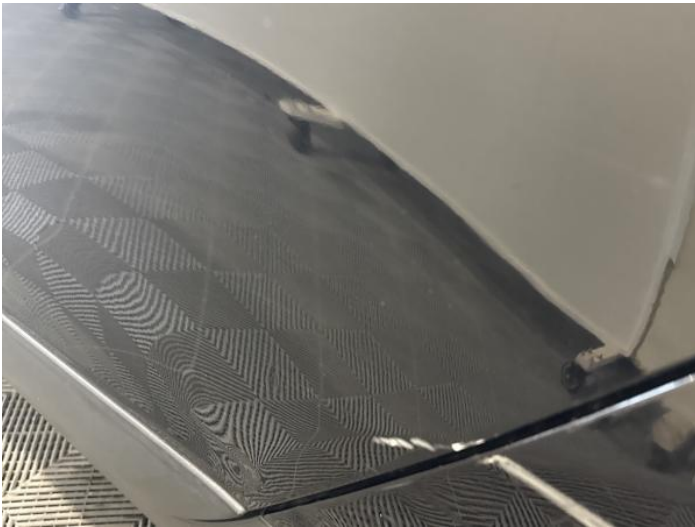
5: Door nsr  
Scratched  
Over 25mm Thru Paint

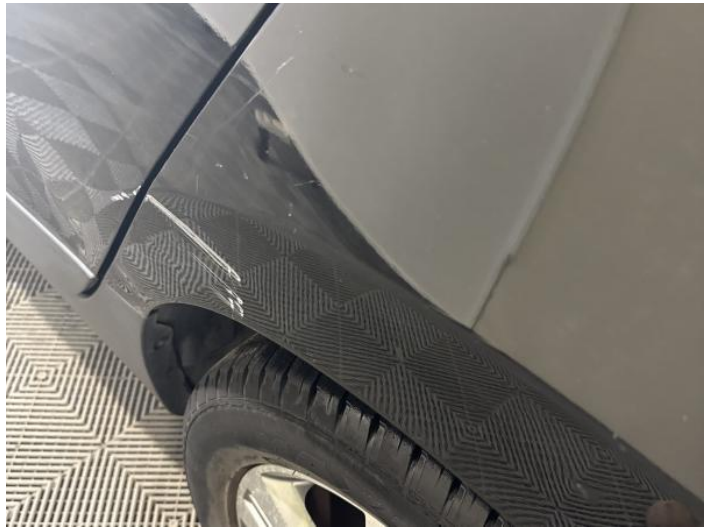
6: Qtr Panel nsr  
Dented  
With Paint Damage

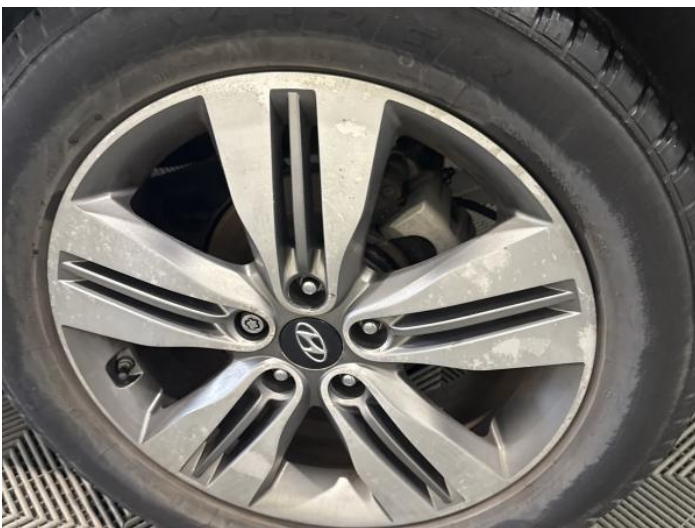
7: Wheel nsr  
Scratched  
Over 50mm

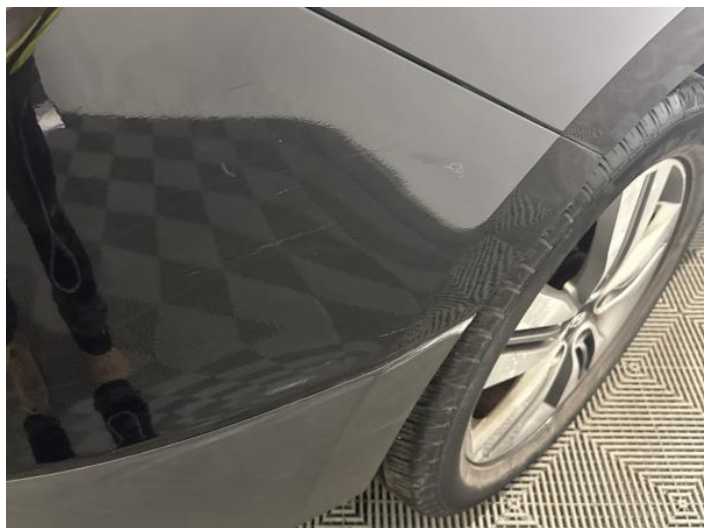
8: Bumper Rear  
Scratched  
Over 100mm Thru Paint

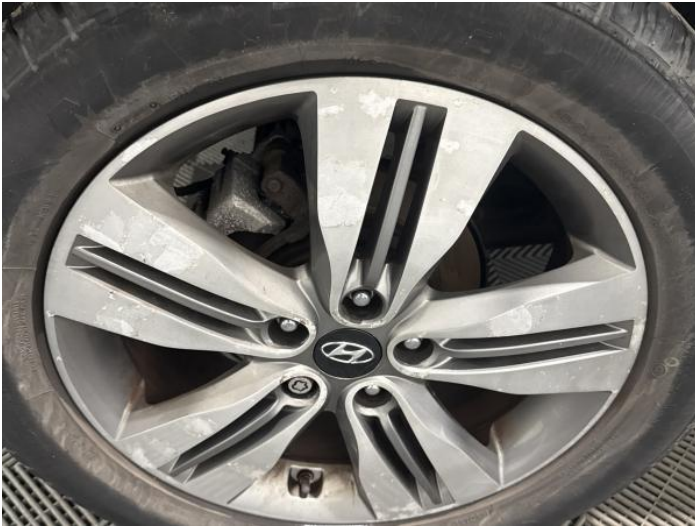
9: Wheel osr  
Scratched  
Over 50mm

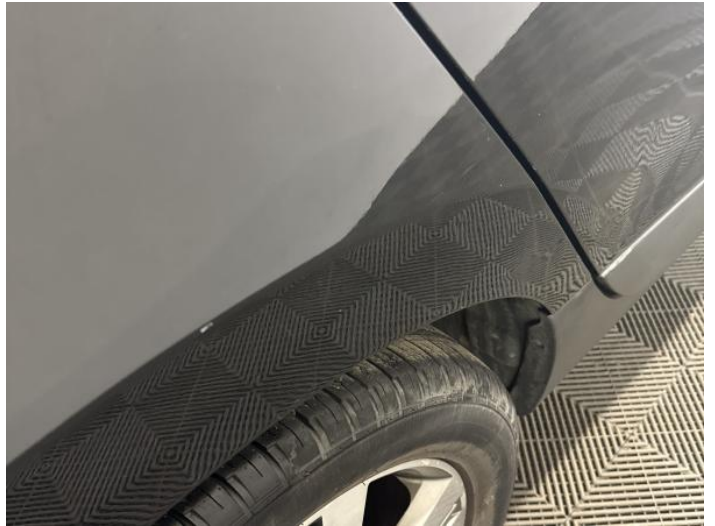
10: Qtr Panel osr  
Scratched  
UpTo 25mm Thru Paint

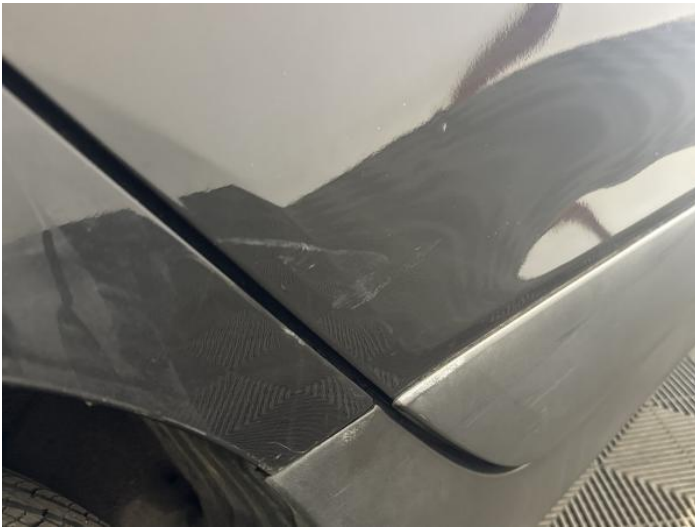
11: Door osr  
Dented  
With Paint Damage

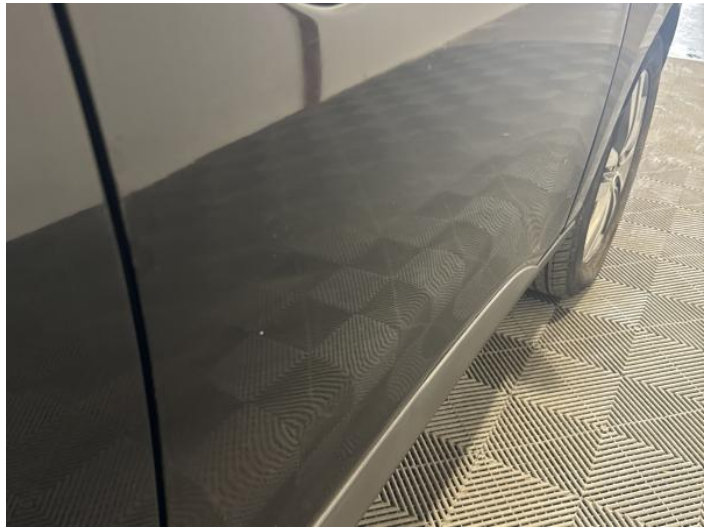
12: Door osf  
Poor Previous Repair  
Rippled UpTo 30%

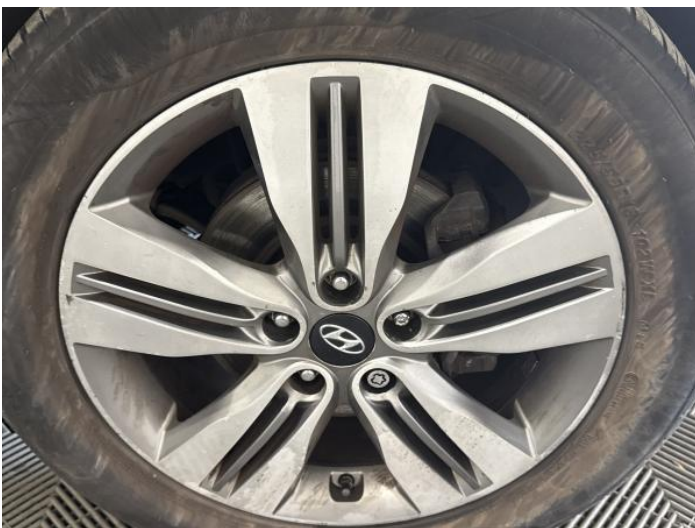
13: Wheel osf  
Scratched  
Over 50mm

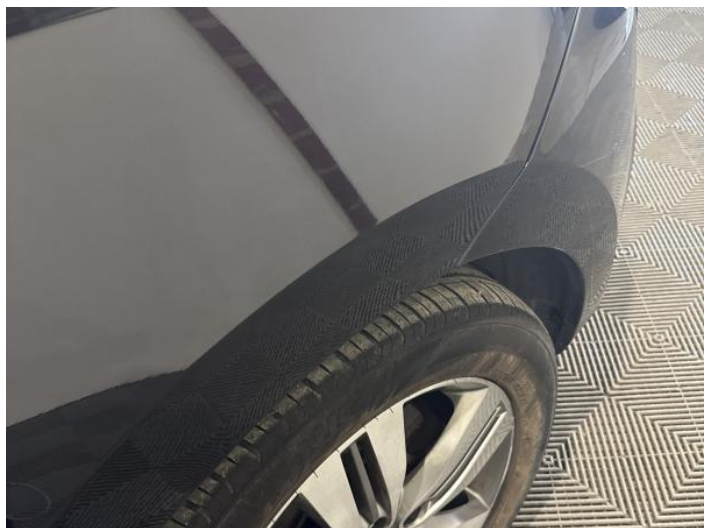
14: Wing osf  
Scratched  
Over 25mm Thru Paint

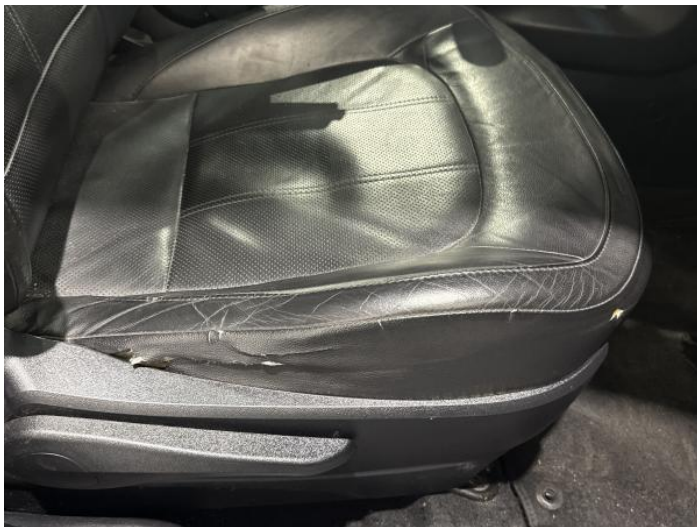
15: Seat Base Cover osf  
Scuffed  
Over 25mm

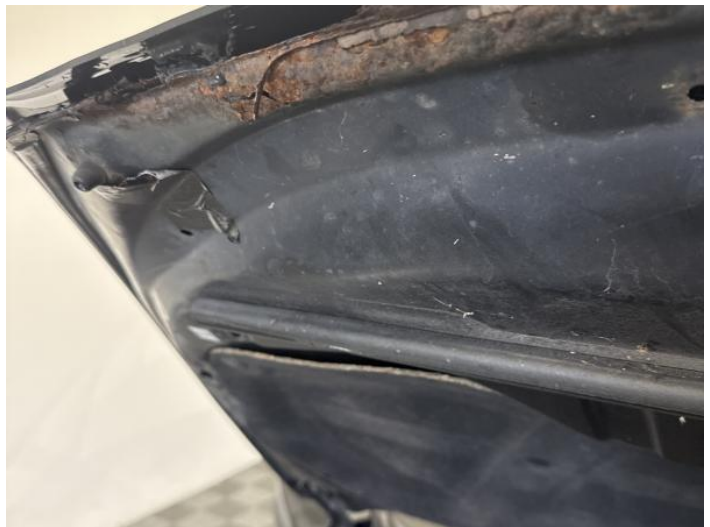
16: Bonnet  
Rusted  
Holed
