VEHICLE INSPECTION REPORT

LS14TYV

Mazda 3 2.0 SE-L 5dr

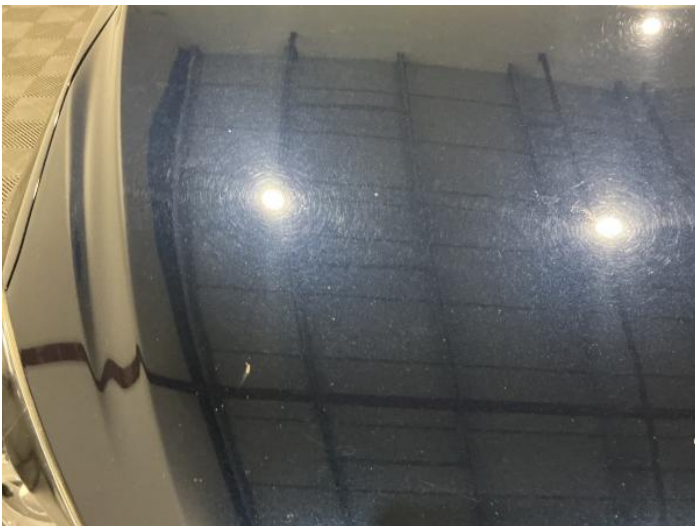
1: Bonnet
Chipped
Multiple Chips

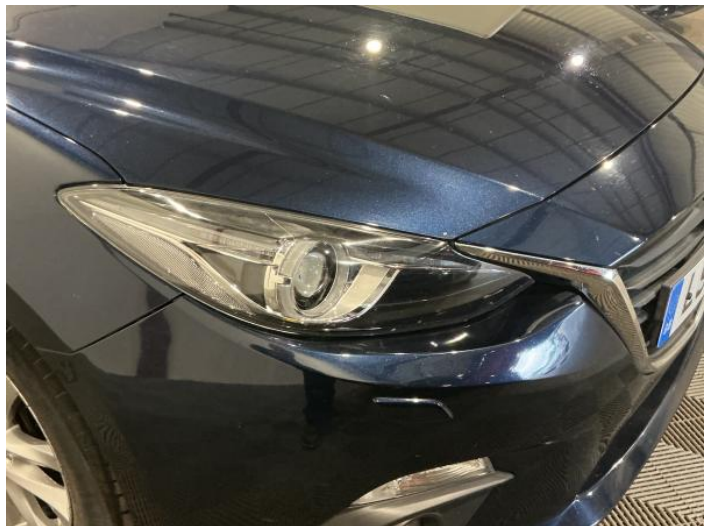
2: Bumper Front
Scratched
Over 100mm Thru Paint

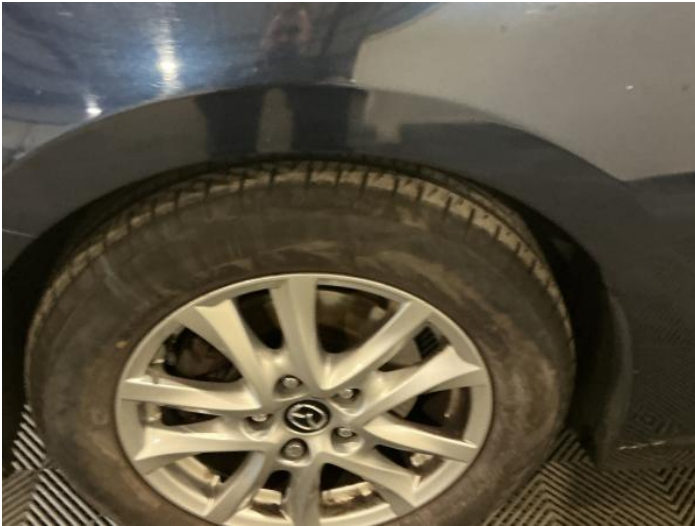
3: Wheel nsf
Scratched
Over 50mm

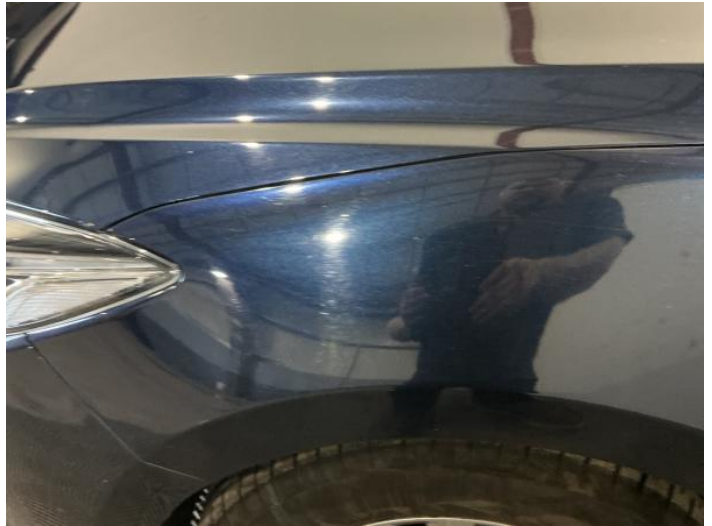
4: Wing nsf
Chipped
1 To 5

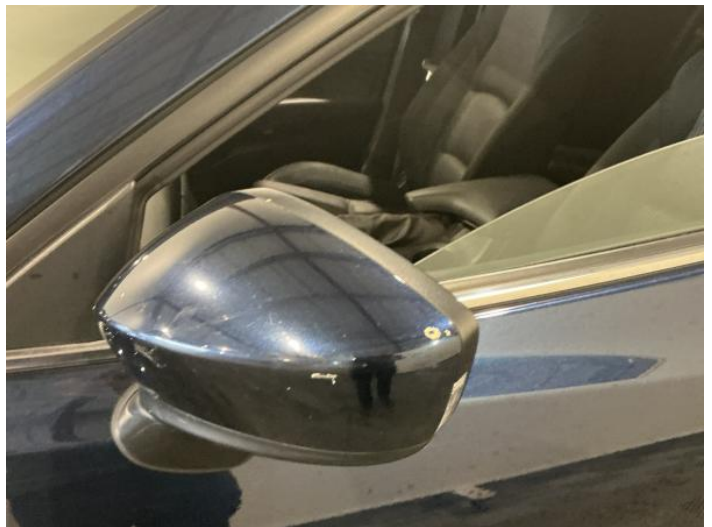
6: Door Mirror Assy nsf
Scratched (Painted)
Over 25mm Thru Paint

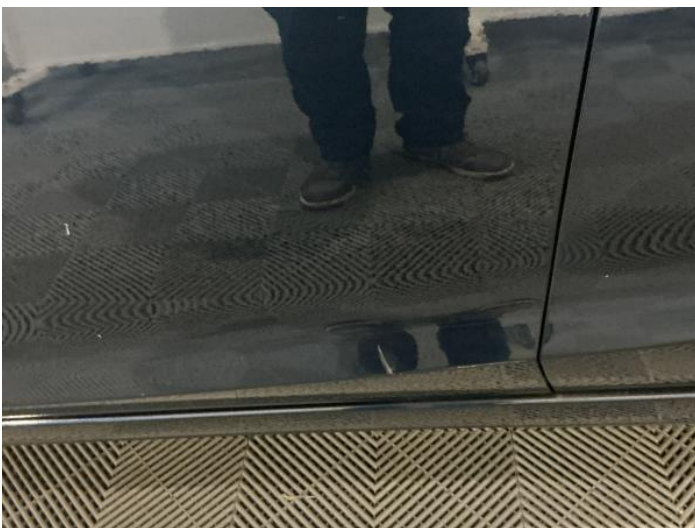
7: Door nsf
Dented
With Paint Damage

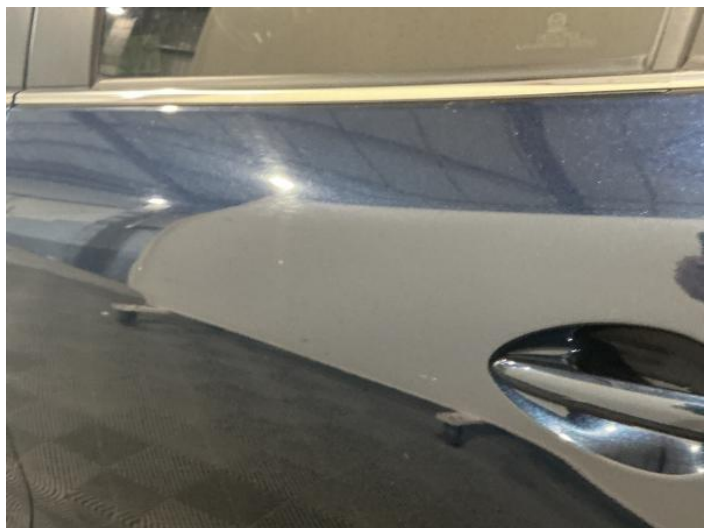
8: Door nsr
Dented
2 Or Less UpTo 10mm

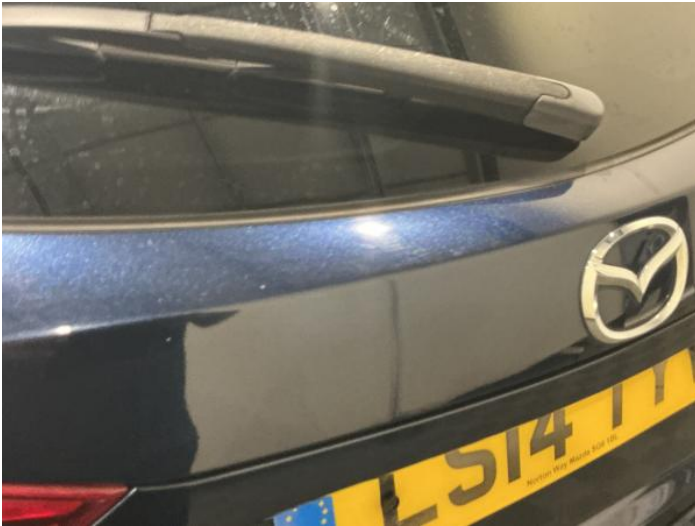
15: Boot Lid
Chipped
1 To 5

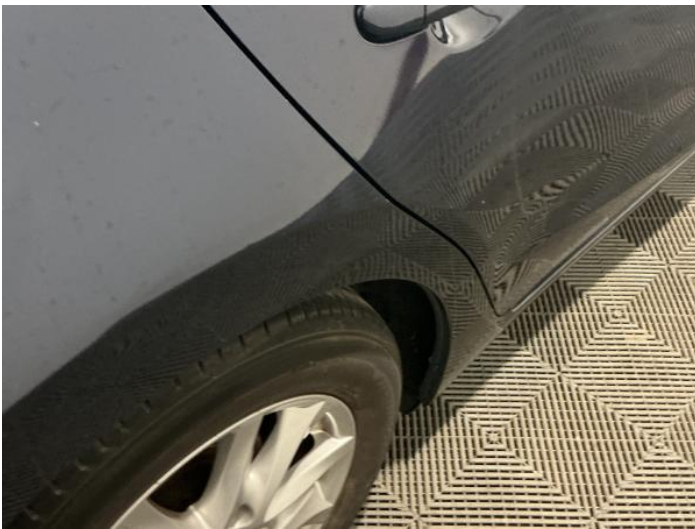
17: Qtr Panel osr
Dented
2 Or Less UpTo 10mm

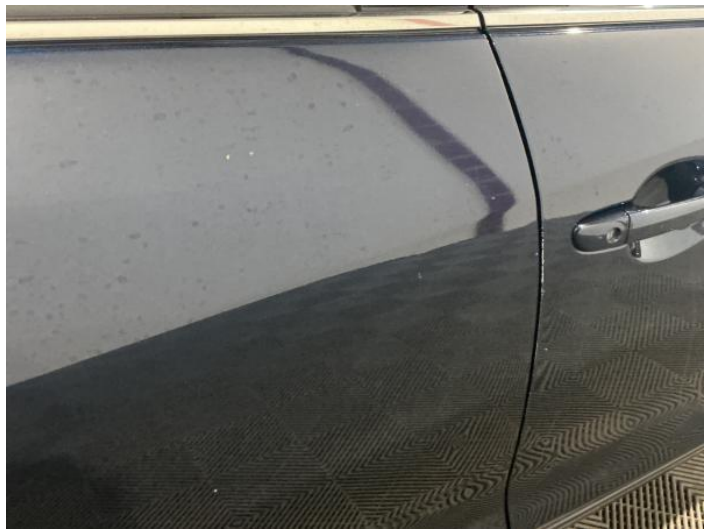
18: Door osr
Chipped
1 To 5

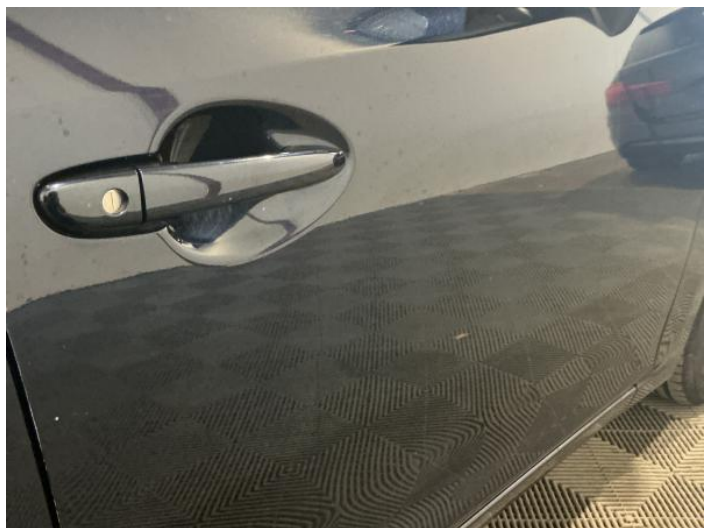
20: Door osf
Chipped
1 To 5

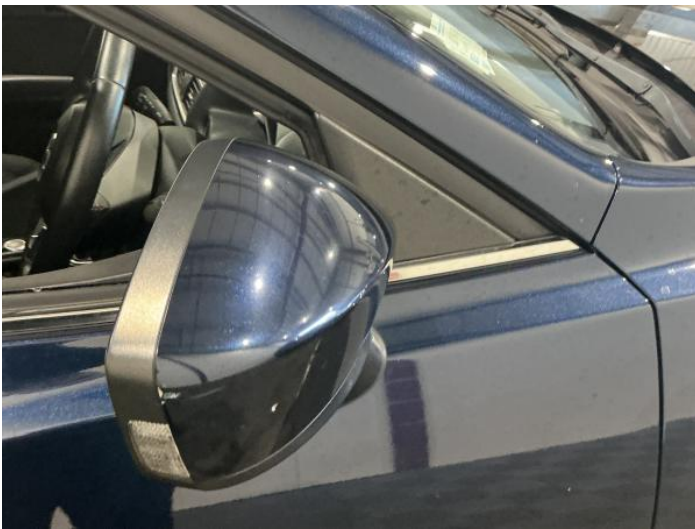
23: Door Mirror Assy osf
Scratched (Painted)
UpTo 25mm Thru Paint

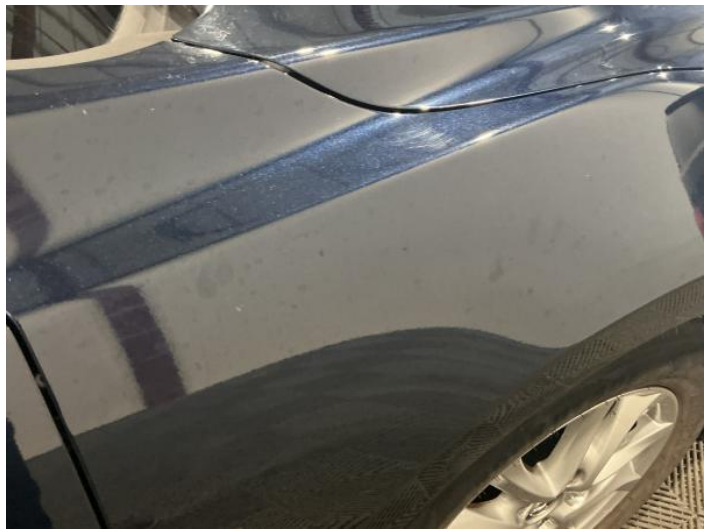
24: Wing osf
Chipped
Multiple Chips

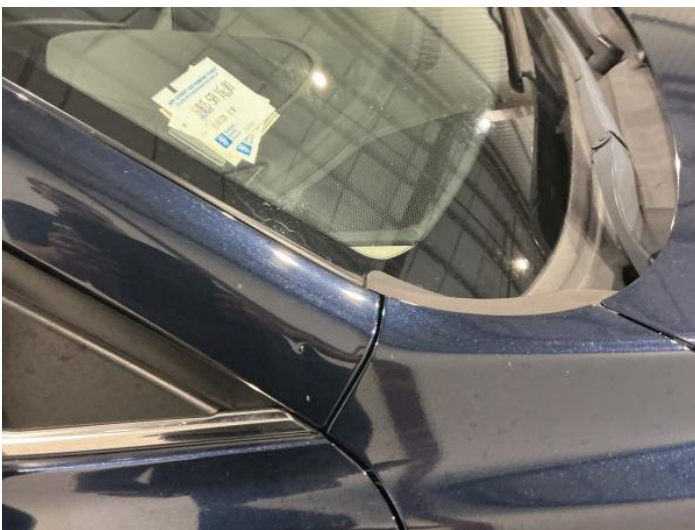
25: A Post os
Dented
Over 2 UpTo 10mm

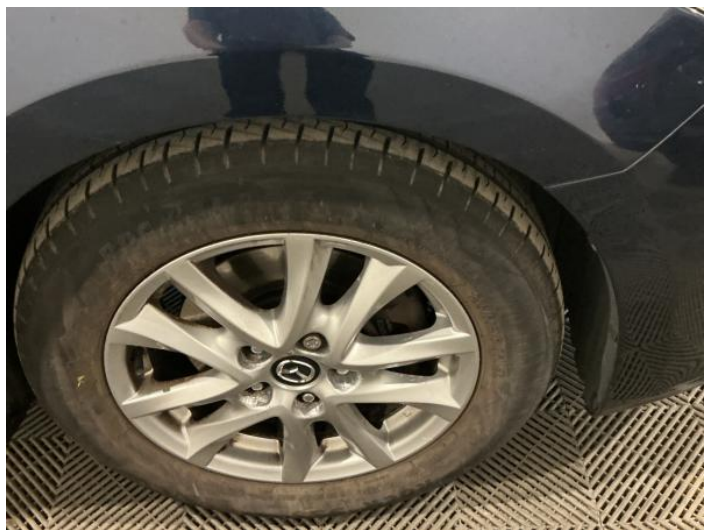
26: Wheel osf
Scratched
Over 50mm
