# VEHICLE INSPECTION REPORT

**LM62SKZ**

## Nissan Juke 1.6 Shiro 5dr

nama  
GRADE  
**3**

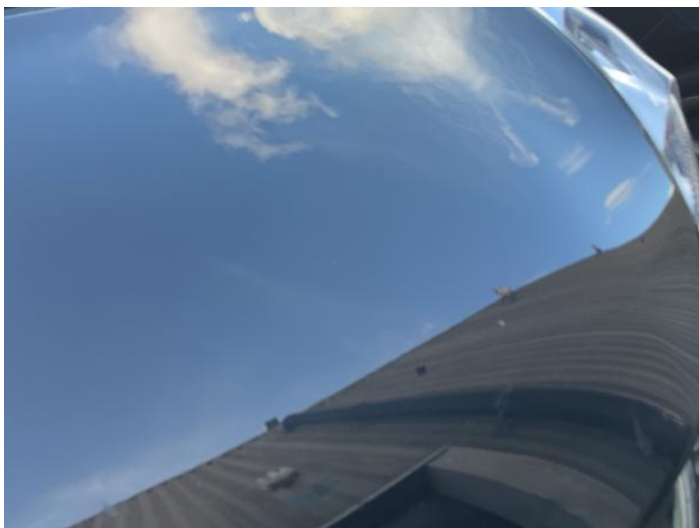
1: Bonnet  
Chipped  
1 To 5

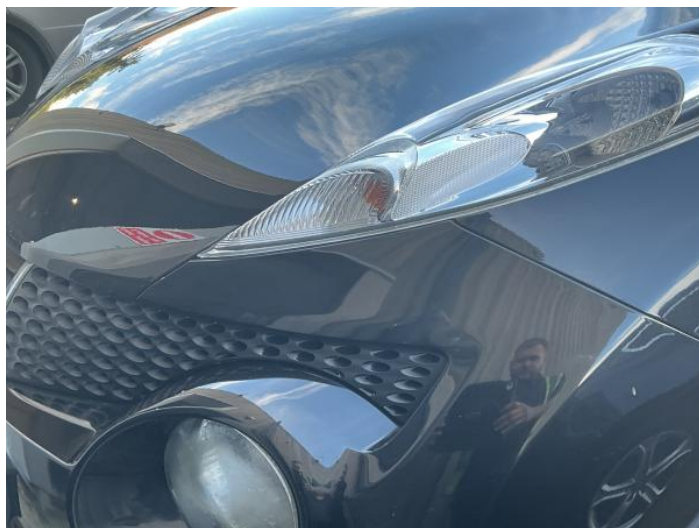
2: Bumper Front  
Chipped  
Multiple Chips

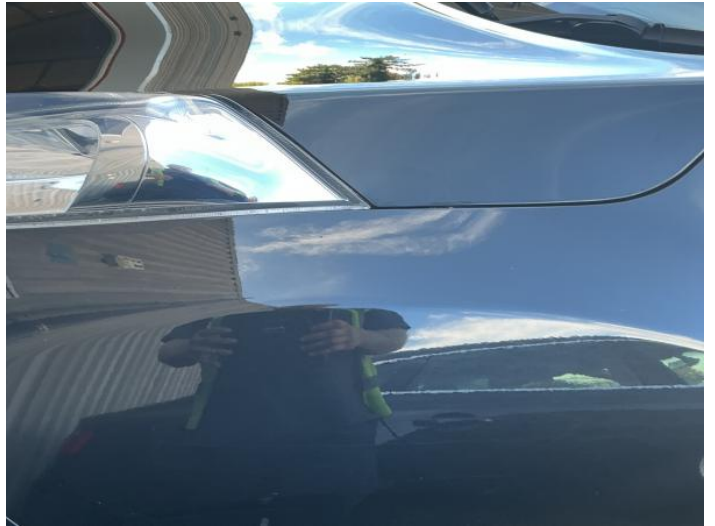
4: Wing nsf  
Chipped  
1 To 5

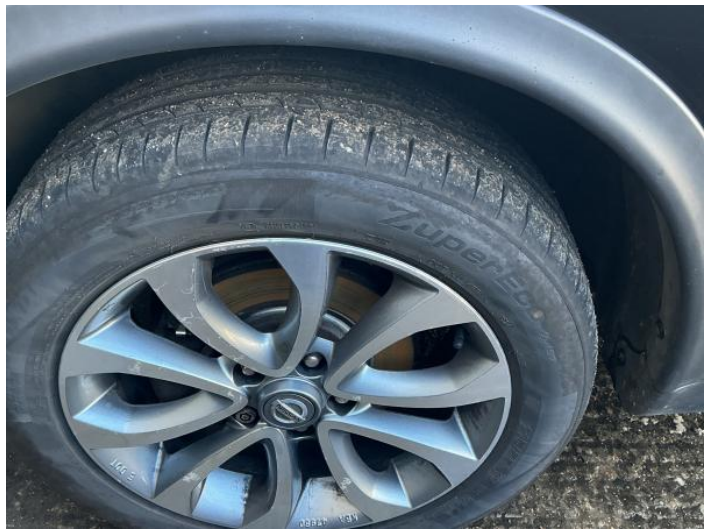
6: Wheel nsf  
Scratched  
Over 50mm

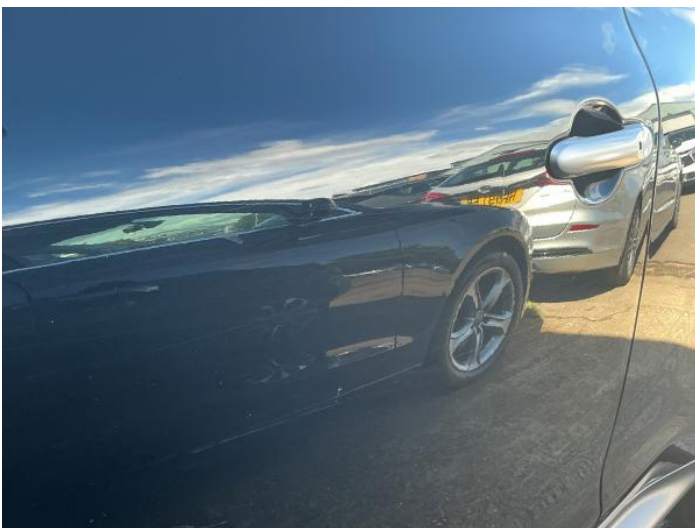
7: Door nsf  
Dented  
With Paint Damage

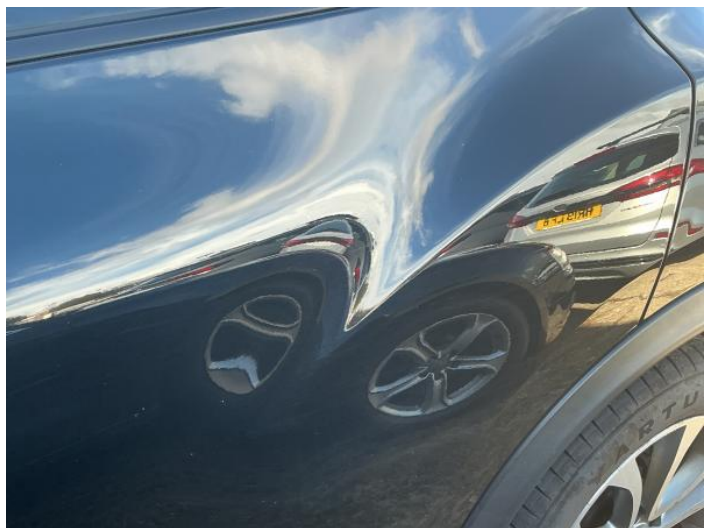
8: Door nsr  
Chipped  
1 To 5

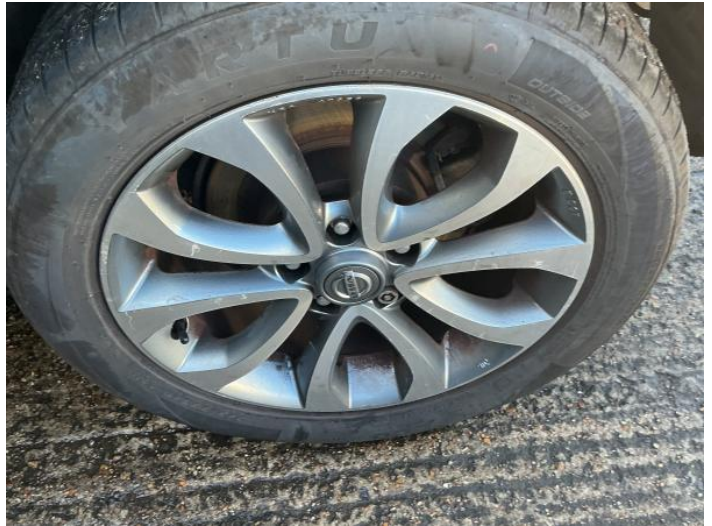
10: Wheel nsr  
Scratched  
Over 50mm

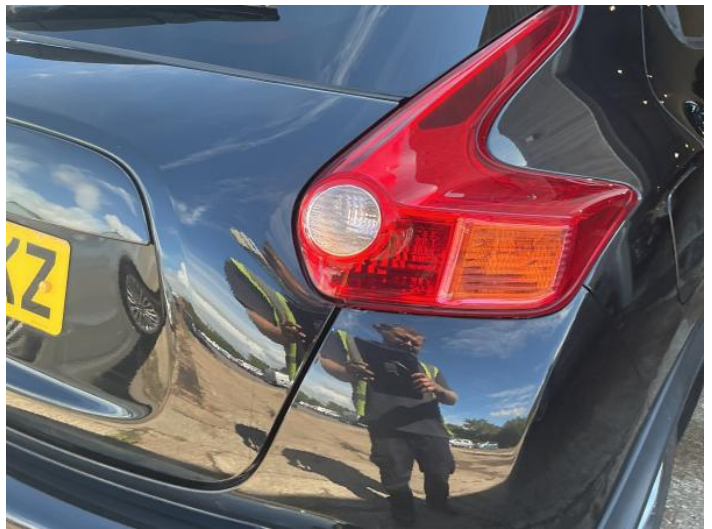
12: Bumper Rear  
Chipped  
Multiple Chips

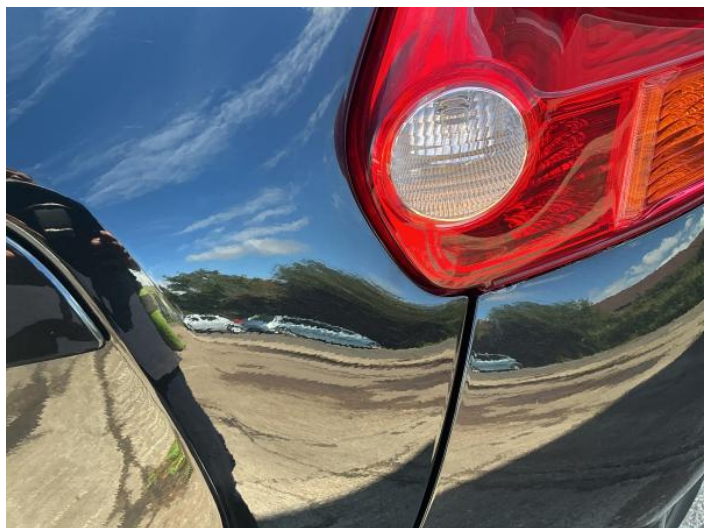
14: Boot Lid  
Dented  
Over 2 UpTo 10mm

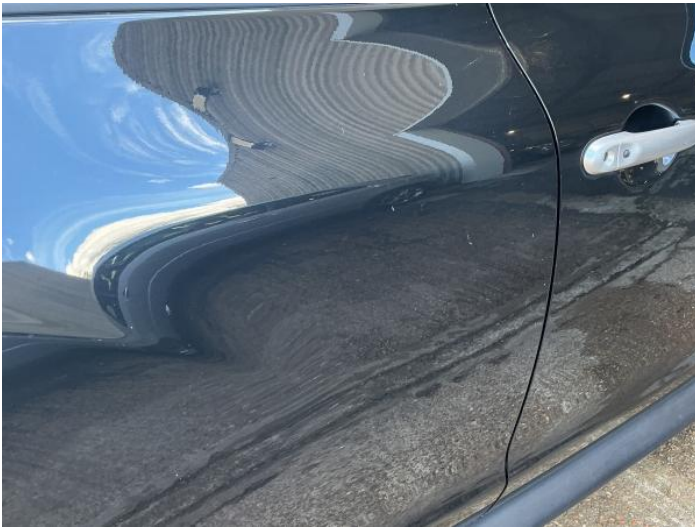
17: Door osr  
Chipped  
1 To 5

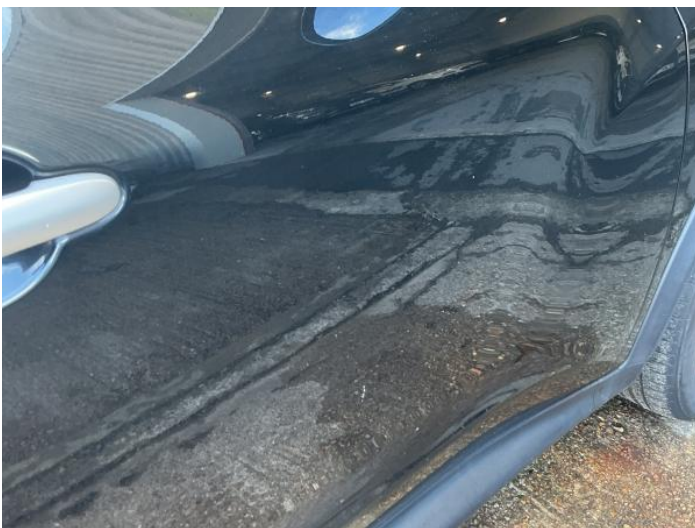
19: Door osf  
Chipped  
Multiple Chips

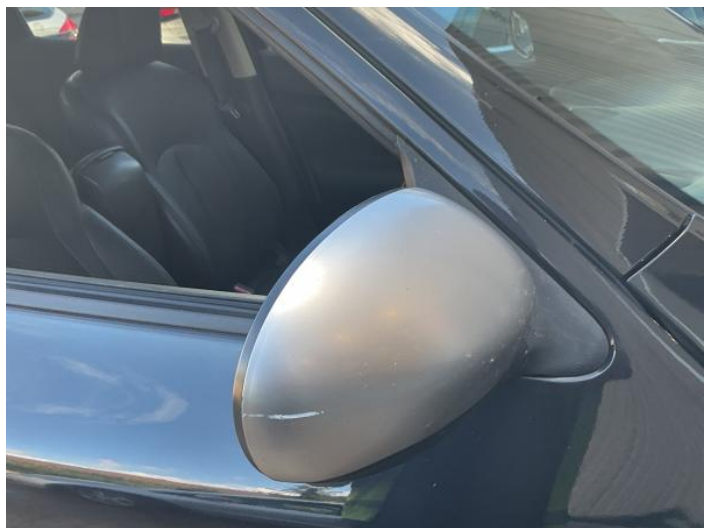
20: Door Mirror Assy osf  
Scratched (Painted)  
UpTo 25mm Thru Paint

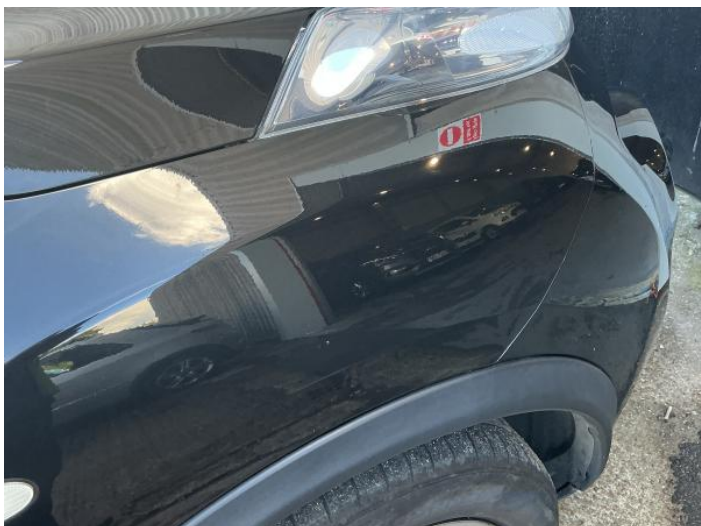
21: Wing osf  
Chipped  
1 To 5

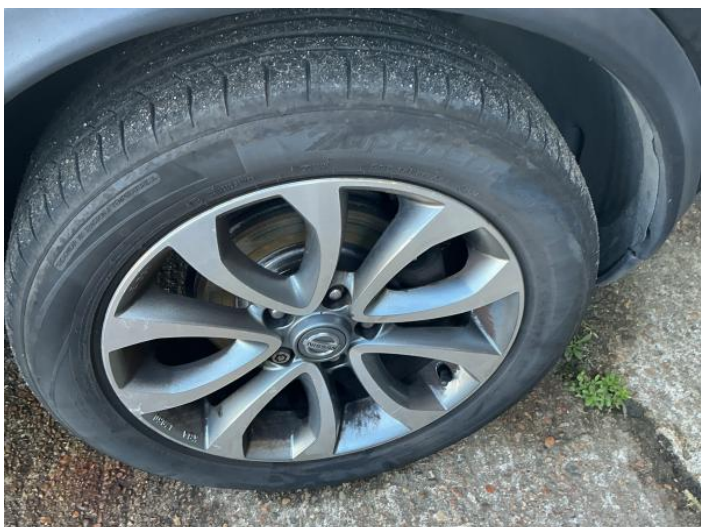
23: Wheel osf  
Scratched  
Up To 50mm

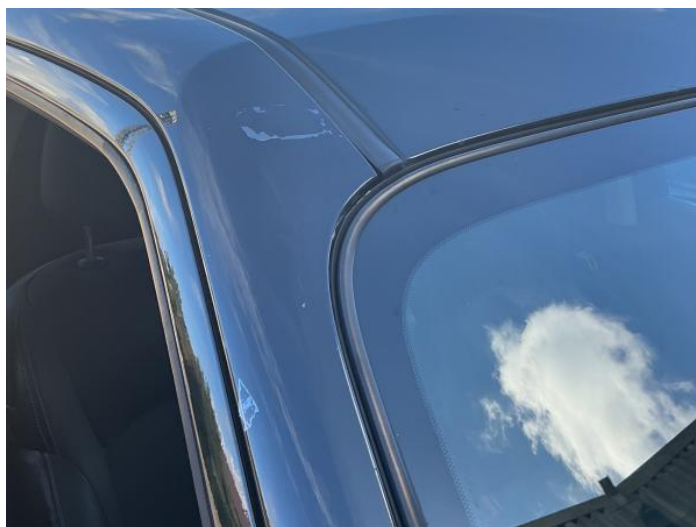
24: A Post os  
Poor Previous Repair  
Paint Flake

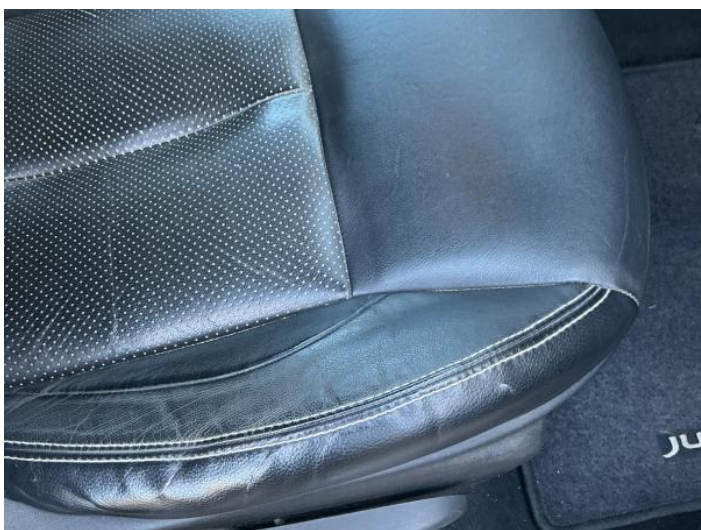
25: Seat Base Cover osf  
Torn  
UpTo 3mm
