VEHICLE INSPECTION REPORT

GU62CFY

Toyota Auris 1.33 Dual VVTi Colour Collection 5dr

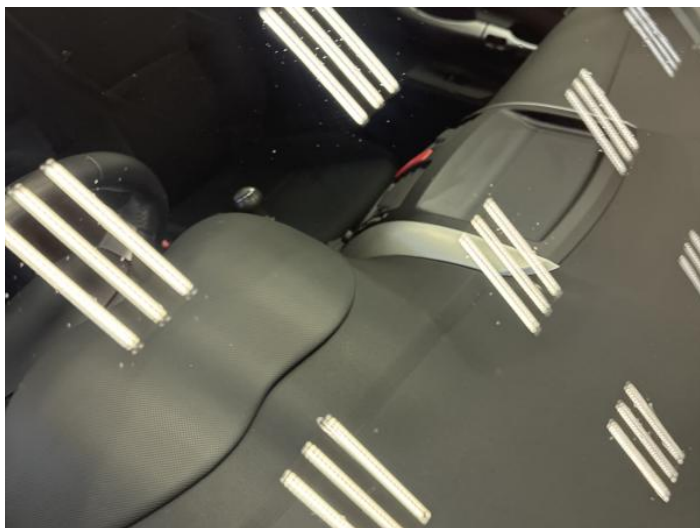
1: Screen Front
Chipped
UpTo 10mm

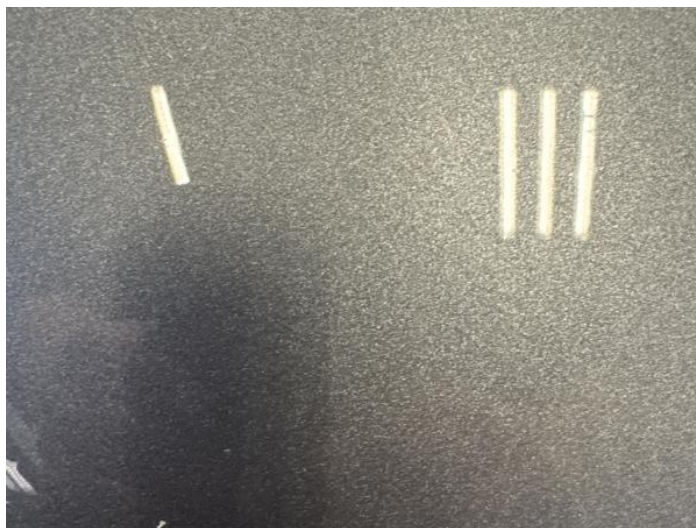
2: Bonnet
Chipped
1 To 5

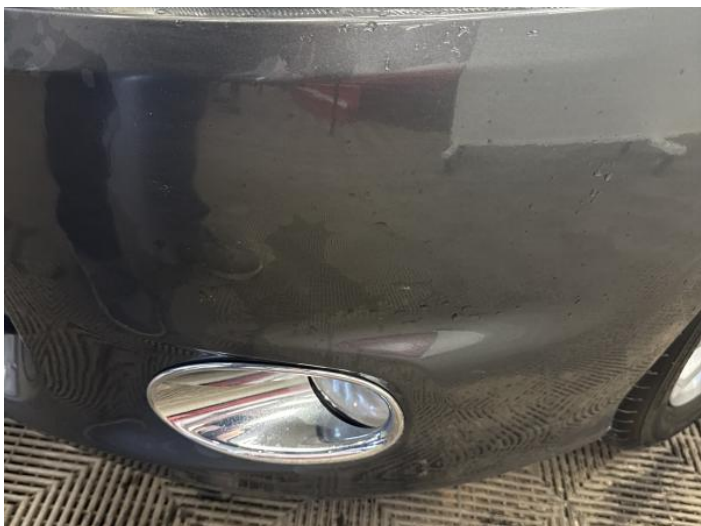
3: Bumper Front
Scratched
25 to 100mm Thru Paint

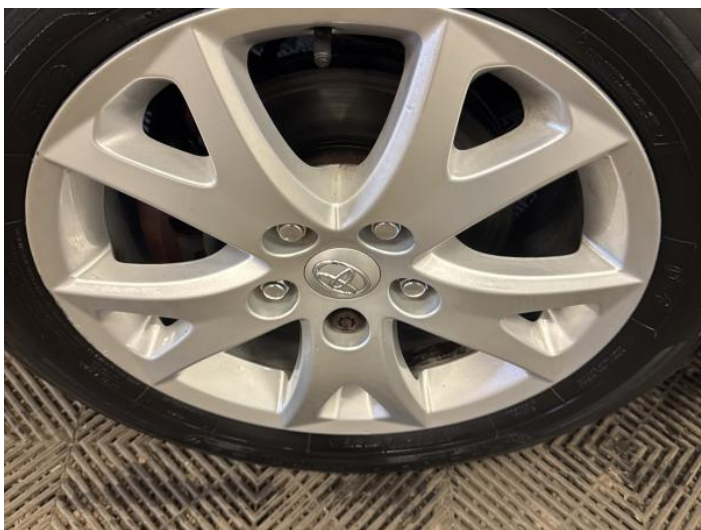
5: Wheel nsf
Scratched
Up To 50mm

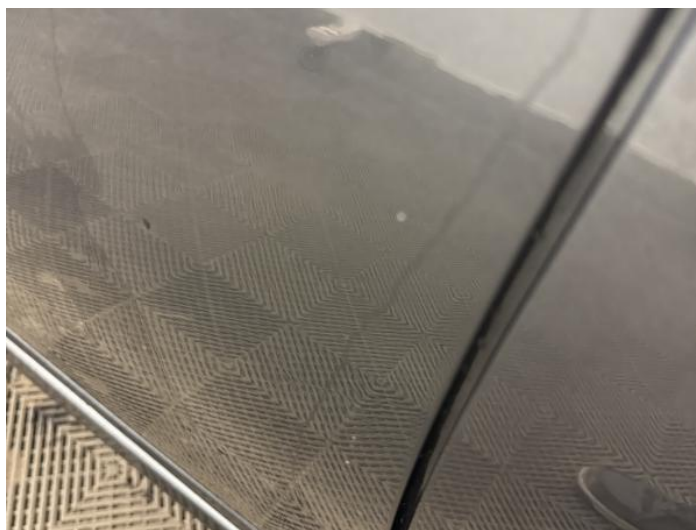
6: Door nsf
Chipped
1 To 5

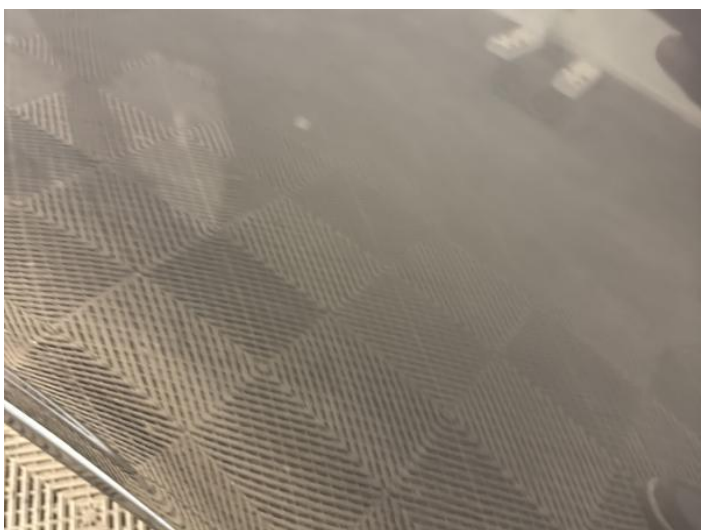
7: Door nsr
Chipped
1 To 5

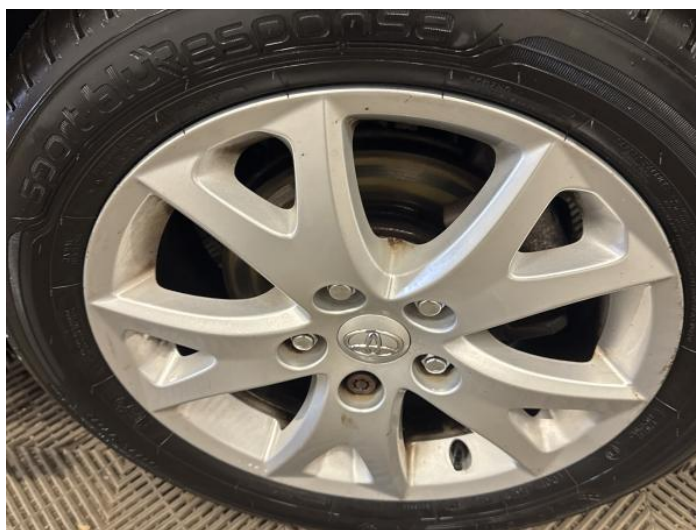
8: Wheel nsr
Scratched
Up To 50mm

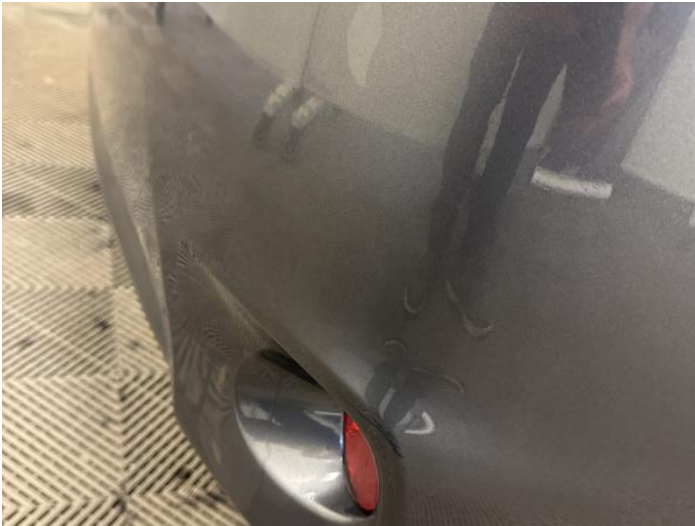
9: Bumper Rear
Scratched
25 to 100mm Thru Paint

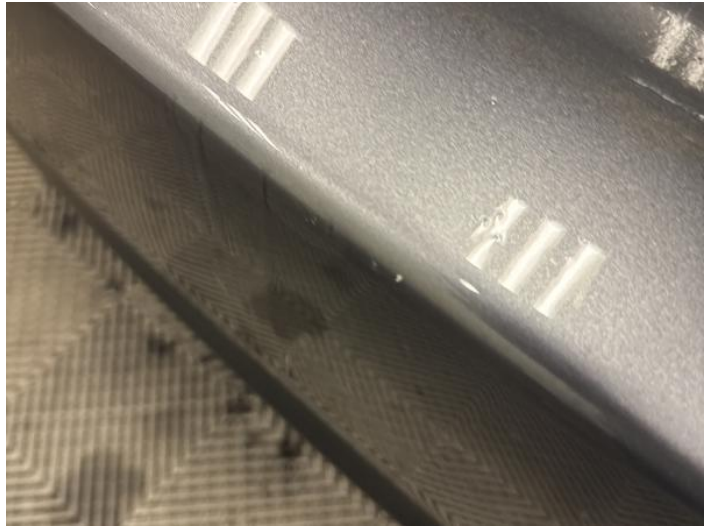
10: Bumper Rear
Chipped
Multiple Chips

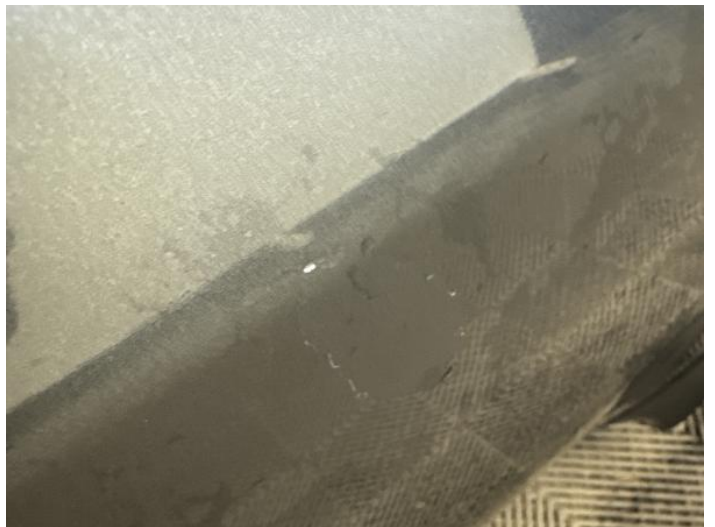
12: Door osf
Poor Previous Repair
Paint Flake

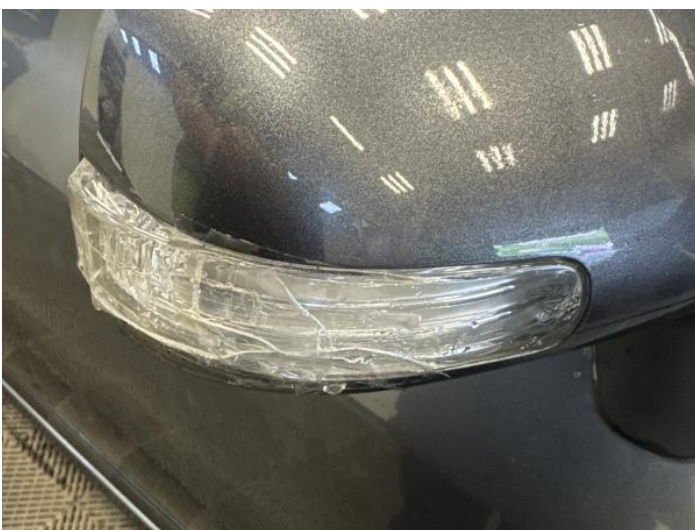
13: Door Mirror Assy osf
Broken
Replace

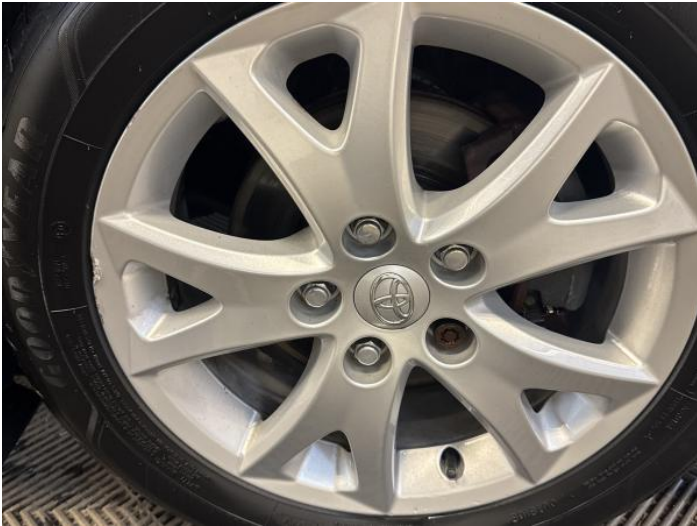
15: Wheel osr
Damaged
Replace
