# VEHICLE INSPECTION REPORT

**ND14WUE**

## Nissan X-Trail 2.0 dCi N-Tec+ 5dr

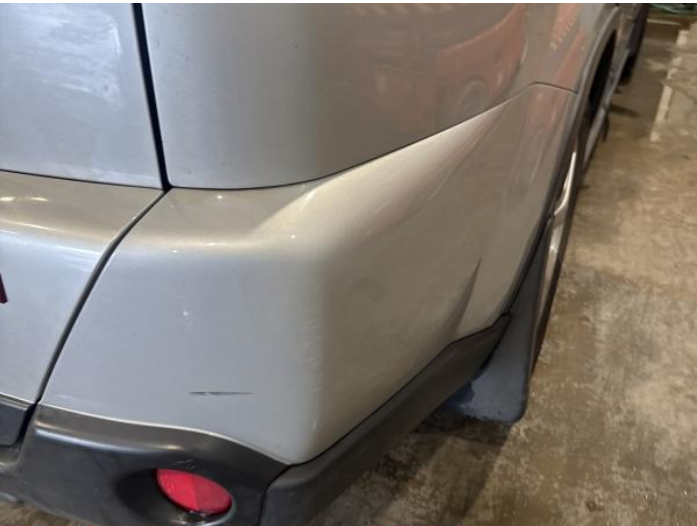
1: Bumper Rear  
Scratched  
25 to 100mm Thru Paint

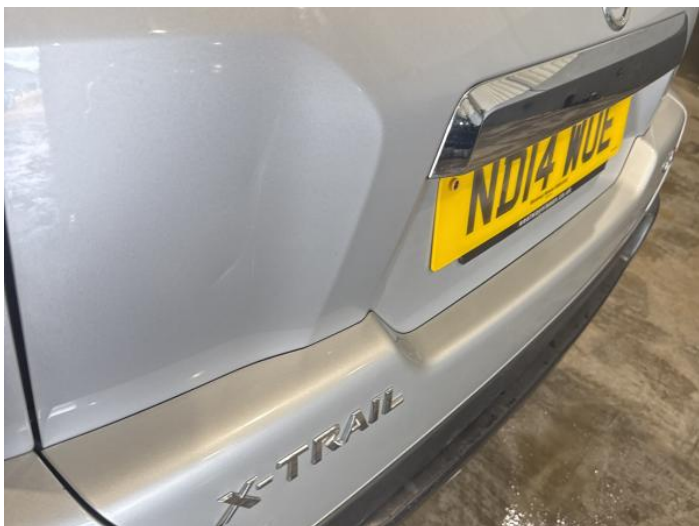
3: Boot Lid  
Chipped  
1 To 5

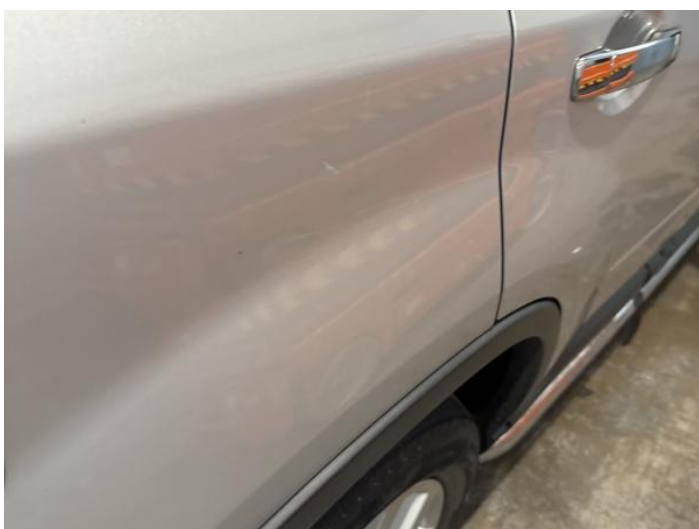
5: Qtr Panel osr  
Dented  
2 Or Less UpTo 10mm

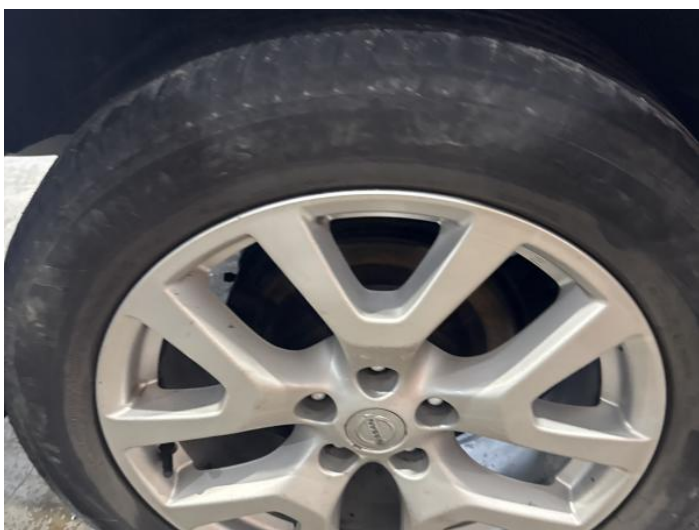
7: Wheel osr  
Scratched  
Up To 50mm

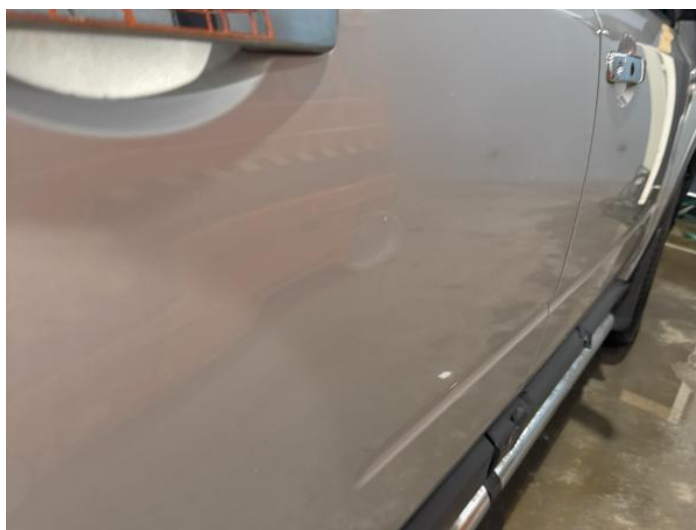
8: Door osr  
Chipped  
1 To 5

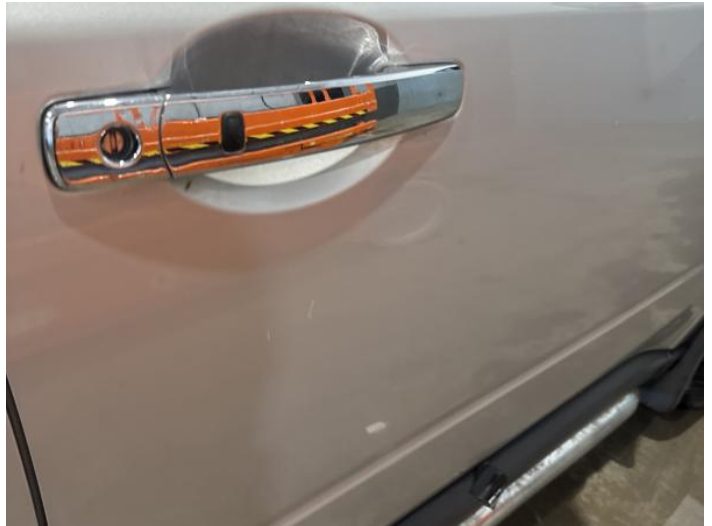
9: Door osr  
Scratched  
Over 25mm Not Thru Paint

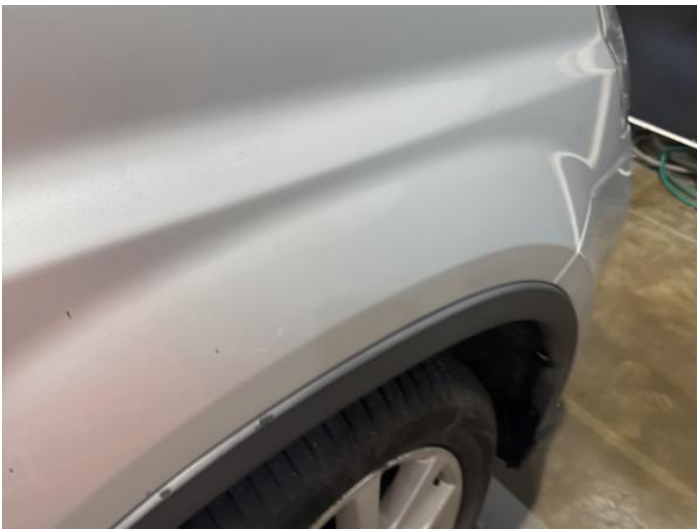
11: Wing osf  
Chipped  
1 To 5

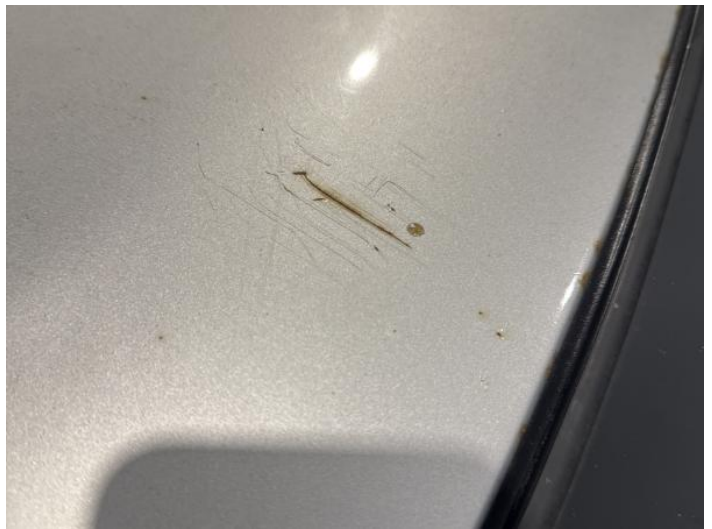
12: Roof  
Rusted  
Over 5mm

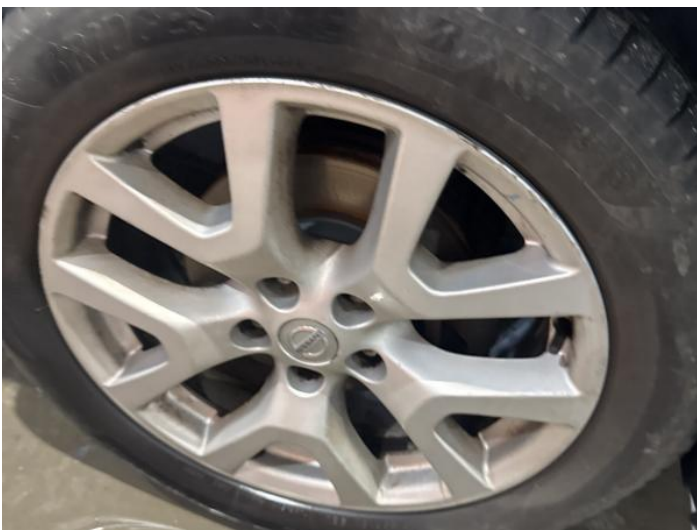
13: Wheel osf  
Scratched  
Over 50mm

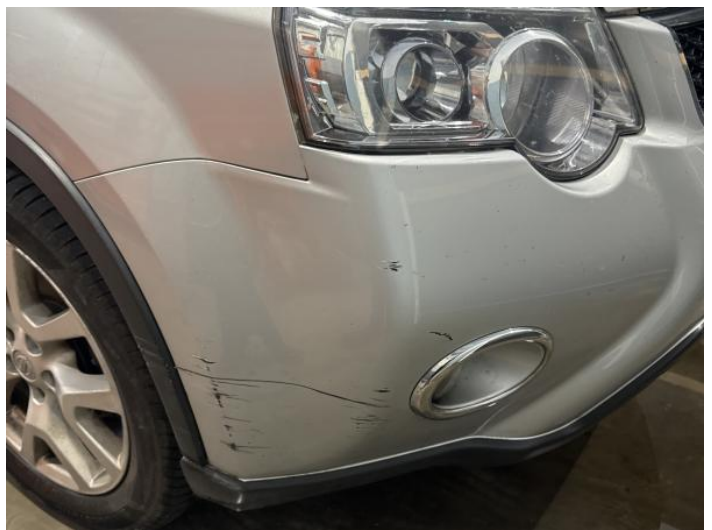
14: Bumper Front  
Scratched  
Over 100mm Thru Paint

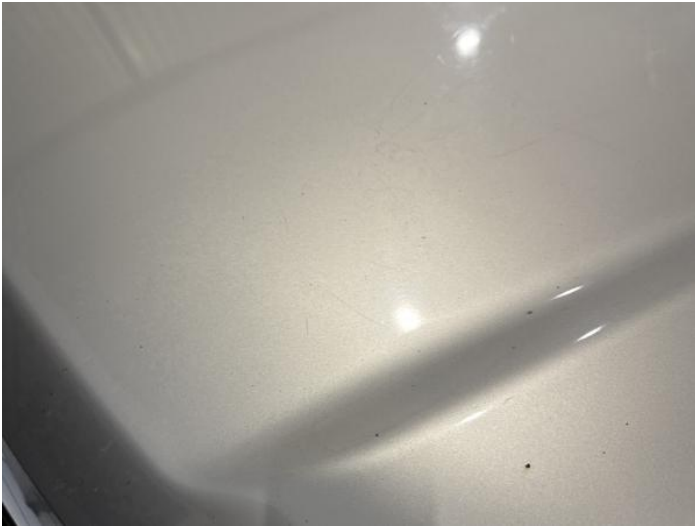
15: Bonnet  
Chipped  
Multiple Chips

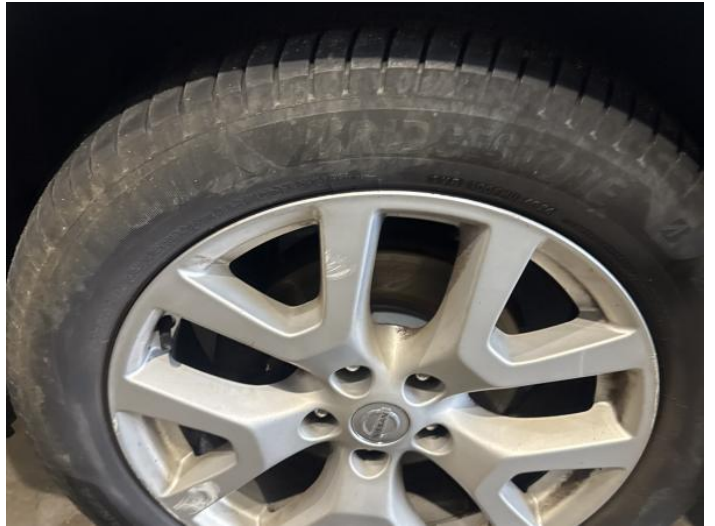
16: Wheel nsf  
Scratched  
Over 50mm

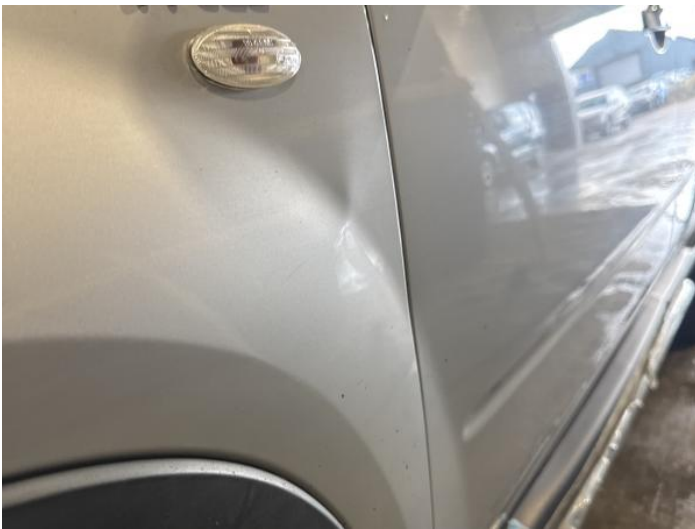
17: Wing nsf  
Dented  
Over 30mm

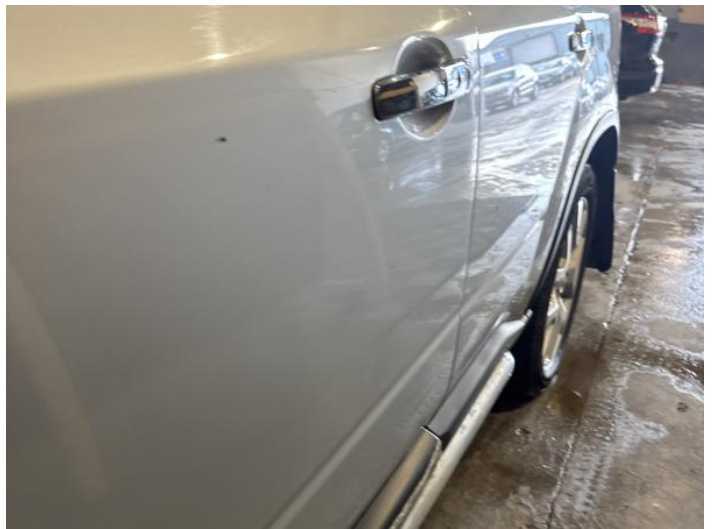
18: Door nsf  
Dented  
Over 30mm

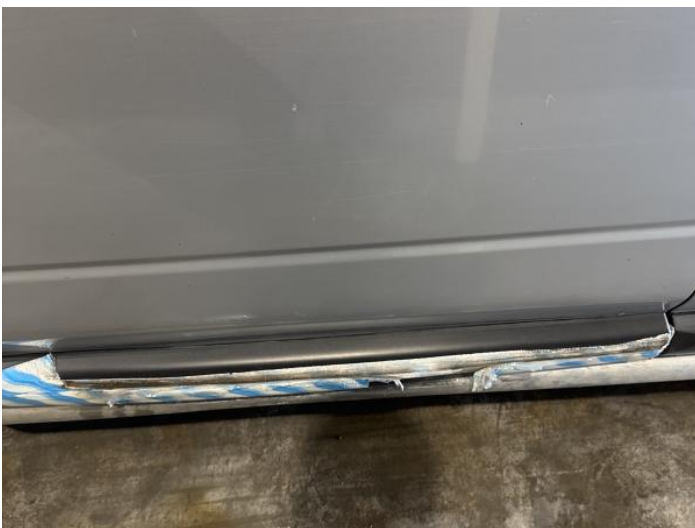
19: Door Moulding nsf  
Broken  
Replace

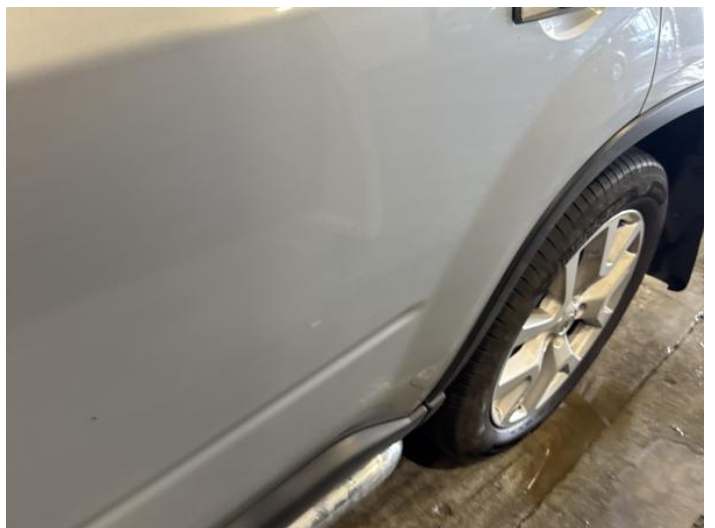
20: Door nsr  
Dented  
Over 30mm

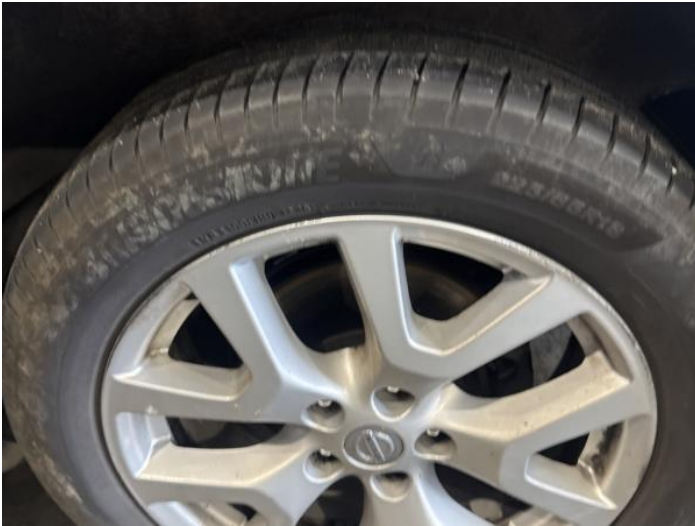
21: Wheel nsr  
Scratched  
Over 50mm

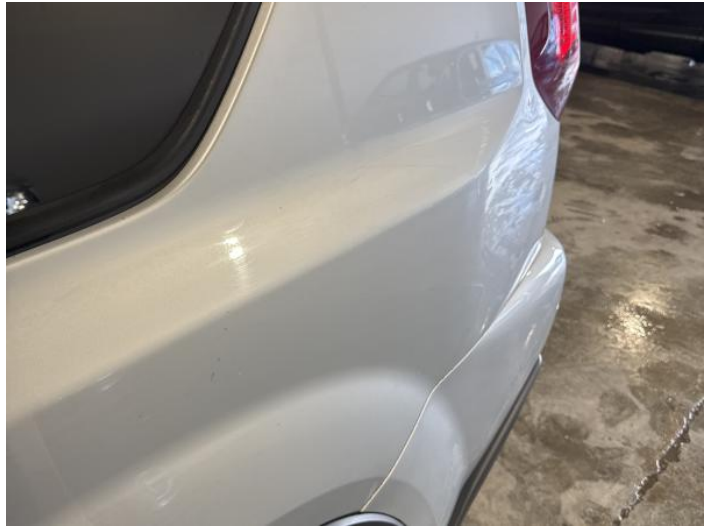
22: Qtr Panel nsr  
Dented  
Over 2 UpTo 10mm

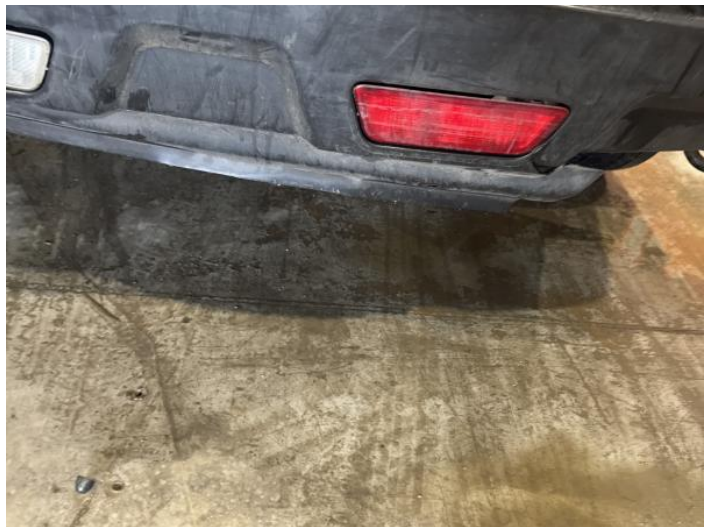
24: Bumper Rear Moulding  
Broken  
Replace

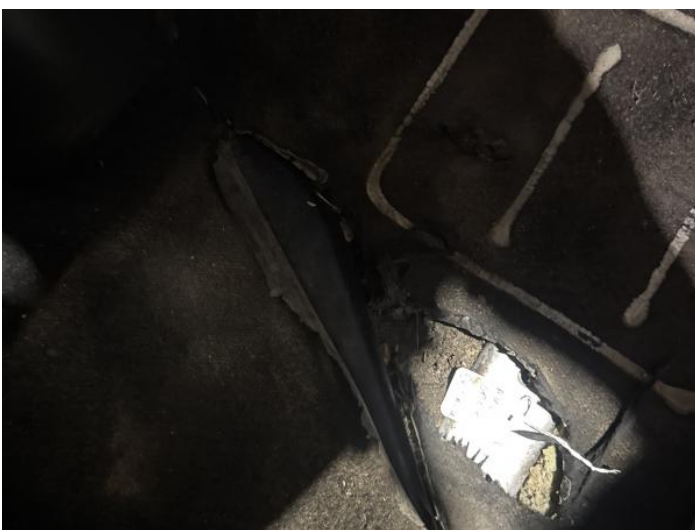
25: Carpets Front  
Torn  
Over 10mm

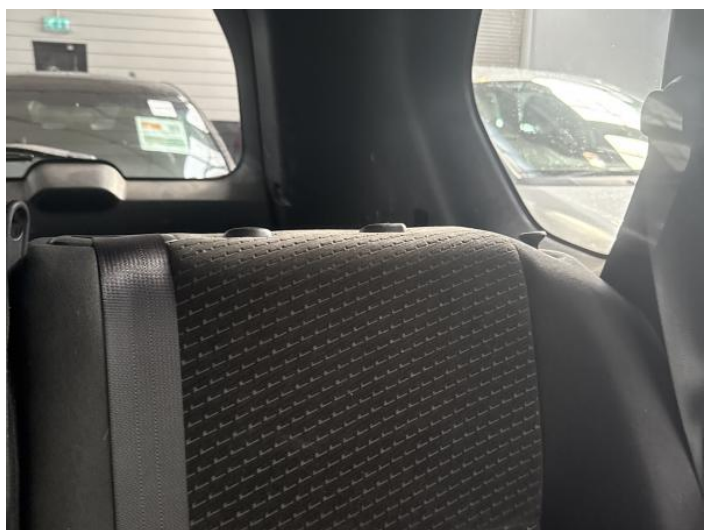
26: Headrest Assy Rear Seat ns  
Missing  
Replace
