VEHICLE INSPECTION REPORT

Kia Sportage 2.0 CRDi KX-3 5dr Auto

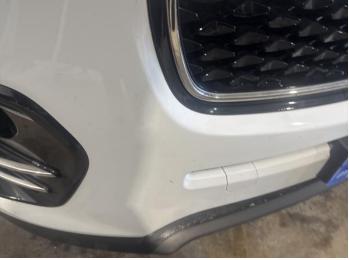
2: Bumper Front Chipped Multiple Chips

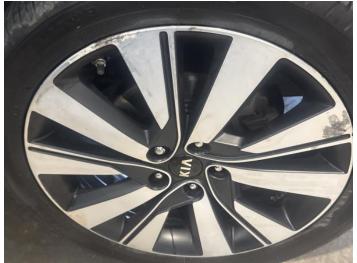
3: Wheel osf Scratched Over 50mm 4: Door osf Scratched Over 25mm Not Thru Paint

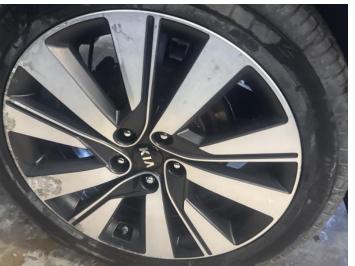
6: Wheel osr Scratched Over 50mm

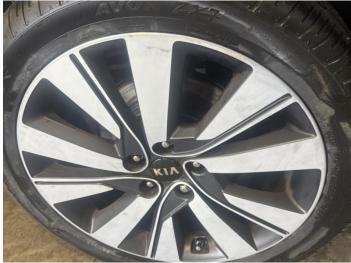
8: Wheel nsr Scratched Over 50mm

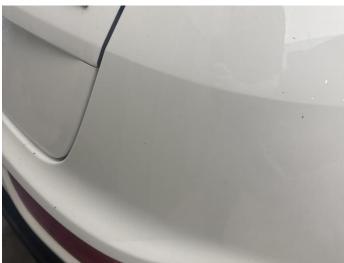
7: Bumper Rear Chipped Multiple Chips

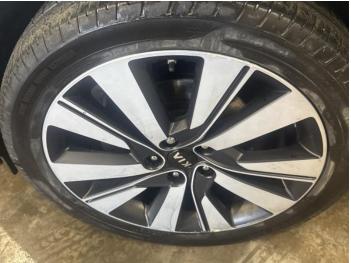
11: Wheel nsf Scratched Over 50mm
