VEHICLE INSPECTION REPORT

GX63FXZ

Honda Civic 1.8 i-VTEC Ti 5dr

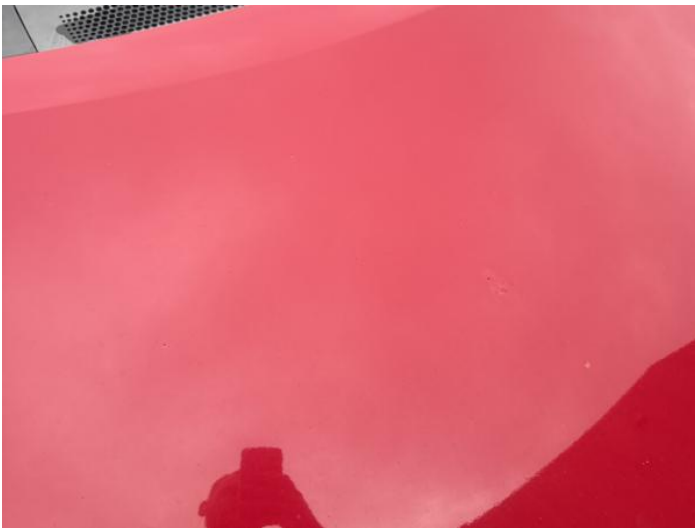
1: Bonnet
Chipped
Multiple Chips

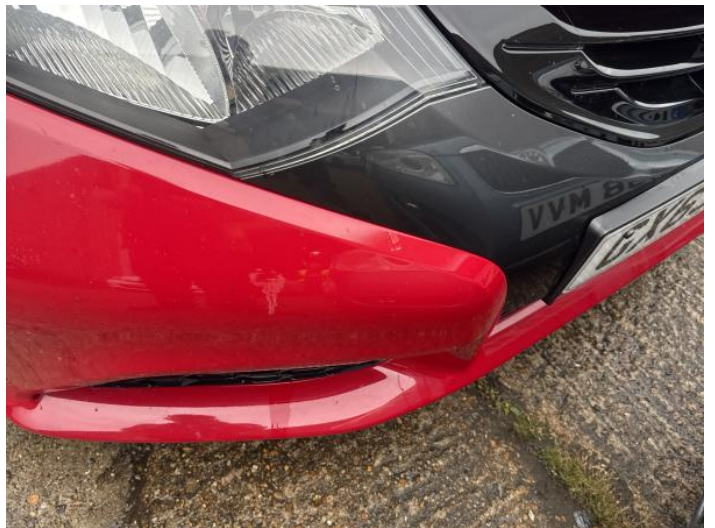
2: Bumper Front
Poor Previous Repair
Poor Paint

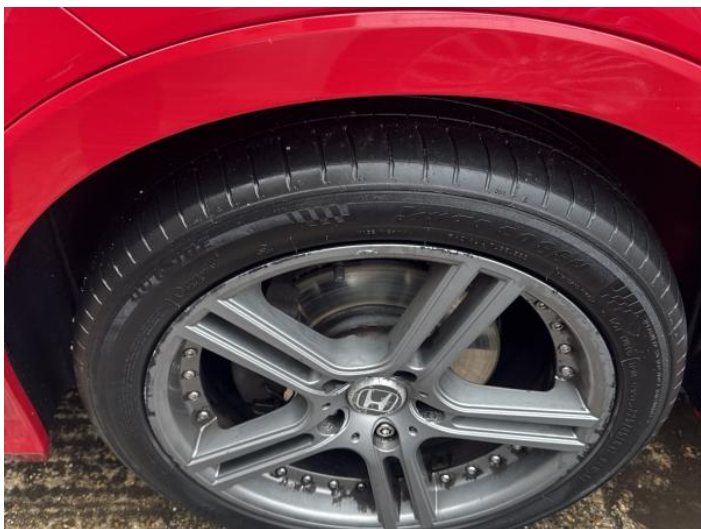
3: Wheel nsf
 Scratched
 Over 50mm

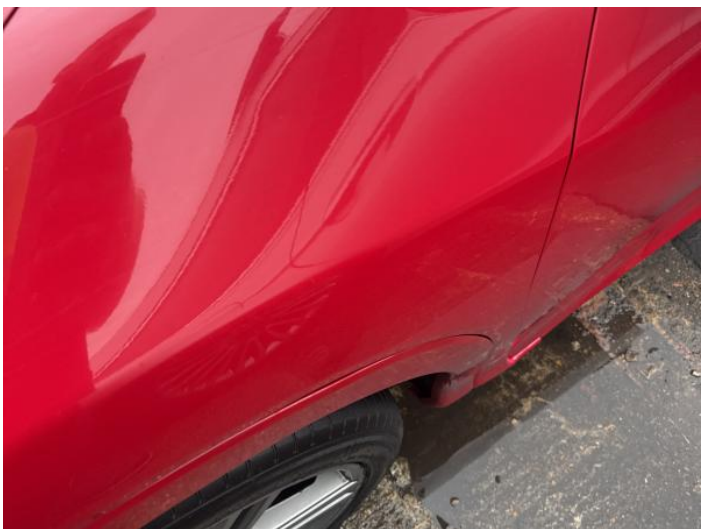
4: Wing nsf
 Dented
 Over 2 UpTo 10mm

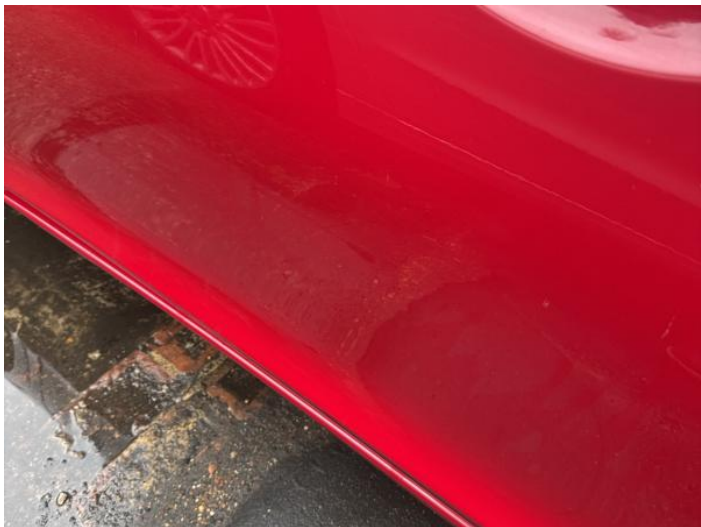
5: Door nsf
 Chipped
 1 To 5

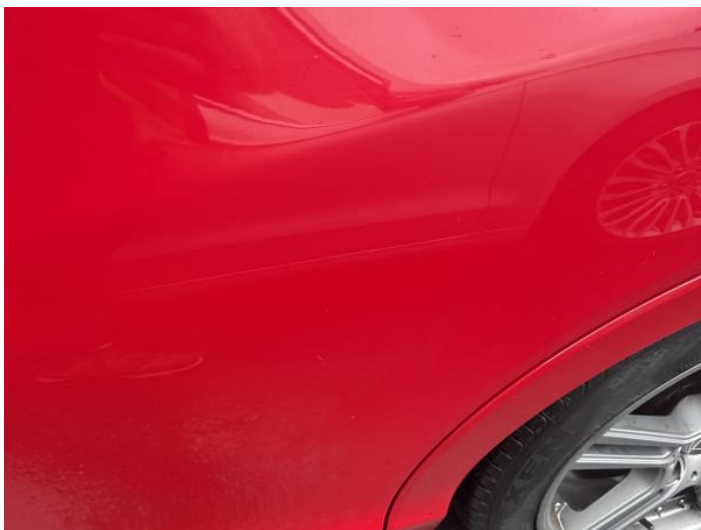
7: Door nsr
 Chipped
 1 To 5

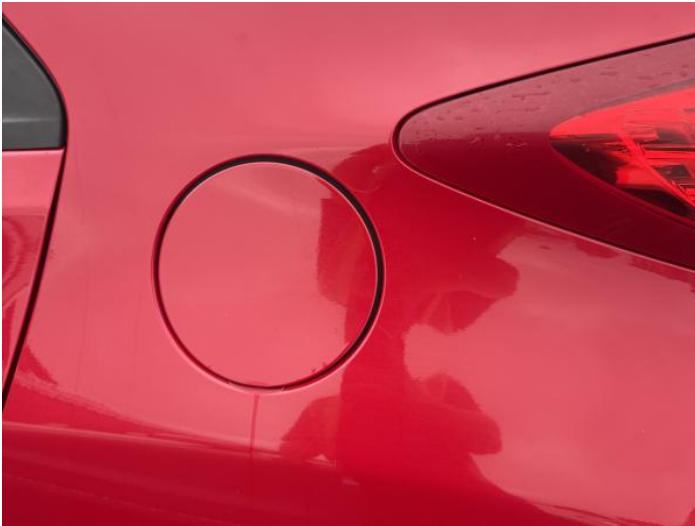
9: Qtr Panel nsr
Chipped
1 To 5

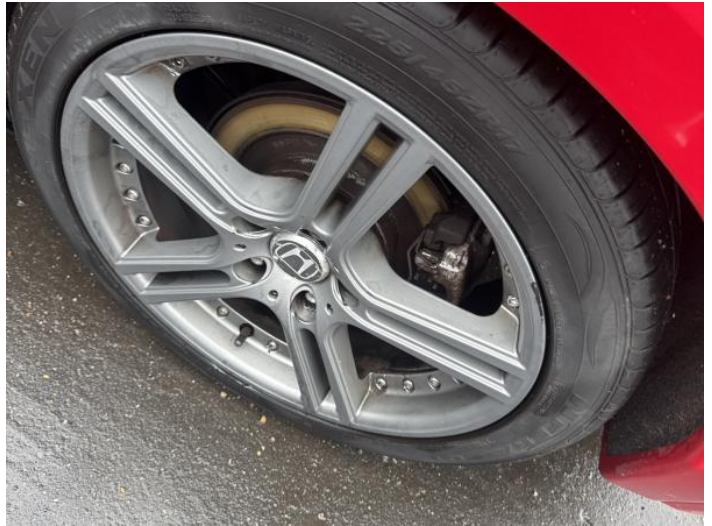
10: Wheel nsr
Scratched
Over 50mm

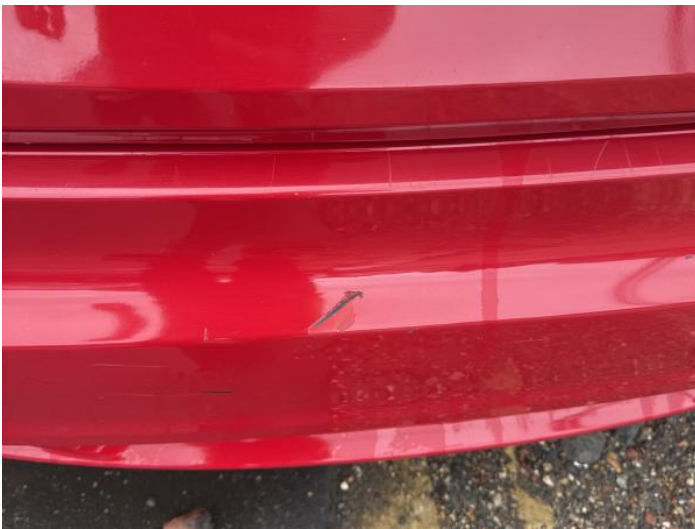
11: Bumper Rear
Scratched
Over 100mm Thru Paint

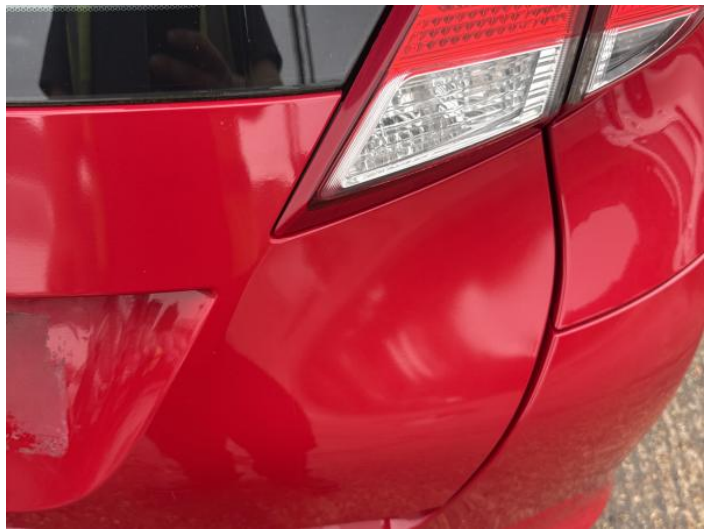
12: Boot Lid
Poor Previous Repair
Poor Paint

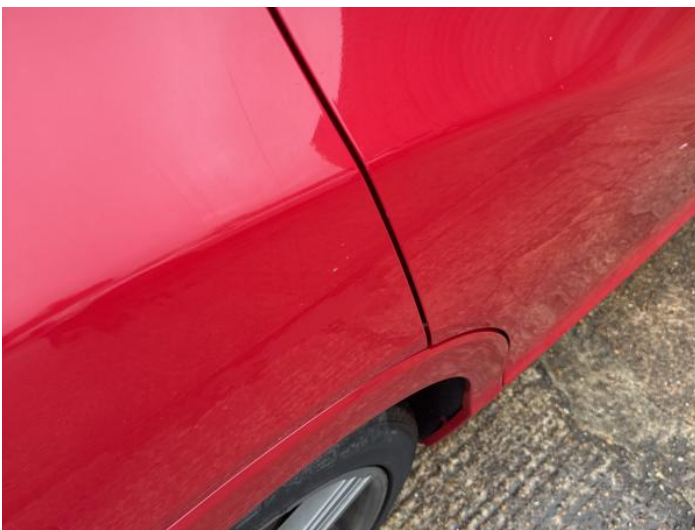
13: Qtr Panel osr
Chipped
1 To 5

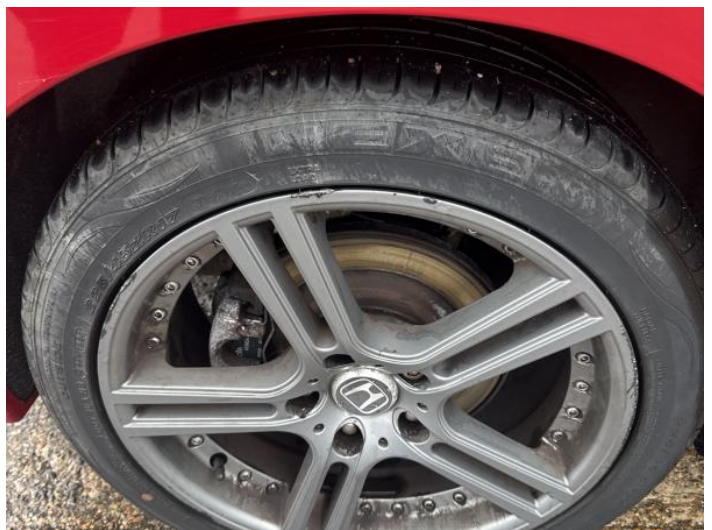
14: Wheel osr
Scratched
Over 50mm

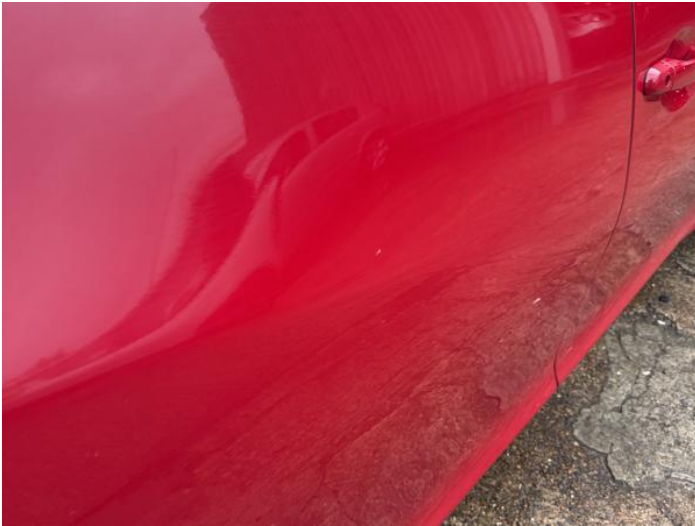
15: Door osr
Chipped
1 To 5

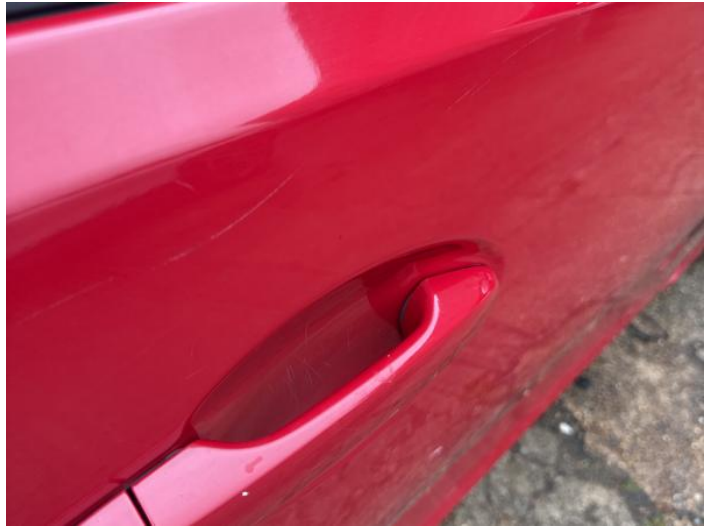
16: Door osf
Scratched
Over 25mm Thru Paint

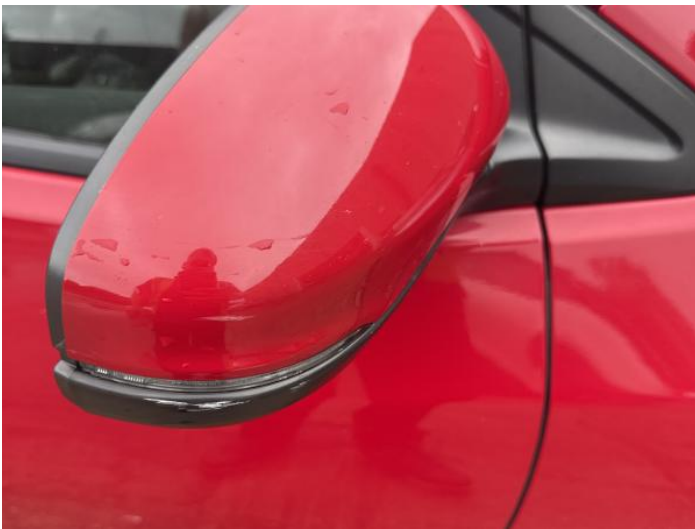
17: Door Mirror Assy osf
Scuffed (Unpainted)
UpTo 100mm

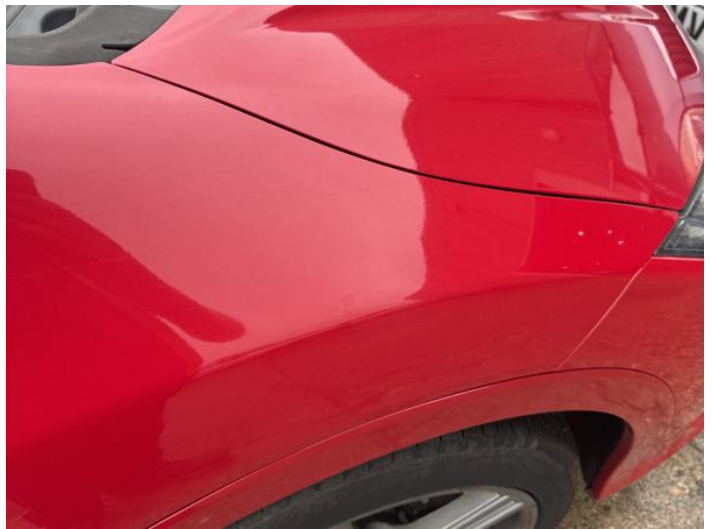
18: Wing osf
Chipped
1 To 5

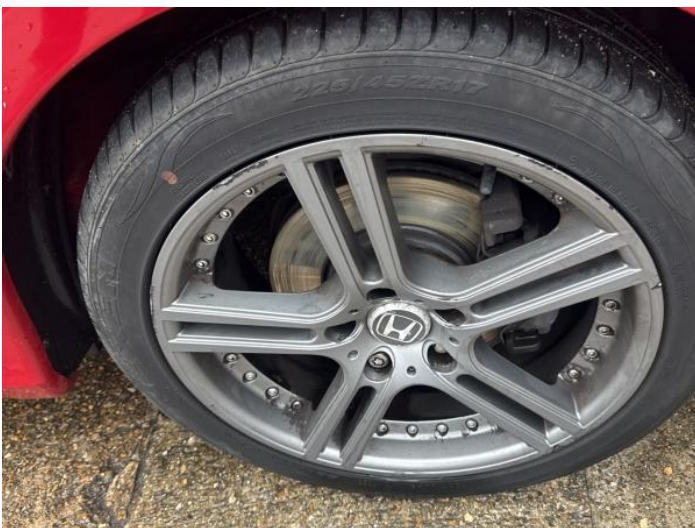
19: Wheel osf
Scratched
Over 50mm

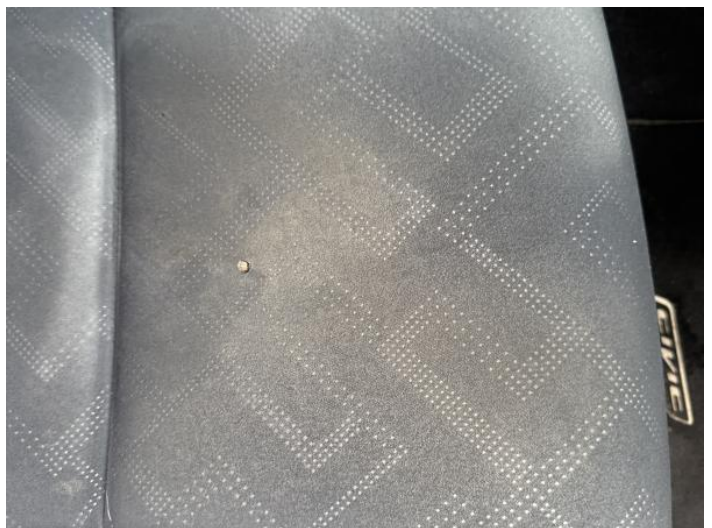
20: Seat Base Cover osf
Holed
UpTo 3mm
