# VEHICLE INSPECTION REPORT

**VK60XOL**

## Suzuki Grand Vitara 1.6 VVT SZ4 3dr

**Non Runner**  
Inspection

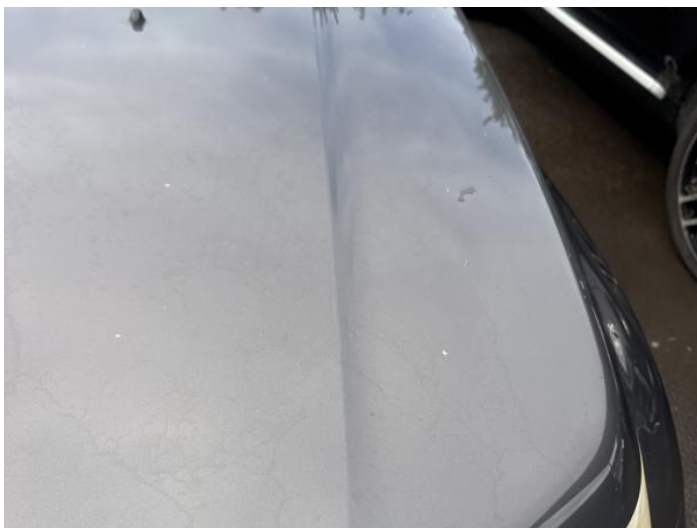
1: Bonnet  
Chipped  
1 To 5

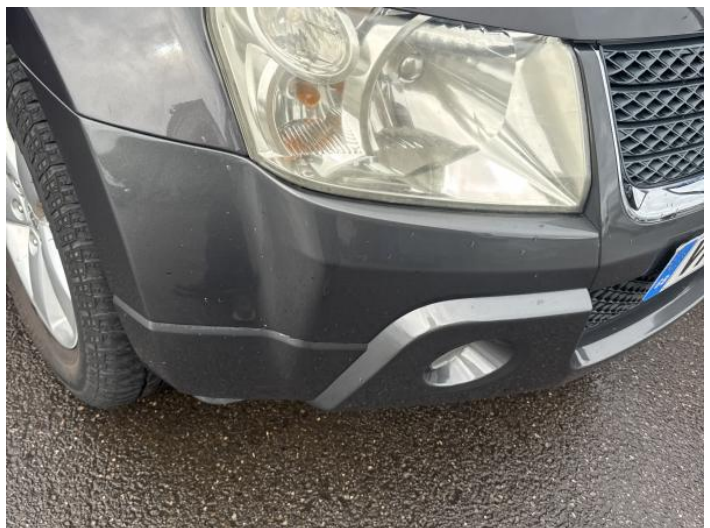
2: Bumper Front  
Poor Previous Repair  
Poor Colour

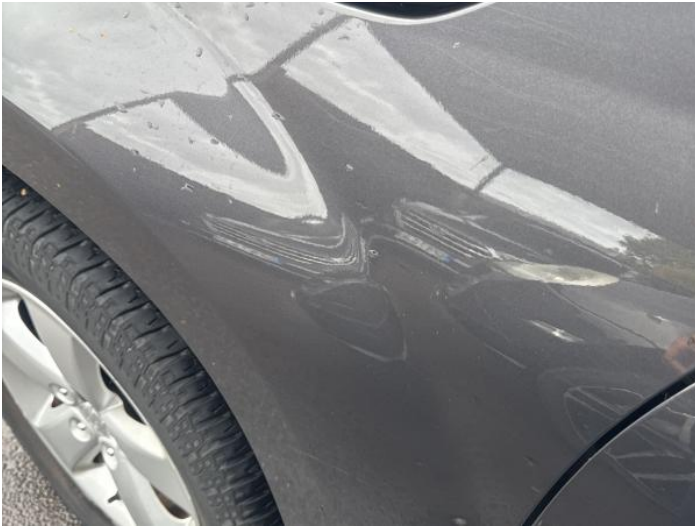
3: Wing nsf  
Chipped  
1 To 5

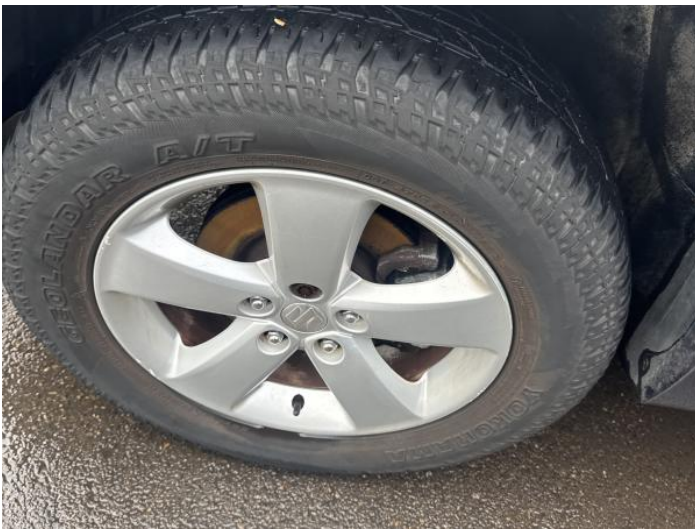
5: Wheel nsf  
Scratched  
Over 50mm

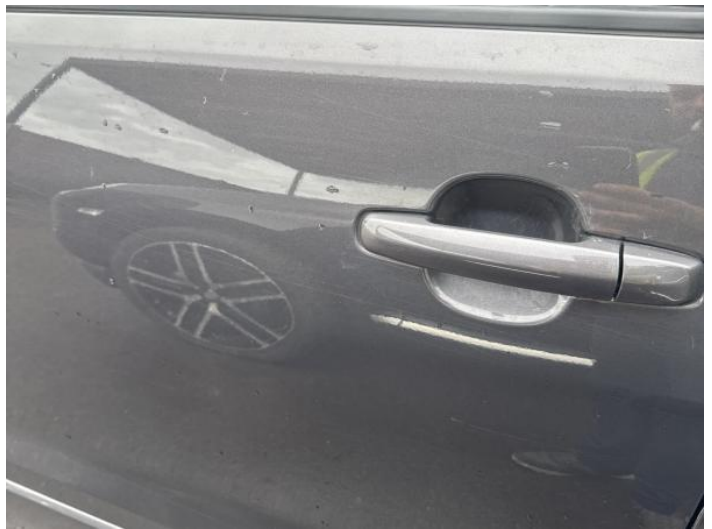
6: Door nsf  
Chipped  
1 To 5

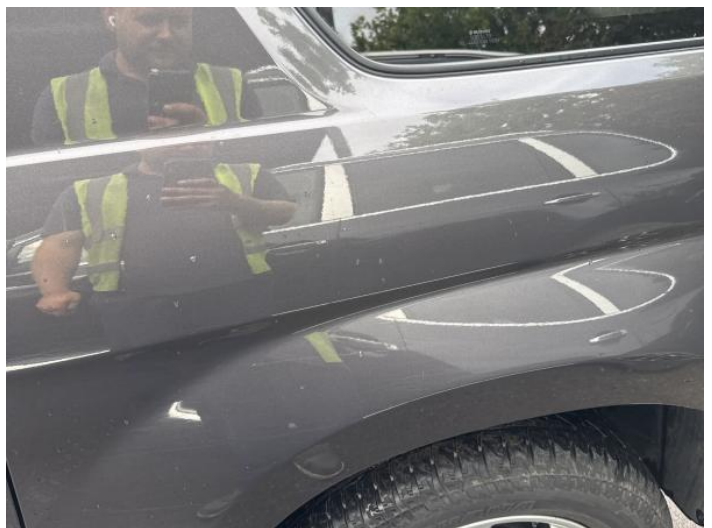
8: Qtr Panel nsr  
Dented  
Over 30mm

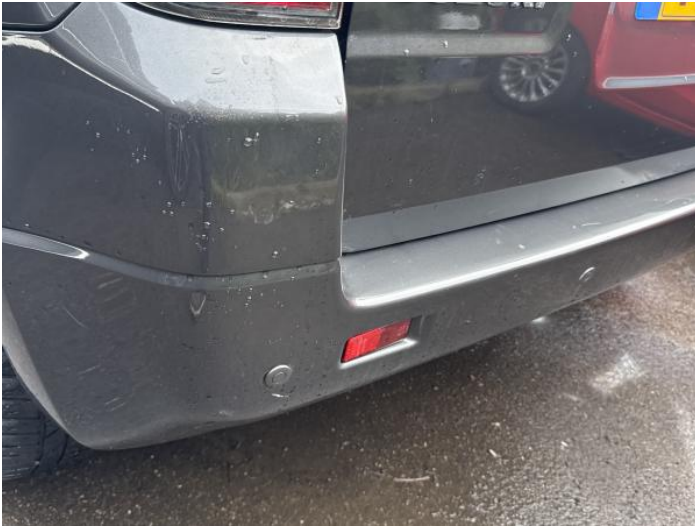
9: Bumper Rear  
Dented  
With Paint Damage

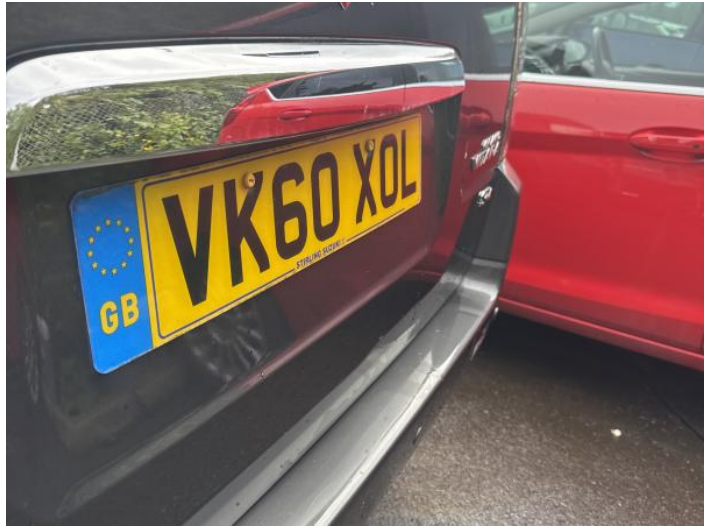
10: Boot Lid  
Dented  
Over 30mm

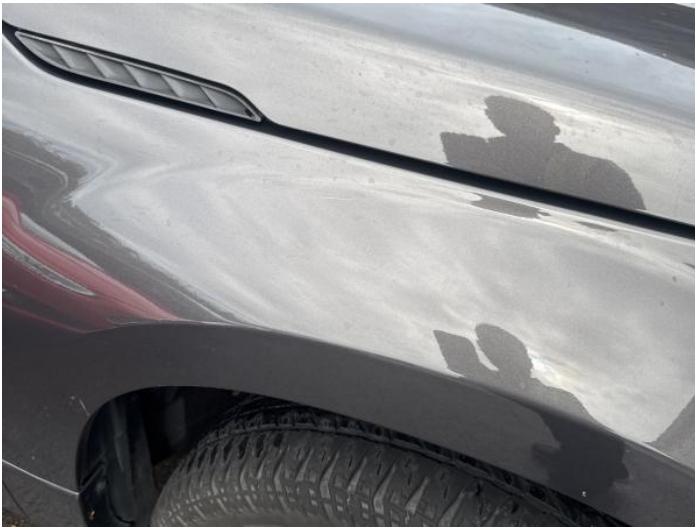
11: Wing osf  
Scratched  
Over 25mm Thru Paint

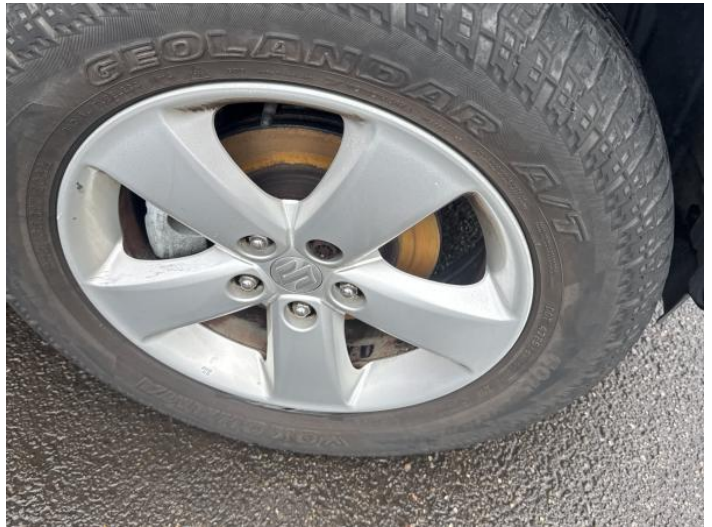
12: Wheel osf  
Scratched  
Over 50mm

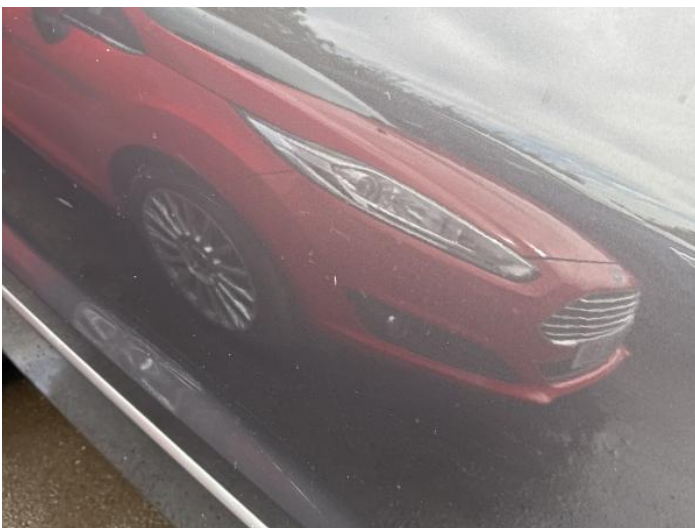
13: Door osf  
Scratched  
Over 25mm Thru Paint

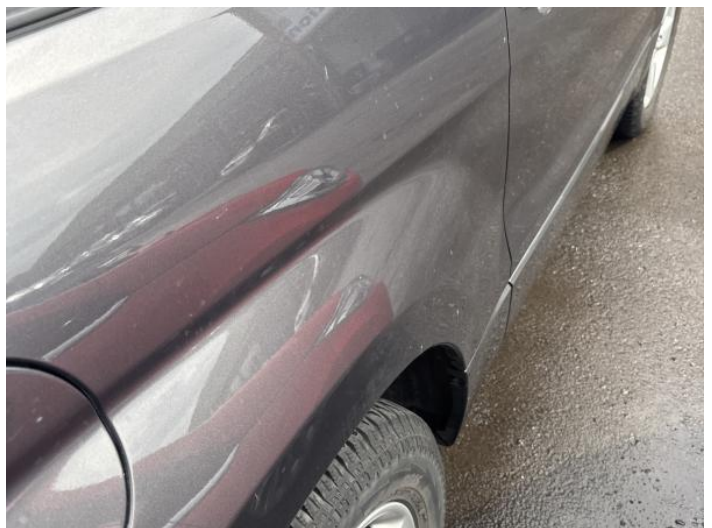
14: Qtr Panel osr  
Chipped  
1 To 5

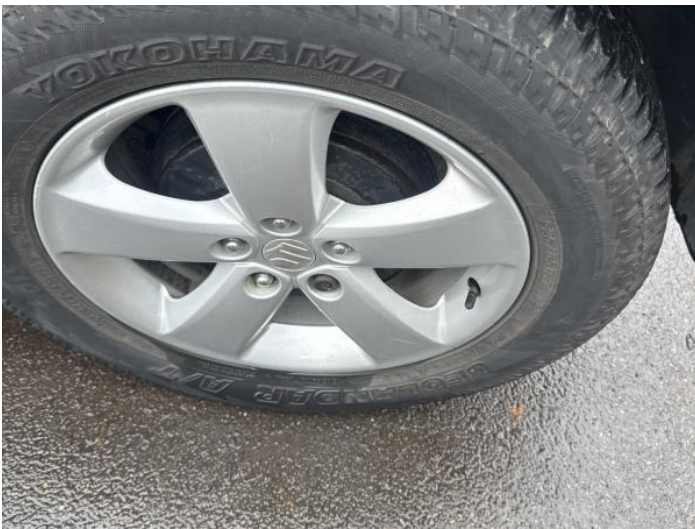
17: Wheel nsr  
Scratched  
Up To 50mm
