VEHICLE INSPECTION REPORT

GU10WHJ

Peugeot 207 1.6 HDi Verve 3dr

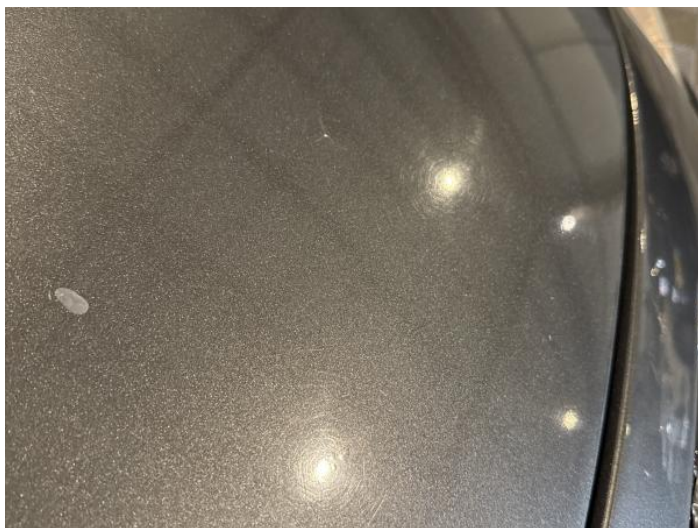
1: Bonnet
Dented
With Paint Damage

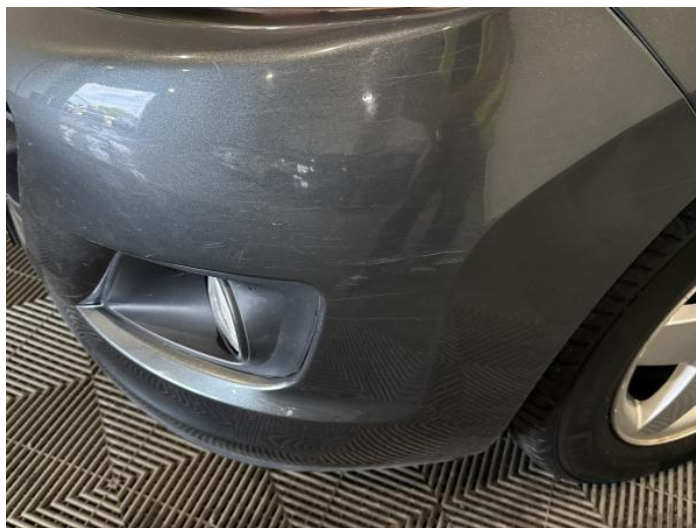
2: Bumper Front
Scratched
Over 100mm Thru Paint

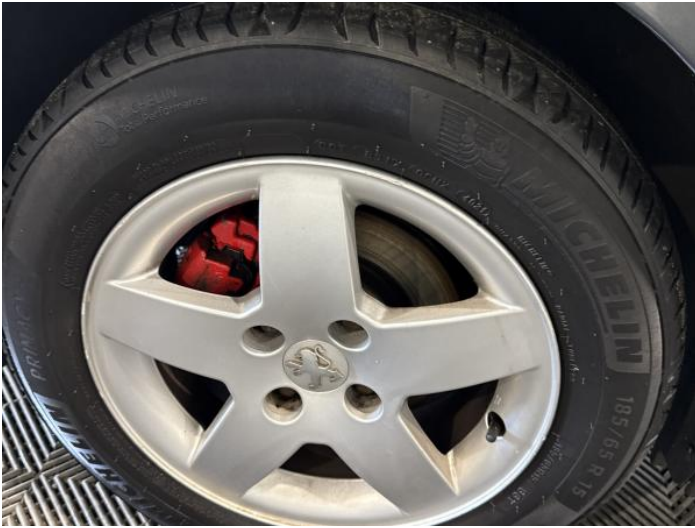
3: Wheel nsf
Scratched
Over 50mm

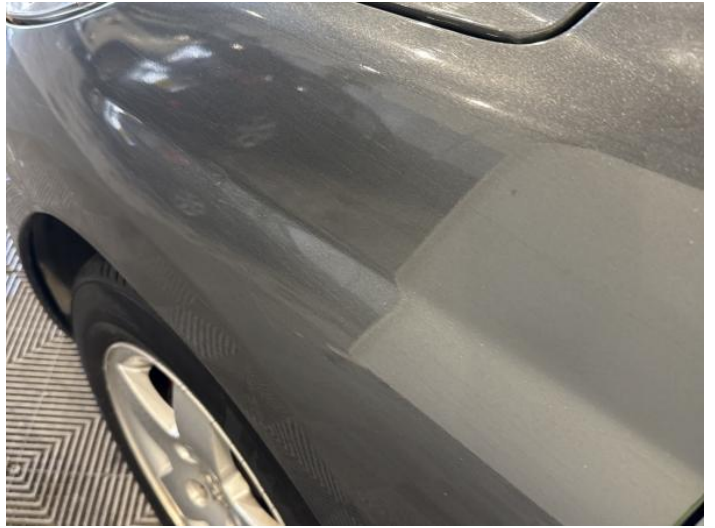
4: Wing nsf
Scratched
Over 25mm Thru Paint

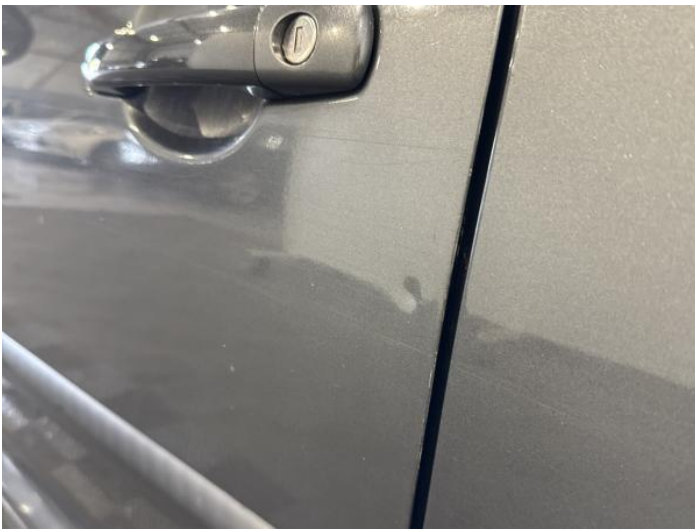
5: Door osf
Dented
With Paint Damage

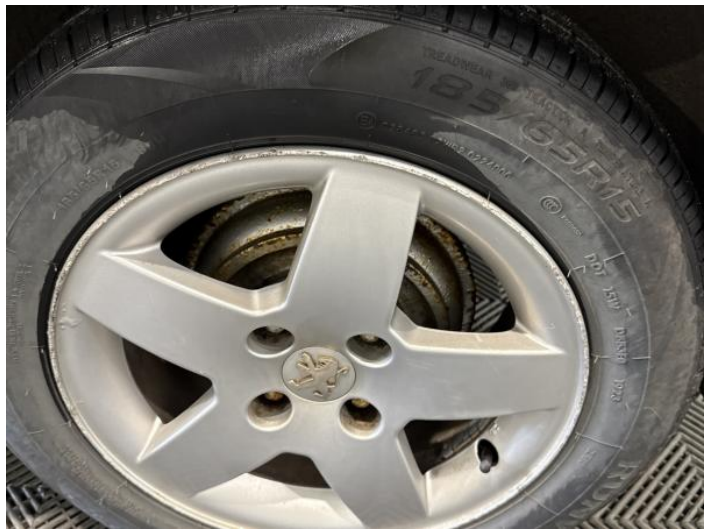
6: Wheel nsr
Scratched
Over 50mm

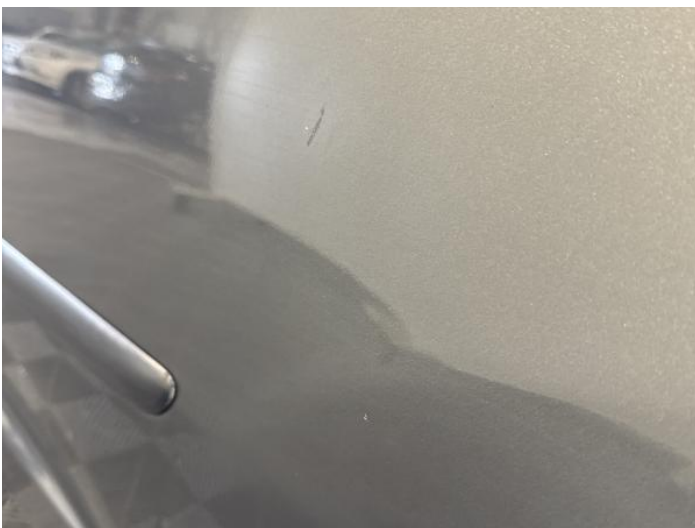
7: Qtr Panel nsr
Dented
With Paint Damage

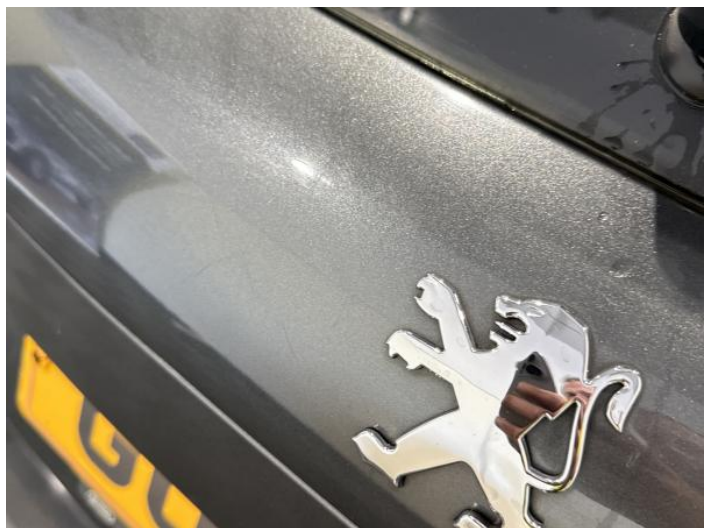
8: Tailgate
Scratched
Over 25mm Thru Paint

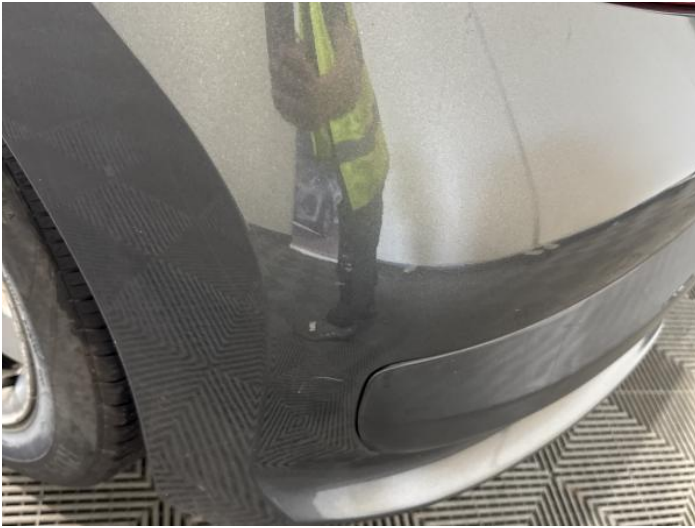
9: Bumper Rear
Scratched
25 to 100mm Thru Paint

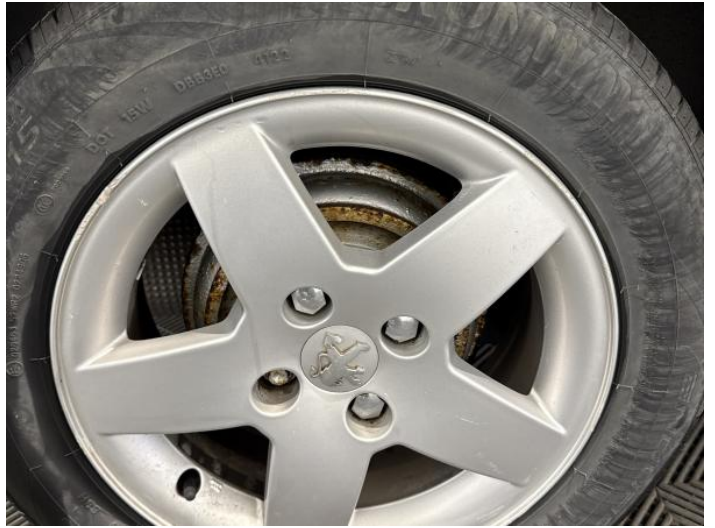
10: Wheel osr
Scratched
Over 50mm

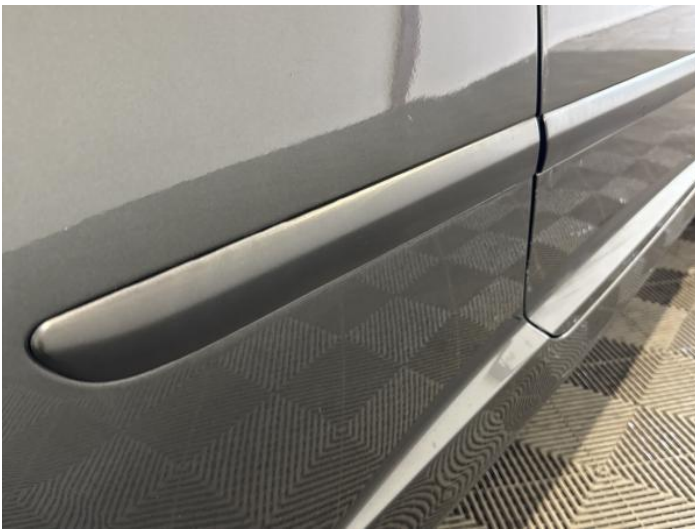
11: Qtr Panel osr
Dented
Over 30mm

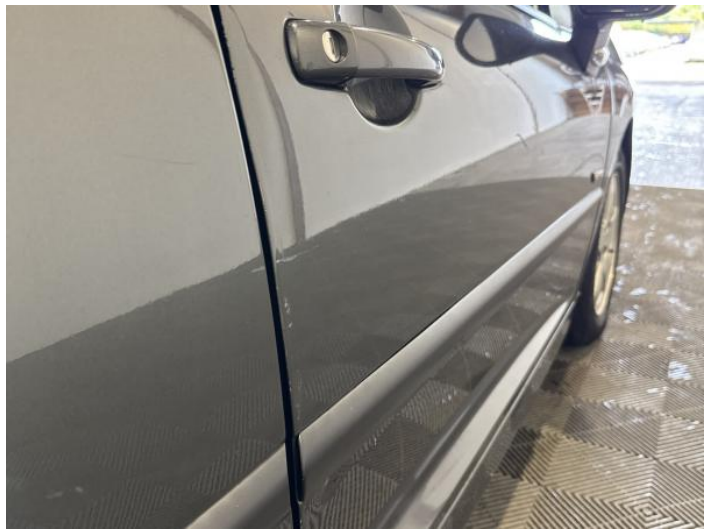
12: Door osf
Dented
Over 30mm

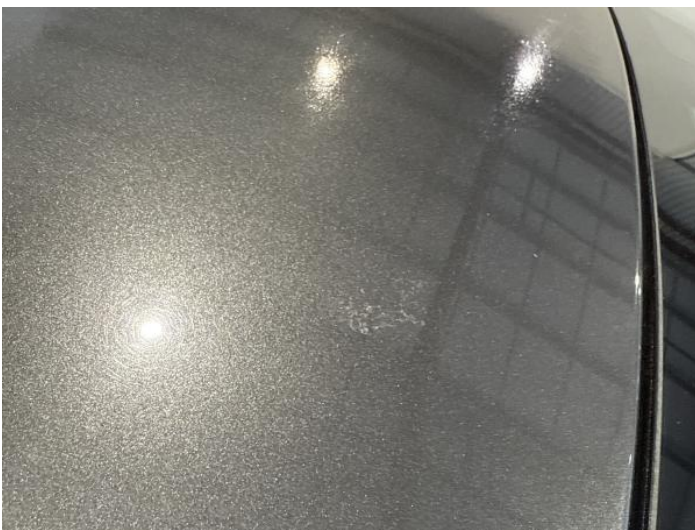
13: Roof
Scratched
Rusted

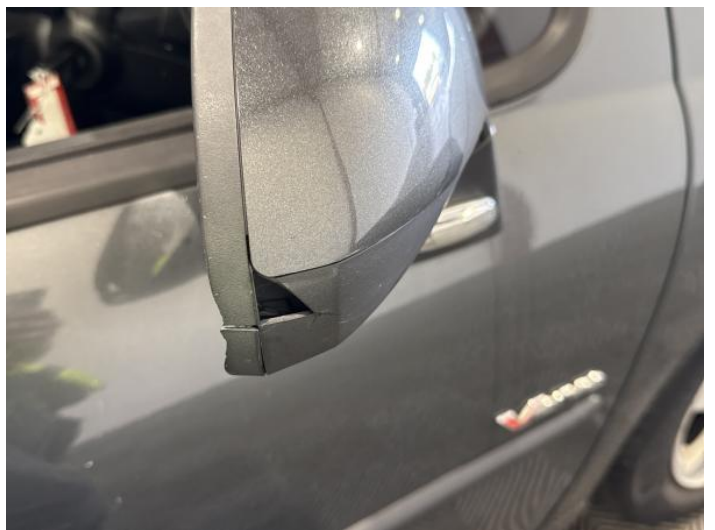
14: Door Mirror Assy osf
Broken
Replace

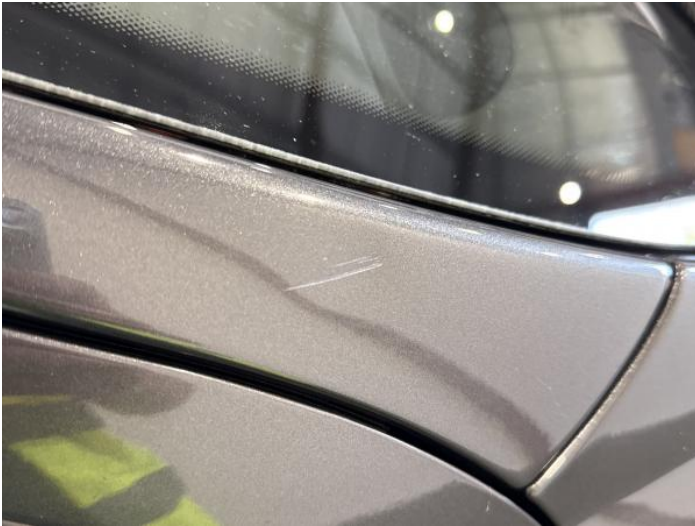
15: A Post os
Dented
Between 10mm + 30mm

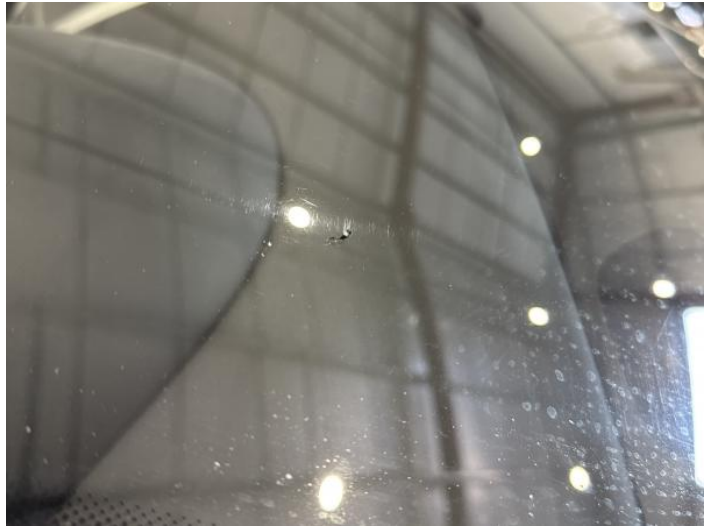
16: Screen Front
Chipped
UpTo 10mm

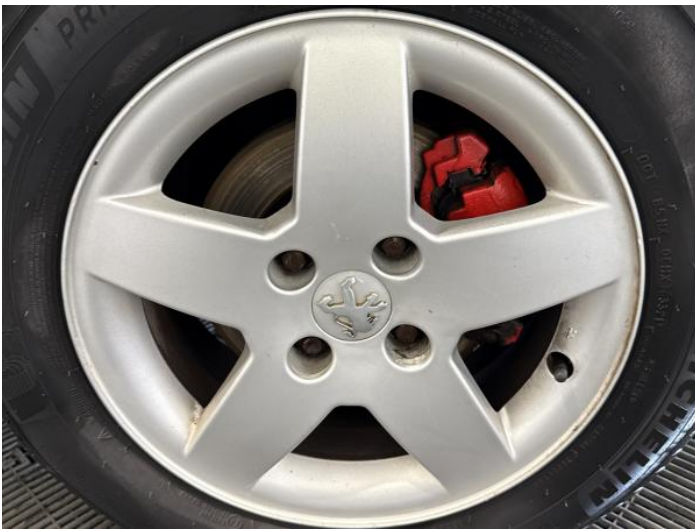
17: Wheel osf
Scratched
Up To 50mm

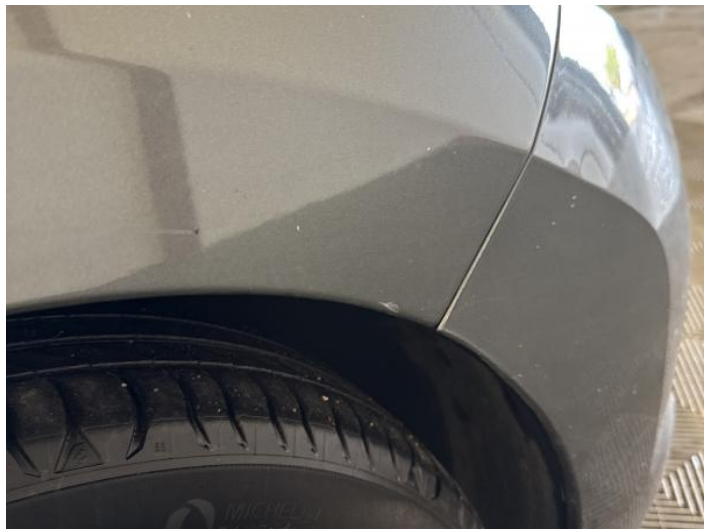
18: Wing osf
Scratched
Over 25mm Thru Paint

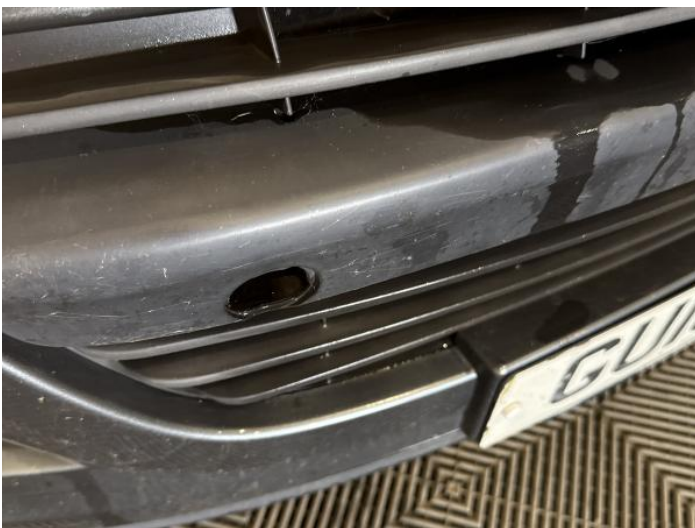
19: Front TowEye Cvr
Missing
Replace
