# VEHICLE INSPECTION REPORT

**SM12NFR**

## Vauxhall Astra 1.6i 16V SRi 5dr

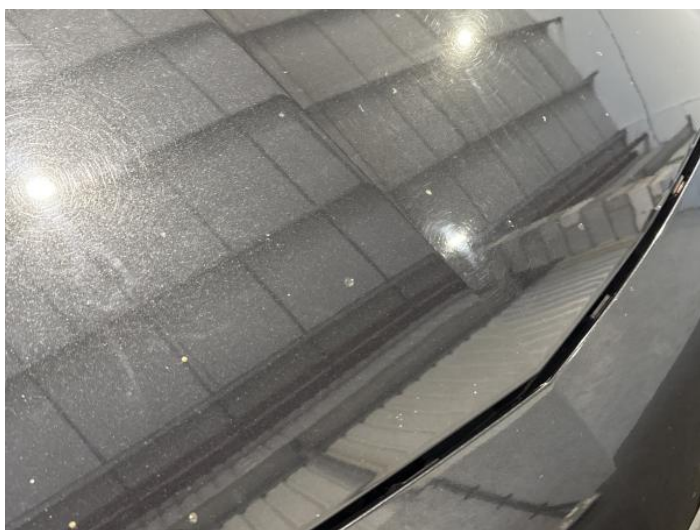
1: Bonnet  
Chipped  
Multiple Chips

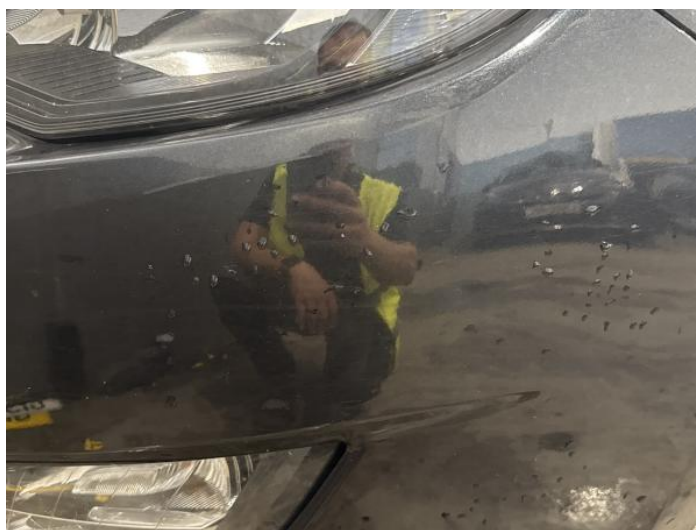
2: Bumper Front  
Scratched  
Over 100mm Thru Paint

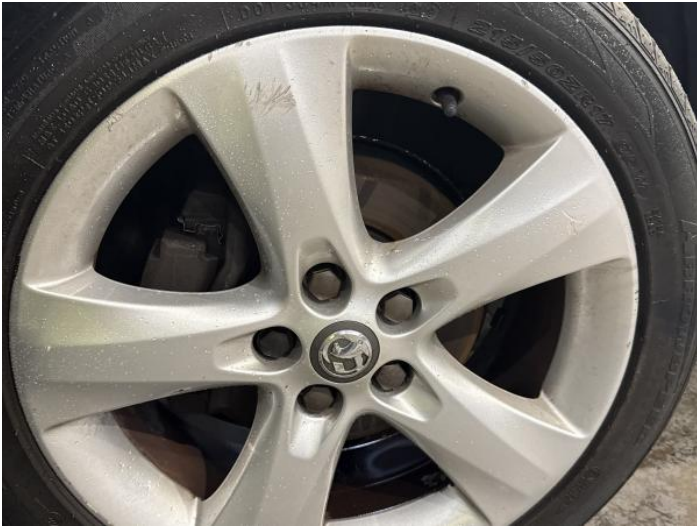
3: Wheel nsf  
Scratched  
Over 50mm

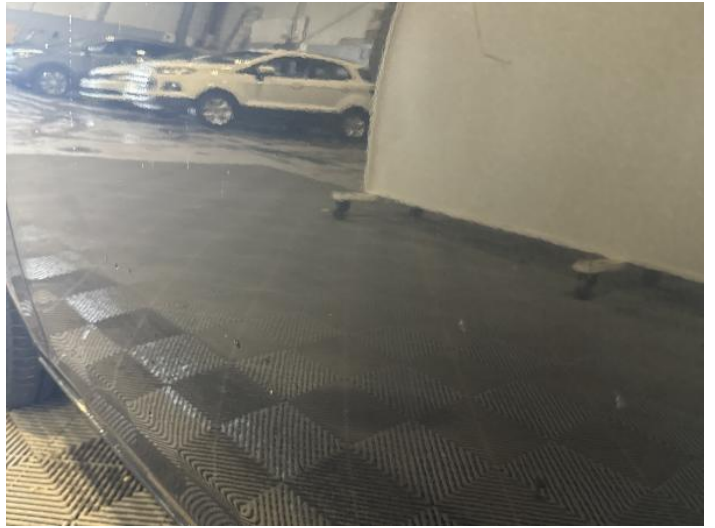
4: Door nsf  
Scratched  
Over 25mm Thru Paint

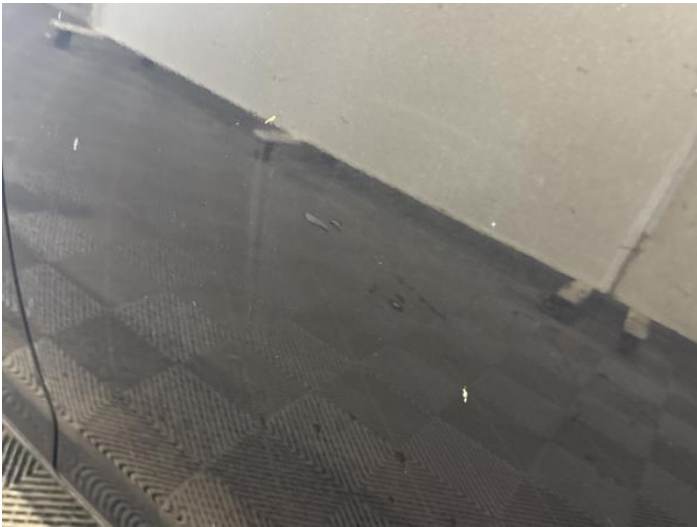
5: Door nsr  
Scratched  
Over 25mm Thru Paint

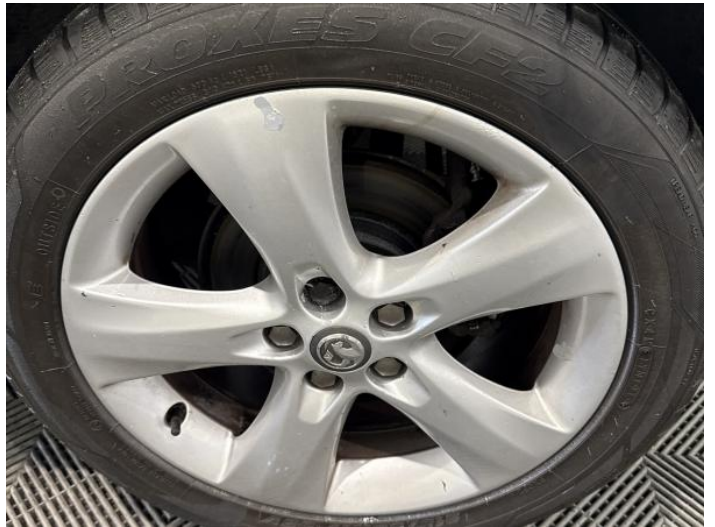
6: Wheel nsr  
Scratched  
Over 50mm

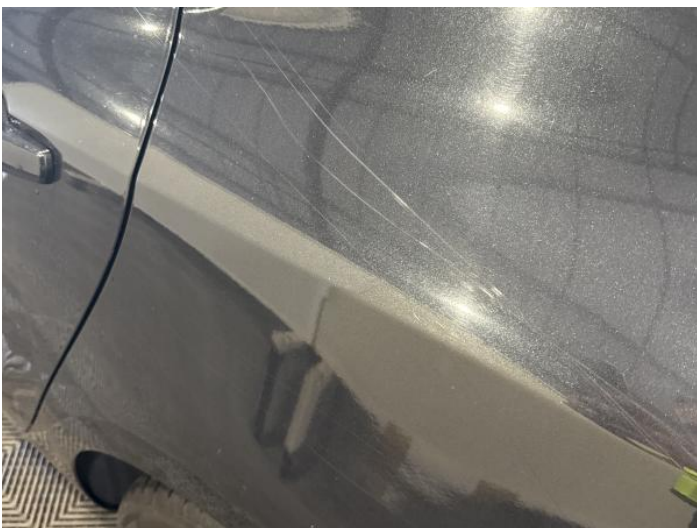
7: Qtr Panel nsr  
Scratched  
Over 25mm Thru Paint

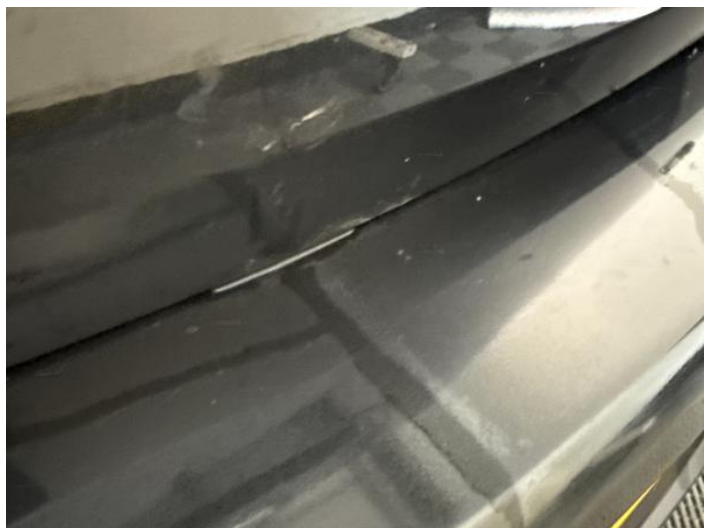
8: Tailgate  
Dented  
With Paint Damage

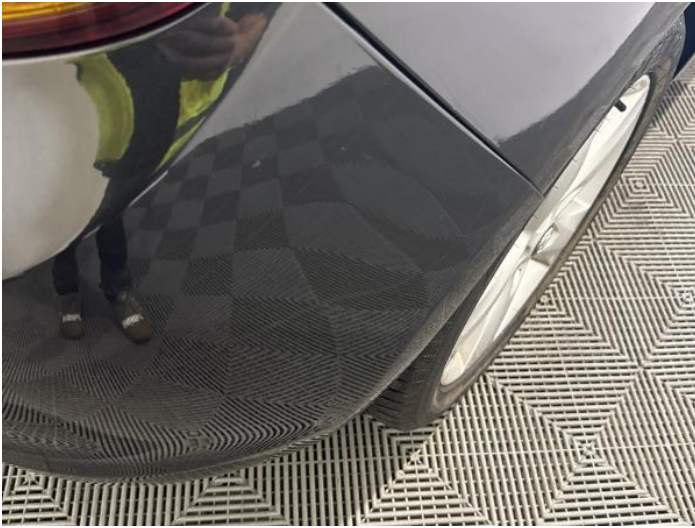
9: Bumper Rear  
Poor Previous Repair  
Poor Paint

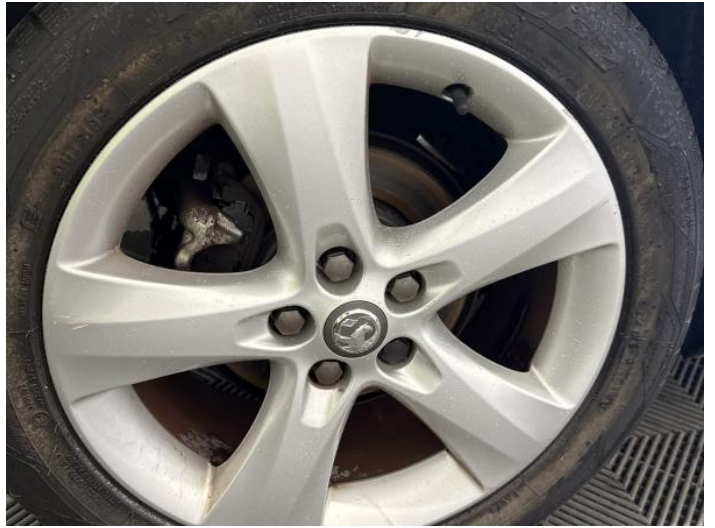
10: Wheel osr  
Scratched  
Over 50mm

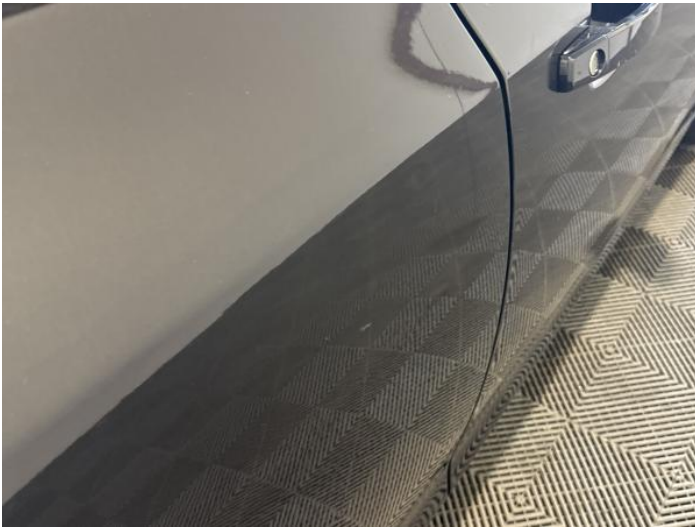
11: Door osr  
Dented  
Over 30mm

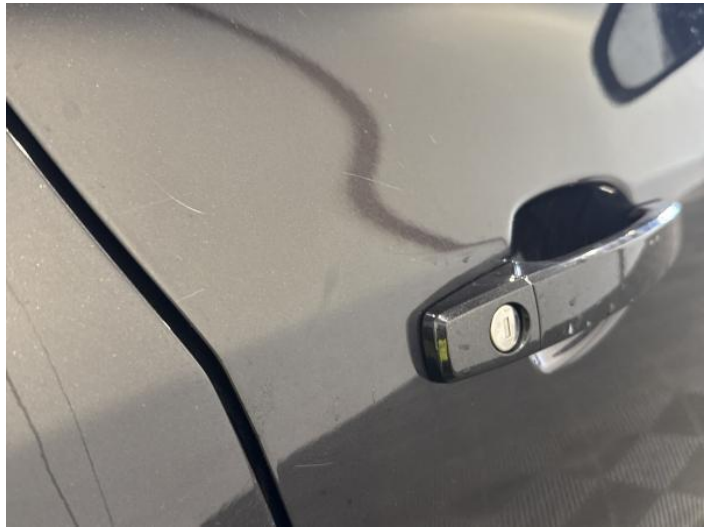
12: Door osf  
Scratched  
Over 25mm Thru Paint

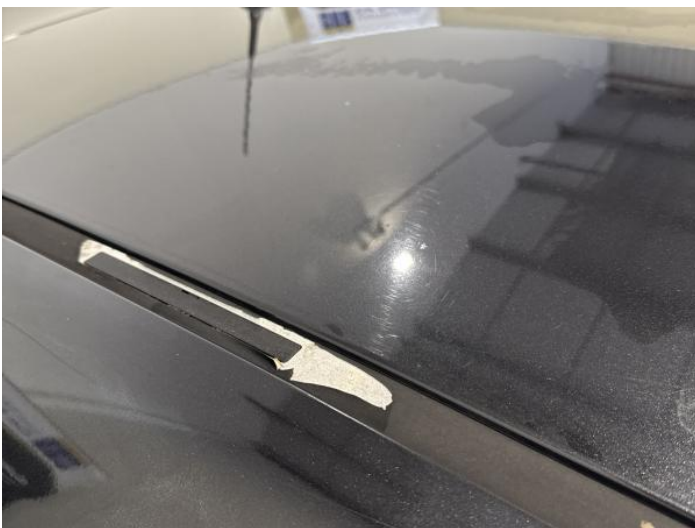
13: Roof  
Scratched  
Over 25mm Thru Paint

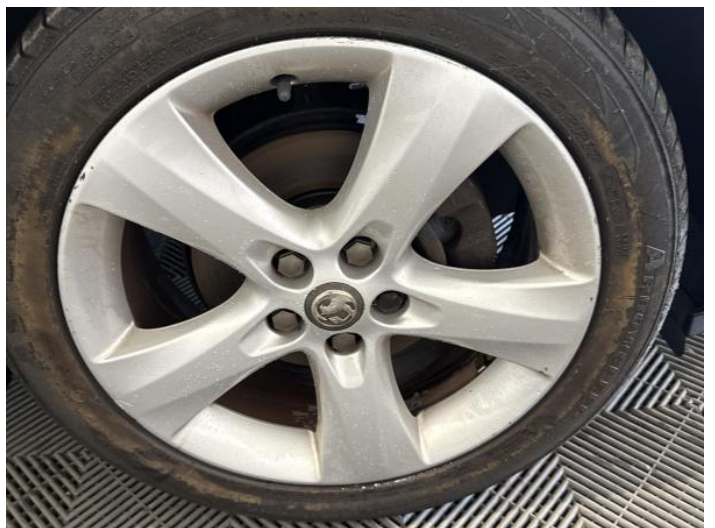
14: Wheel osf  
Scratched  
Up To 50mm

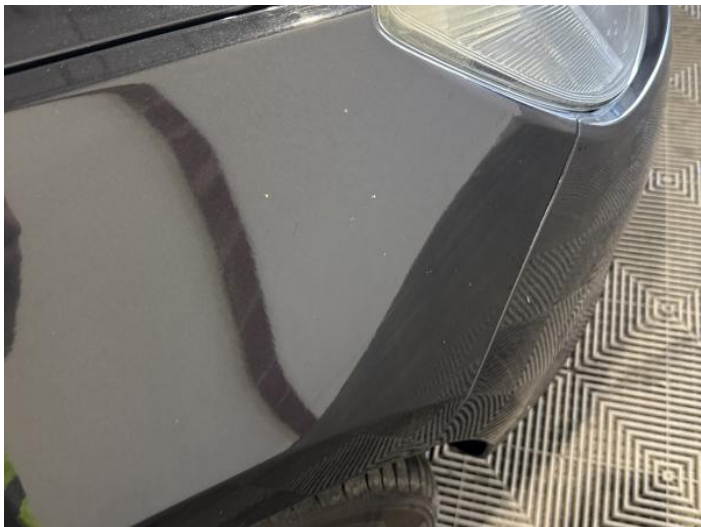
15: Wing osf  
Chipped  
1 To 5
