VEHICLE INSPECTION REPORT

GY67Nzb

Vauxhall Corsa 1.4T [150] Black Edition 3dr

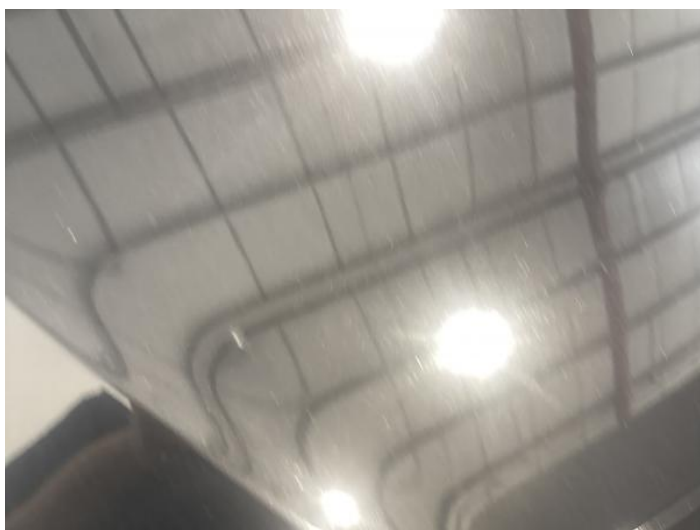
1: Bonnet
Chipped
Multiple Chips

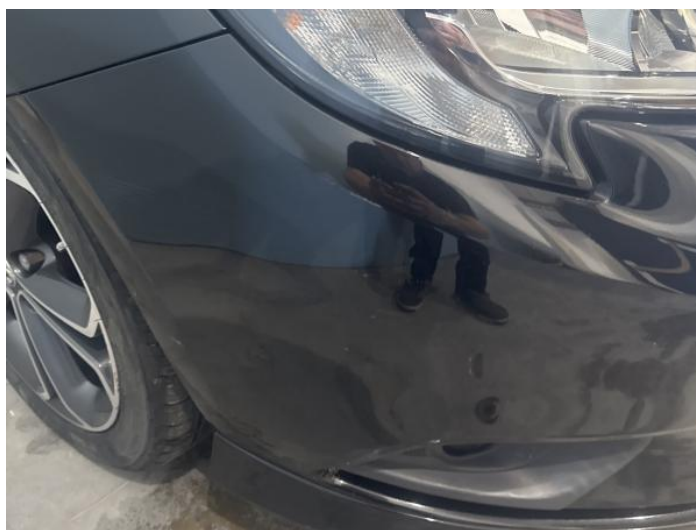
2: Bumper Front
Scratched
Over 100mm Thru Paint

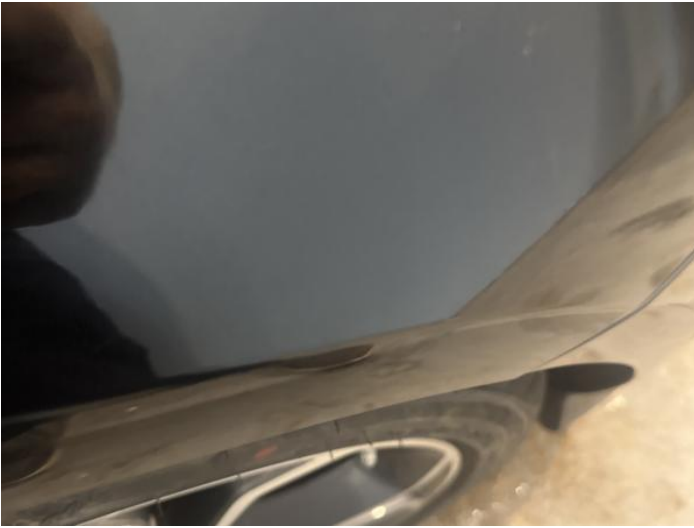
3: Wing osf
Dented
Over 2 UpTo 10mm

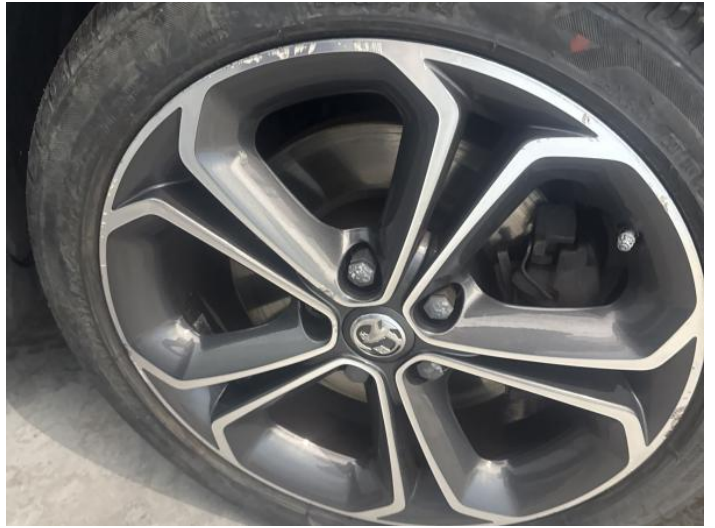
4: Wheel osf
Scratched
Over 50mm

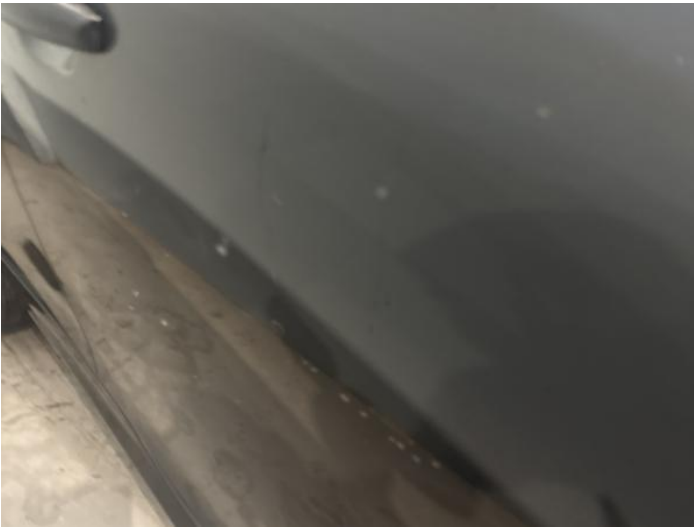
5: Door osf
Chipped
Multiple Chips

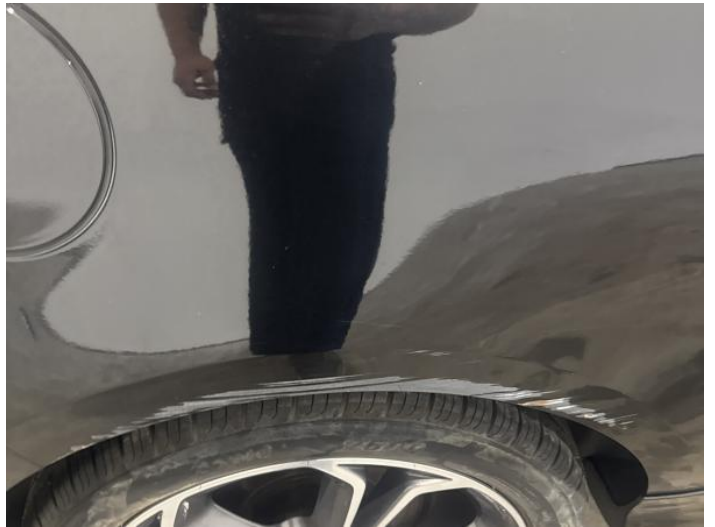
6: Qtr Panel osr
Dented
With Paint Damage

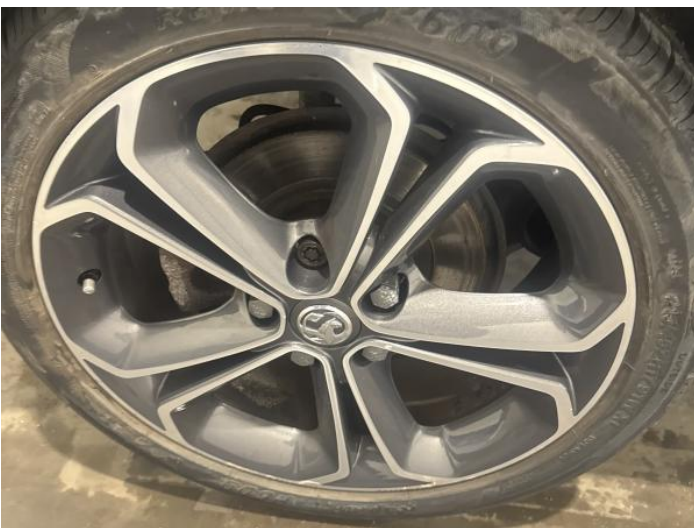
7: Wheel osr
Scratched
Over 50mm

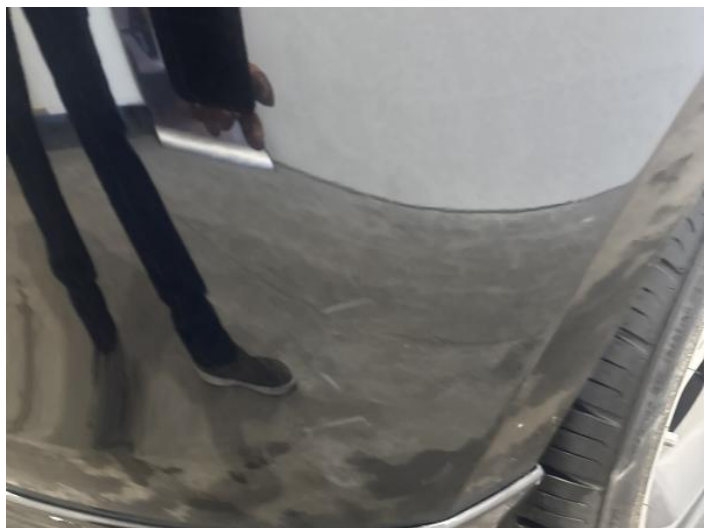
8: Bumper Rear
Scratched
25 to 100mm Thru Paint

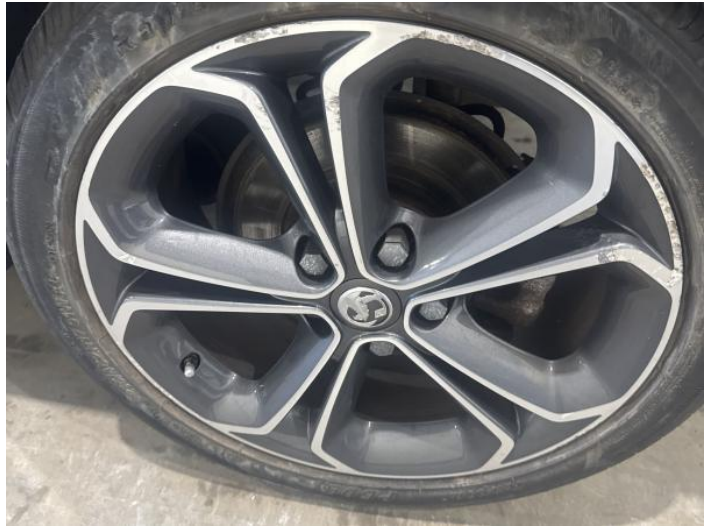
10: Wheel nsr
Scratched
Over 50mm

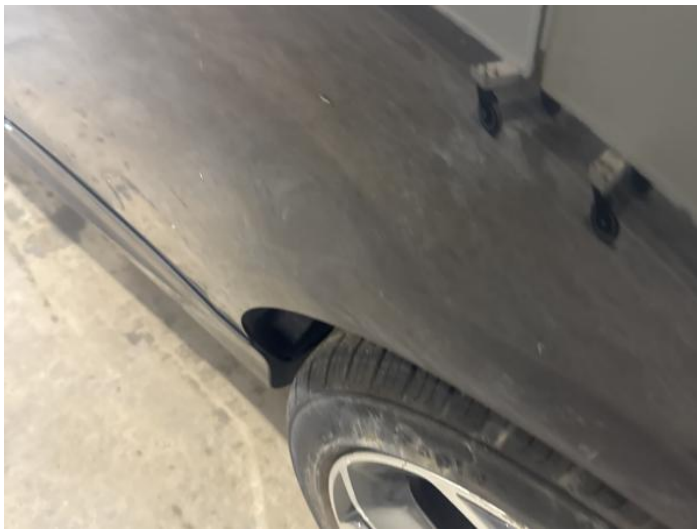
11: Qtr Panel nsr
Dented
Over 30mm

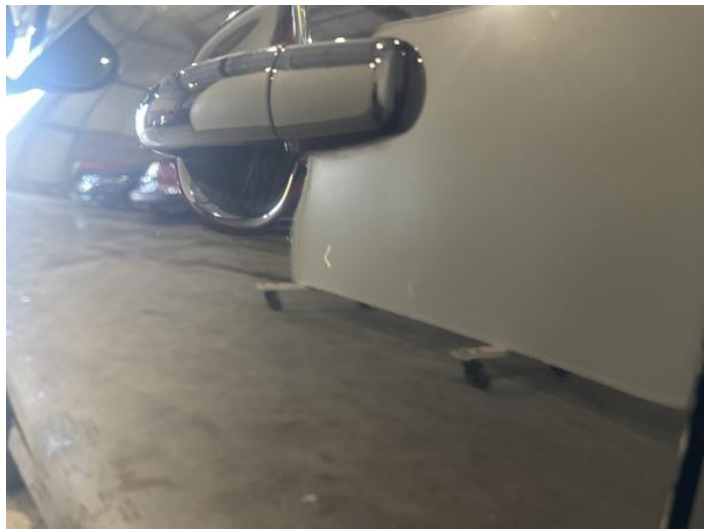
12: Door nsf
Chipped
1 To 5

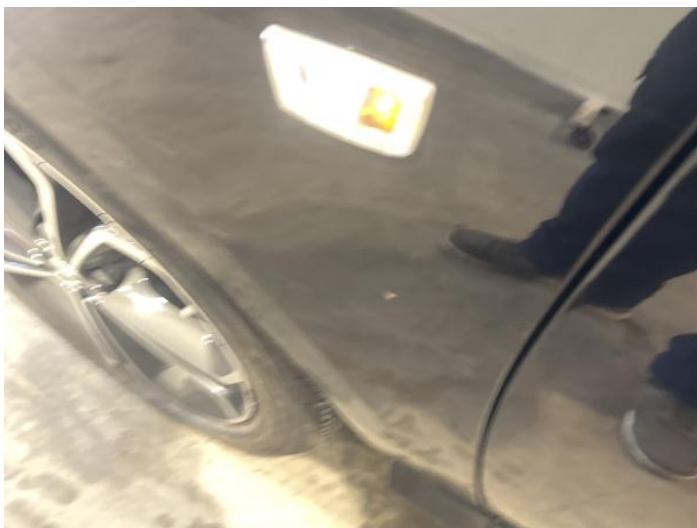
13: Wing nsf
Dented
With Paint Damage

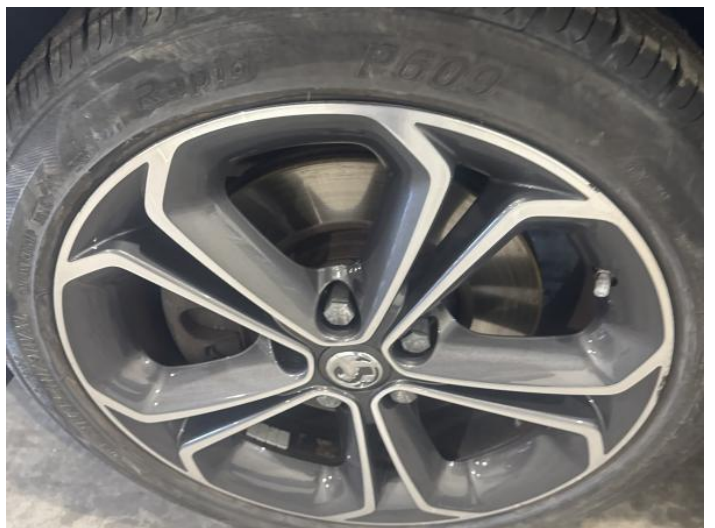
14: Wheel nsf
Scratched
Over 50mm
