VEHICLE INSPECTION REPORT

HJ13HLA

Volkswagen Caravelle 2.0 BiTDI Business 180 5dr DSG

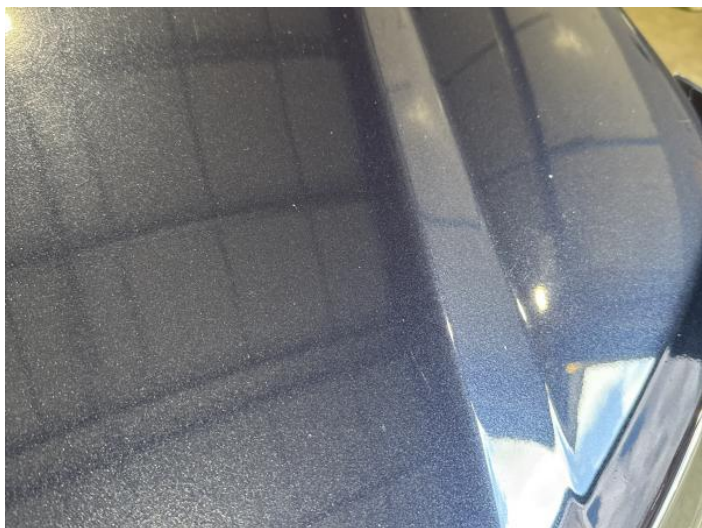
1: Bonnet
Chipped
Multiple Chips

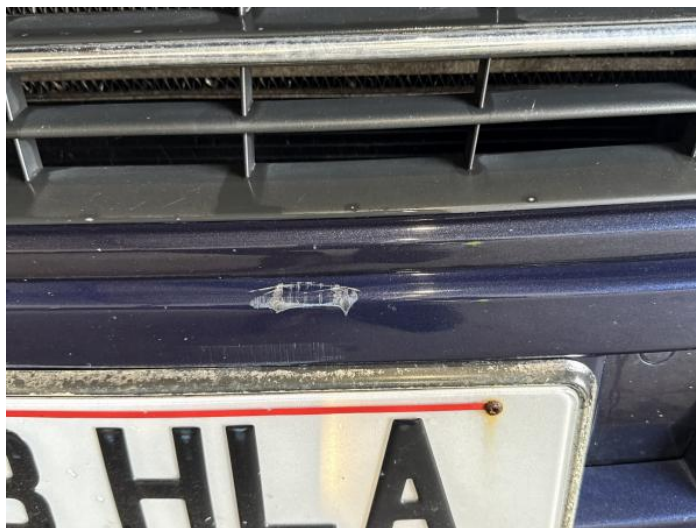
2: Bumper Front
Scratched
Over 100mm Thru Paint

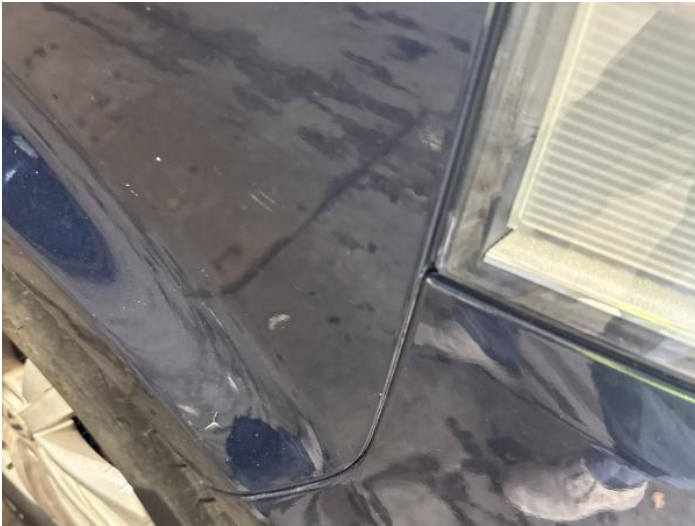
3: Wing osf
Scratched
UpTo 25mm Thru Paint

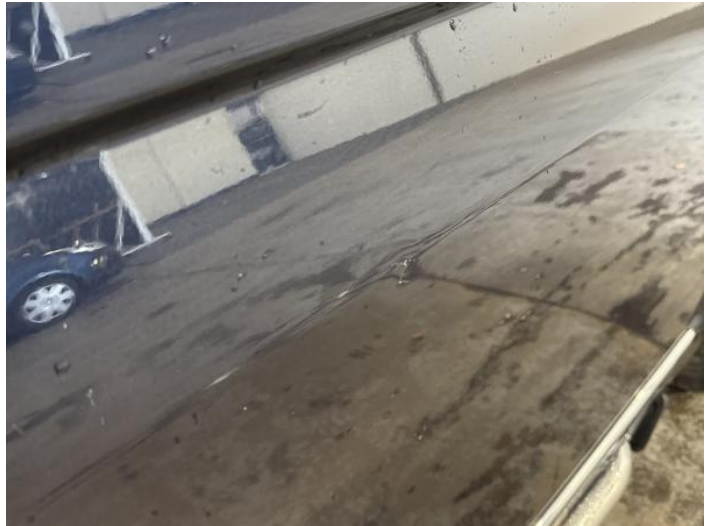
4: Door osf
Dented
Between 10mm + 30mm

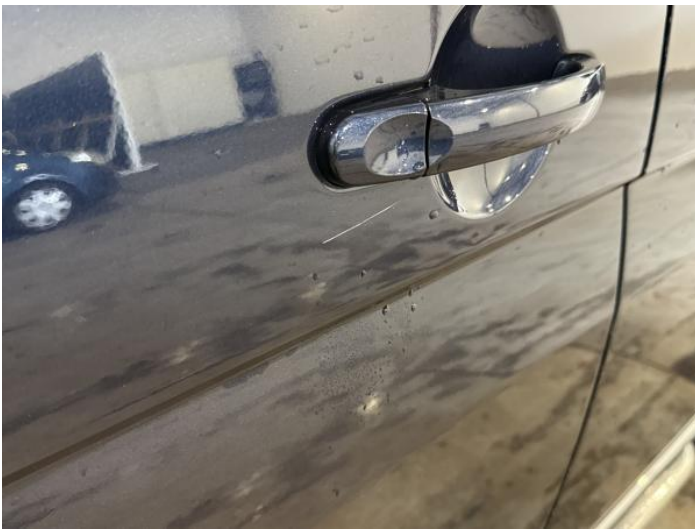
5: Door osr
Scratched
Over 25mm Thru Paint

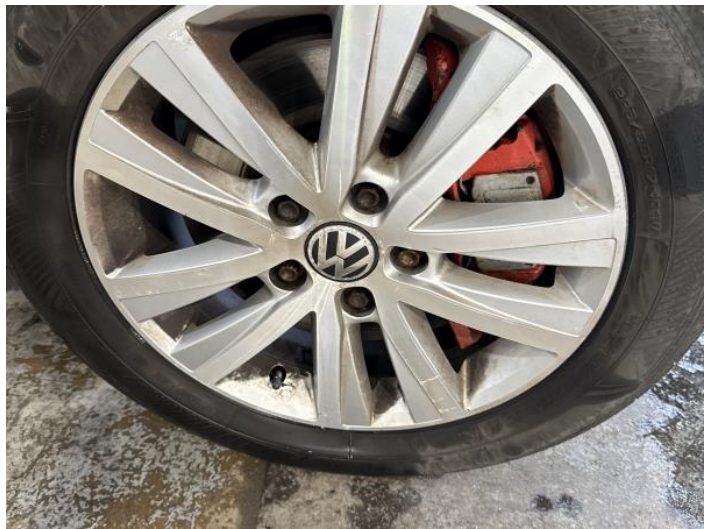
6: Wheel osf
Scratched
Over 50mm

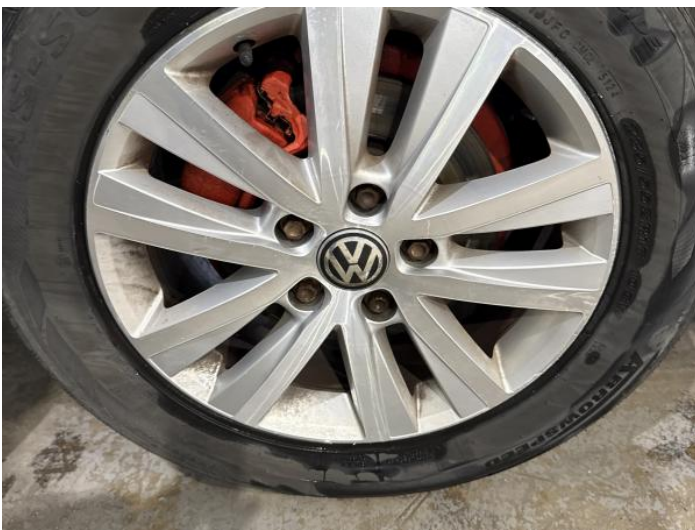
7: Wheel osr
Scratched
Up To 50mm

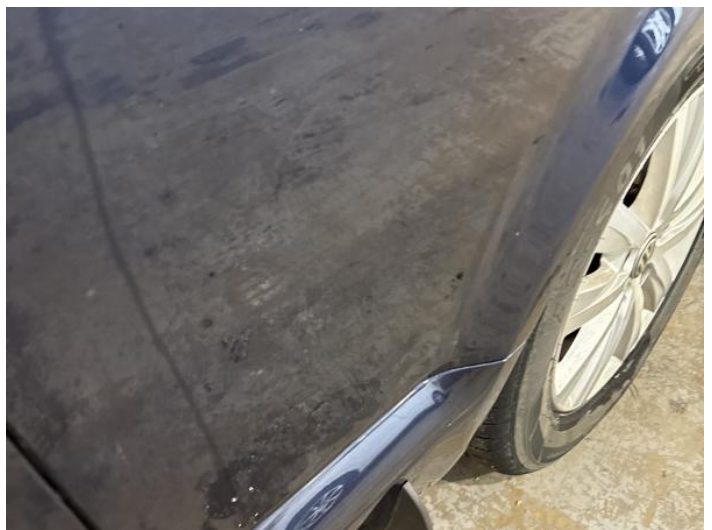
8: Qtr Panel osr
Chipped
1 To 5

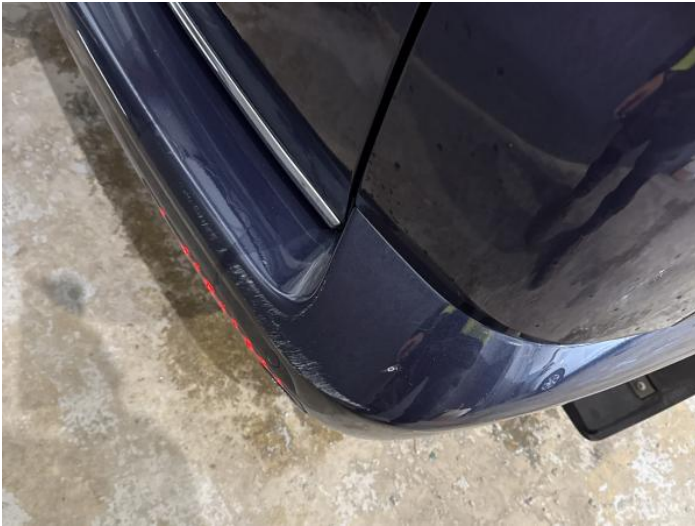
9: Bumper Rear
Scratched
Over 100mm Thru Paint

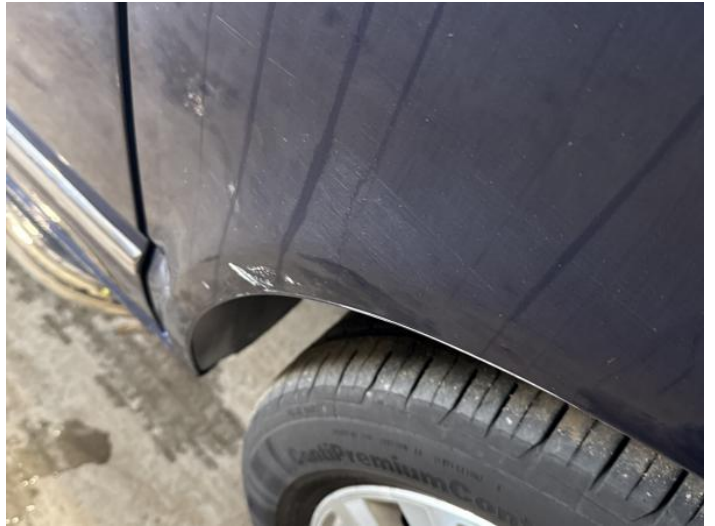
10: Qtr Panel nsr
Scratched
Over 25mm Thru Paint

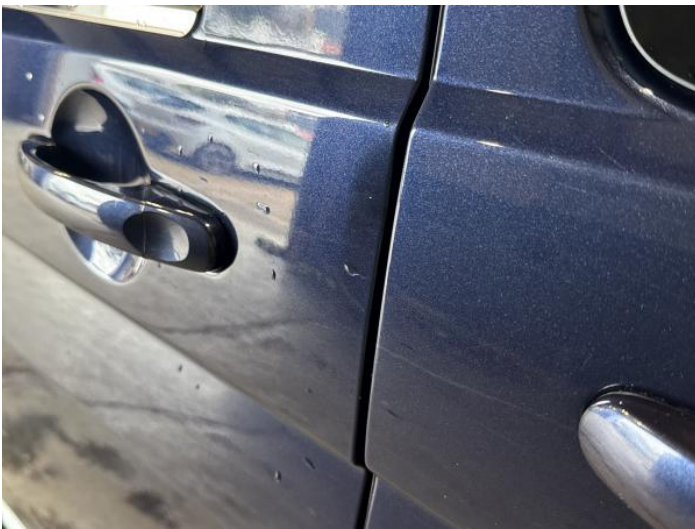
11: Door nsf
Dented
Over 30mm

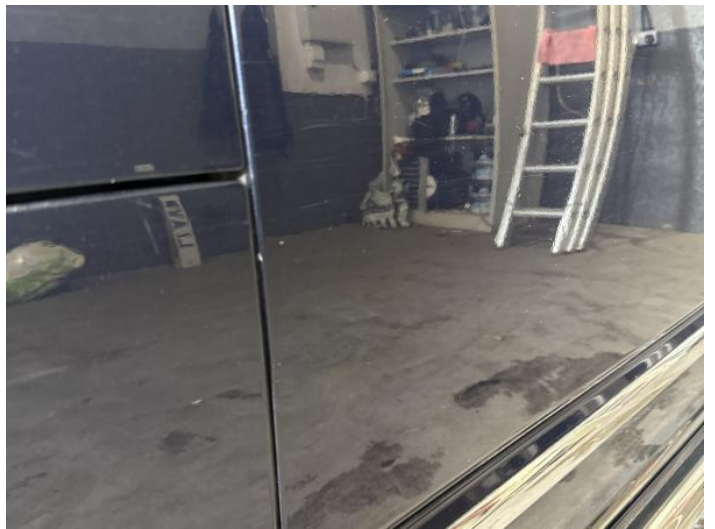
12: Door nsr
Scratched
Over 25mm Thru Paint

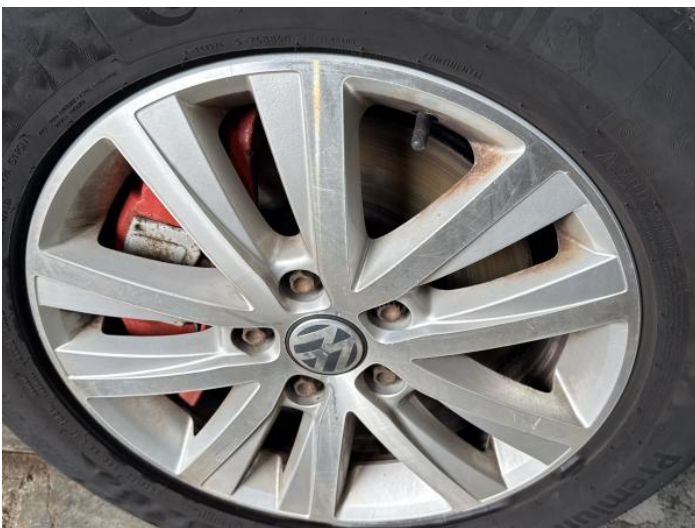
13: Wheel nsf
Scratched
Up To 50mm

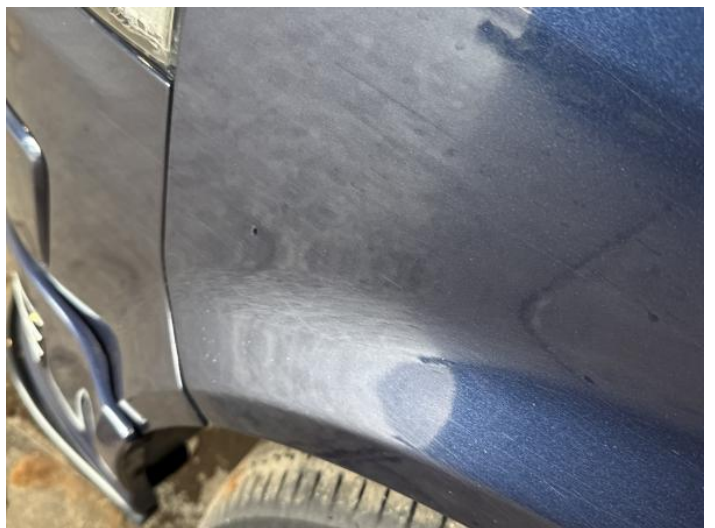
14: Wing nsf
Scratched
Over 25mm Thru Paint

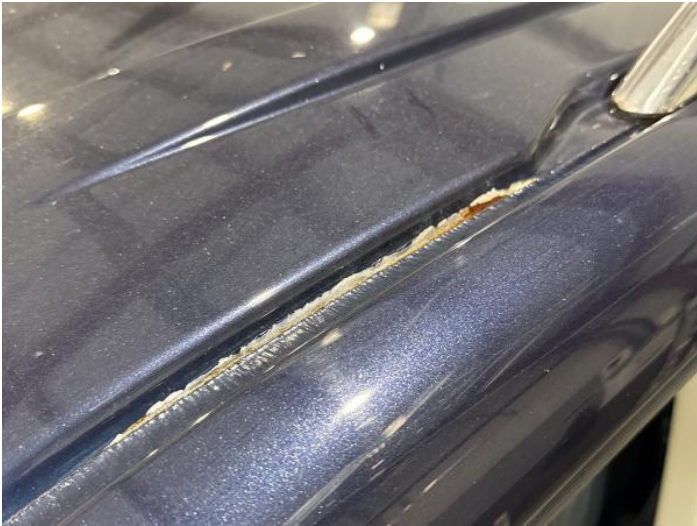
15: Roof
Poor Previous Repair
Paint Flake

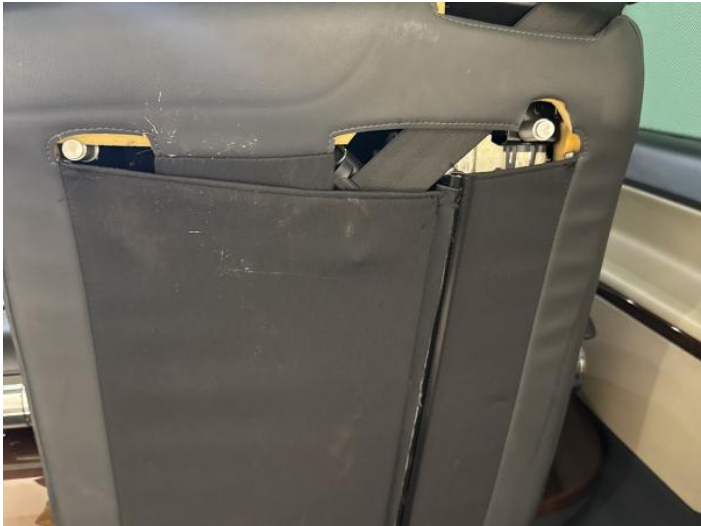
16: Seat Back Cover osf
Scuffed
Over 25mm

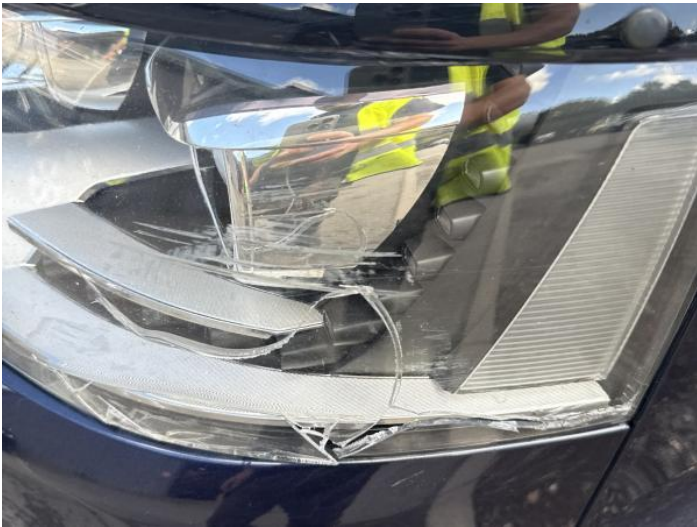
17: Headlamp ns
Broken
Replace
