VEHICLE INSPECTION REPORT

YG13YTV

Volkswagen Golf 1.4 TSI SE 5dr DSG

nama
GRADE
3

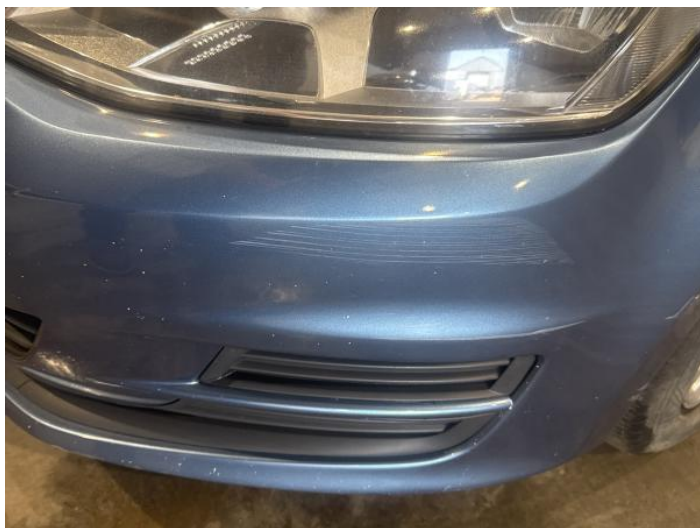
1: Bumper Front
Scratched
Over 100mm Thru Paint

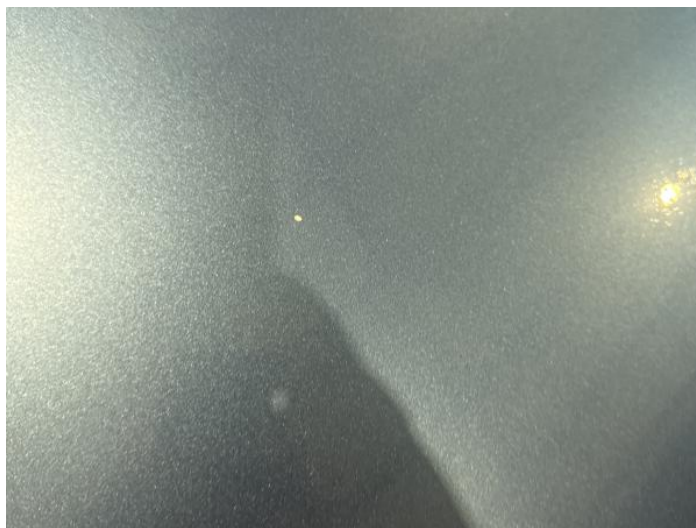
2: Bonnet
Chipped
1 To 5

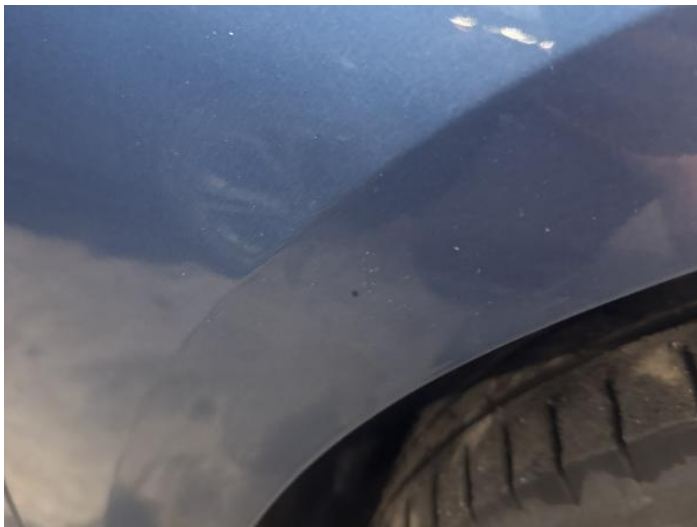
3: Wing osf
Dented
Between 10mm + 30mm

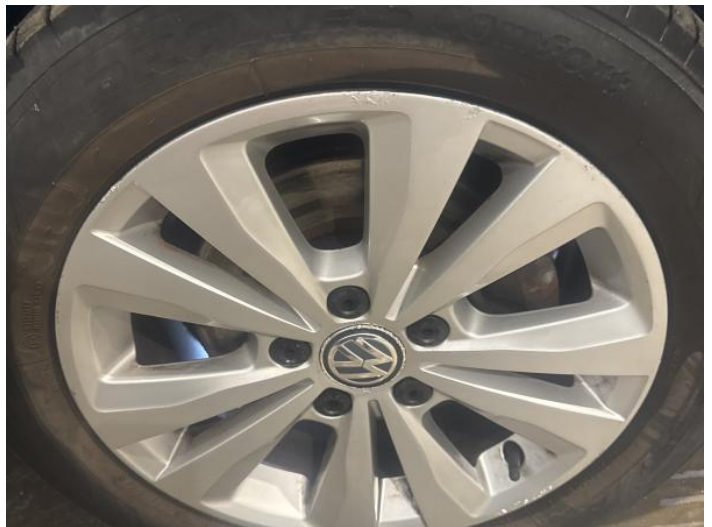
4: Wheel osf
Scratched
Over 50mm

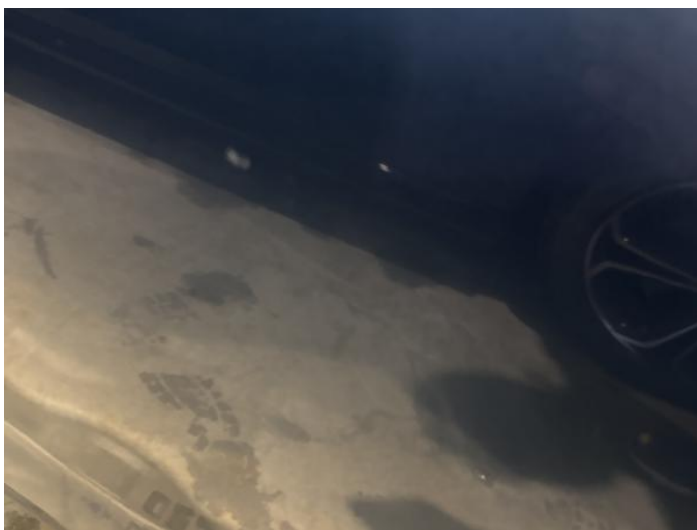
5: Door osf
Chipped
1 To 5

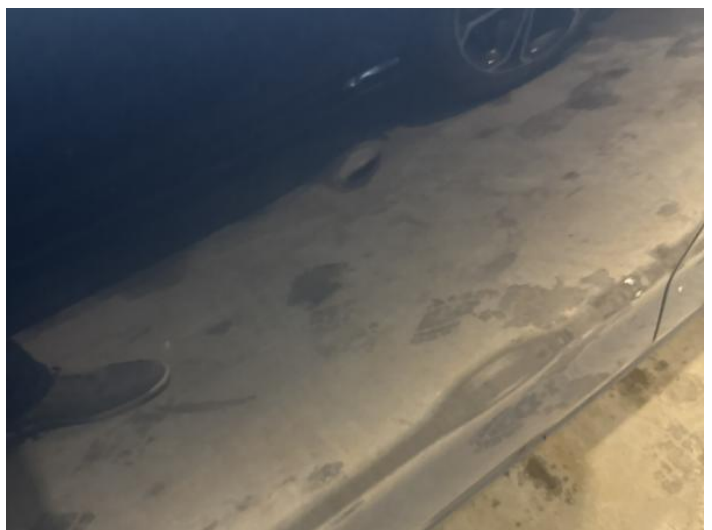
6: Door osr
Dented
Between 10mm + 30mm

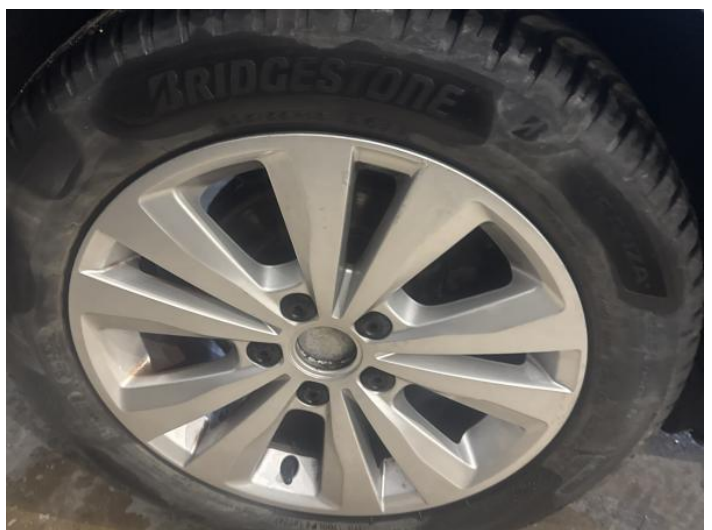
8: Wheel osr
Scratched
Over 50mm

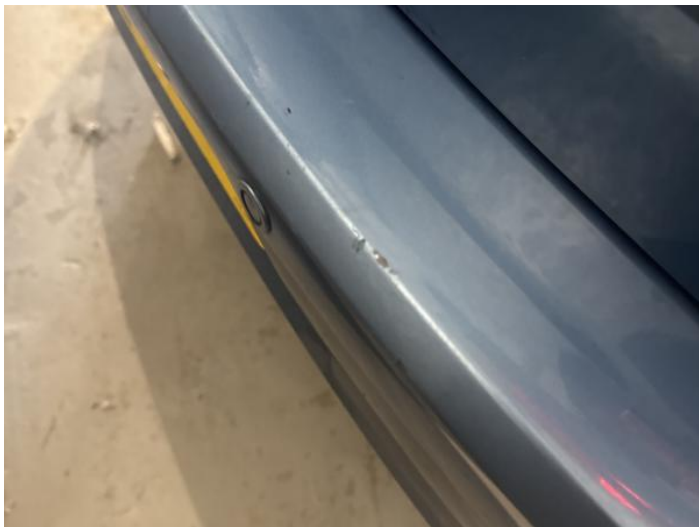
9: Bumper Rear
Scratched
25 to 100mm Thru Paint

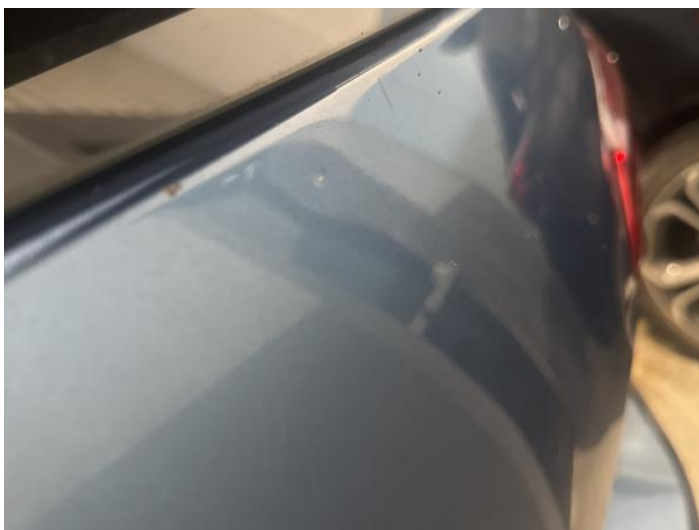
11: Boot Lid
Dented
Over 2 UpTo 10mm

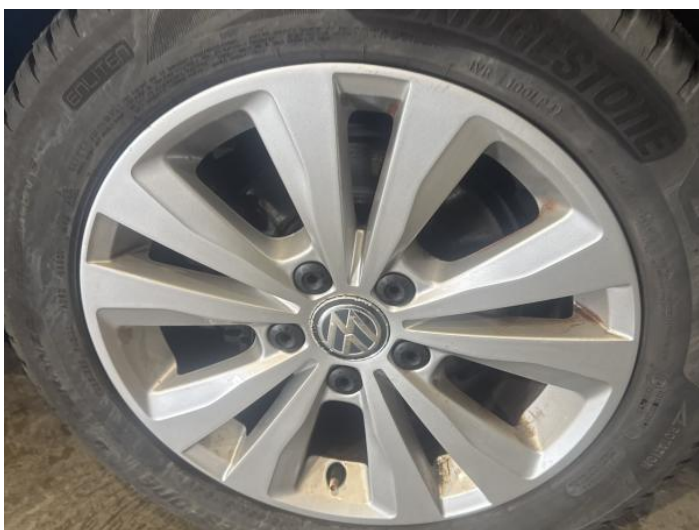
13: Wheel nsr
Scratched
Up To 50mm

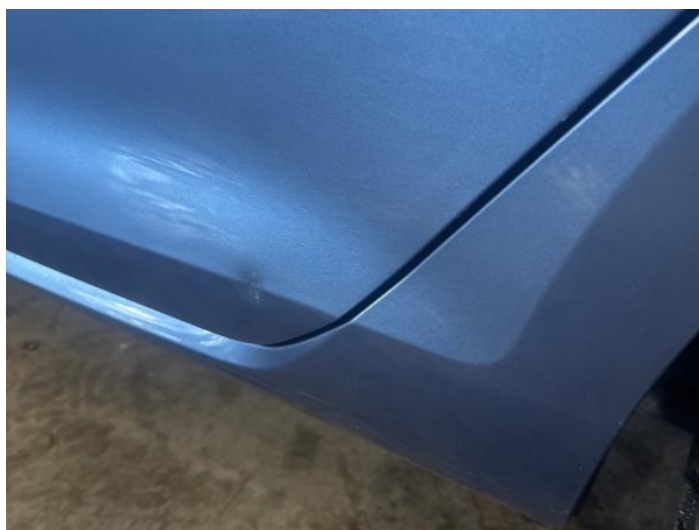
14: Door nsr
Dented
With Paint Damage

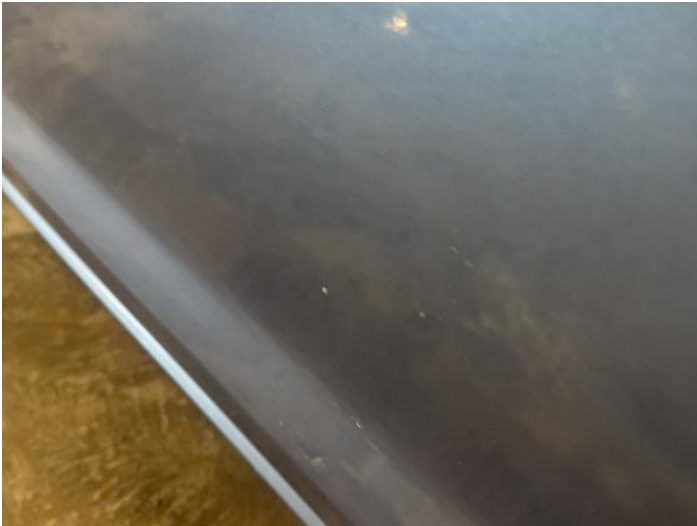
15: Door nsf
Chipped
1 To 5

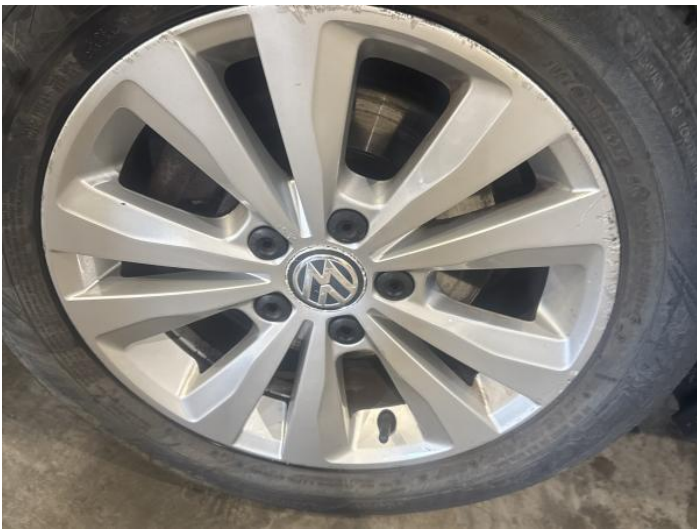
17: Wheel nsf
Scratched
Over 50mm
