# VEHICLE INSPECTION REPORT

**KP57GZK**

## Mercedes-Benz S Class S320 CDI

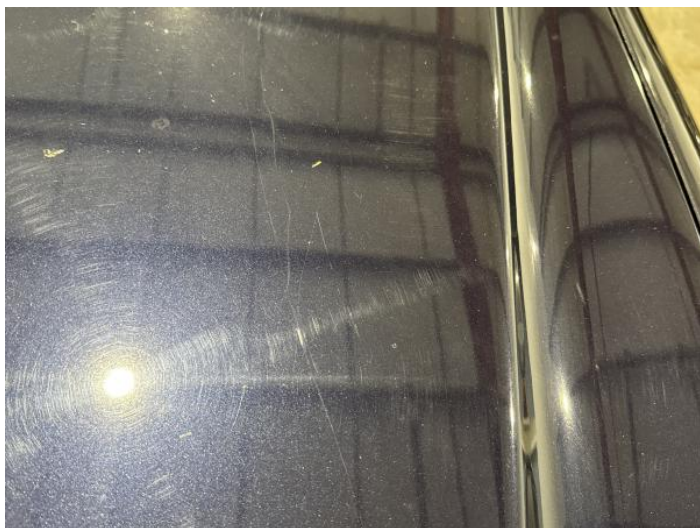
1: Bonnet  
Scratched  
Over 25mm Thru Paint

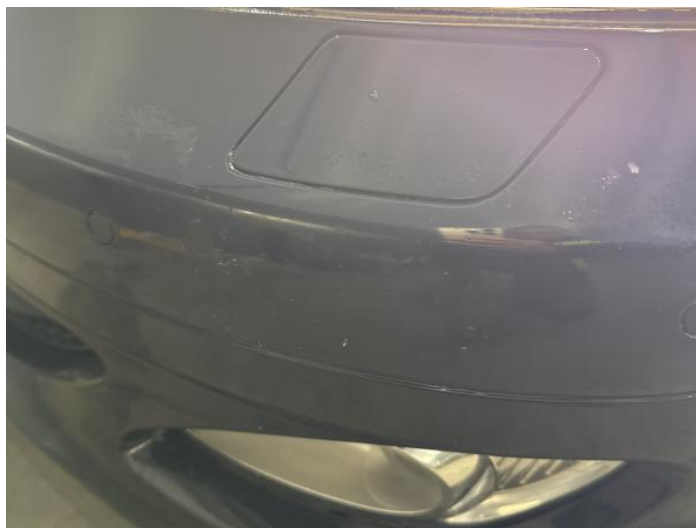
2: Bumper Front  
Poor Previous Repair  
Poor Paint

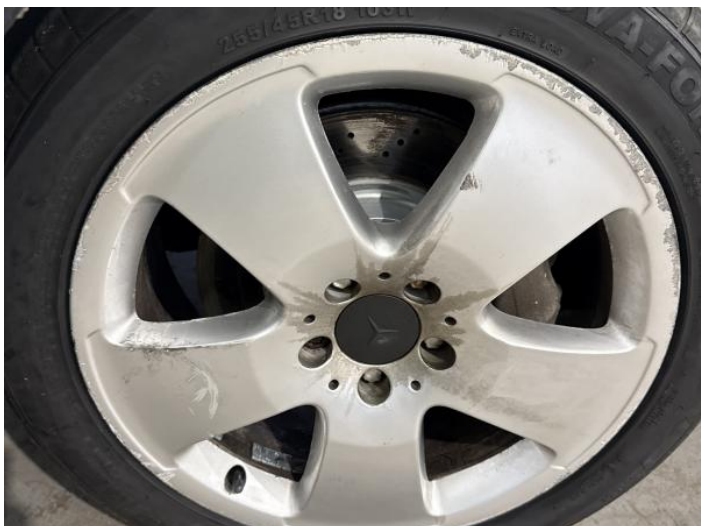
3: Wheel nsf  
Scratched  
Over 50mm

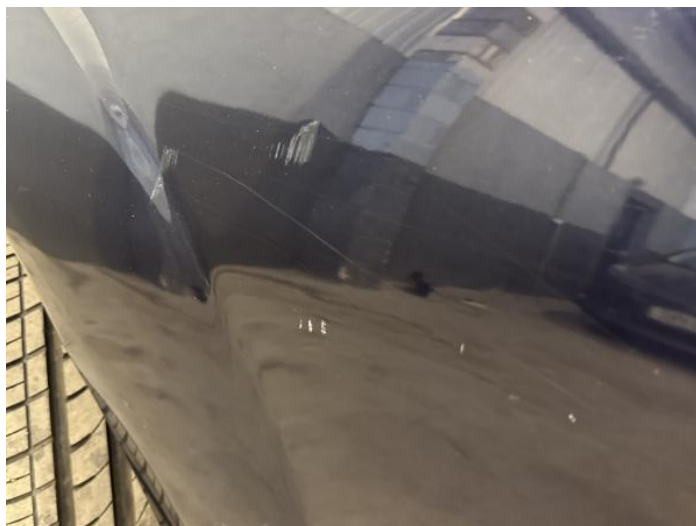
4: Wing nsf  
Dented  
With Paint Damage

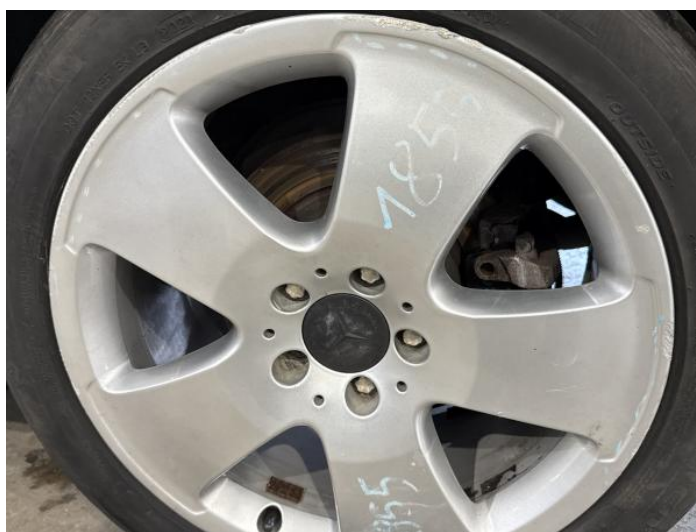
6: Wheel nsr  
Scratched  
Over 50mm

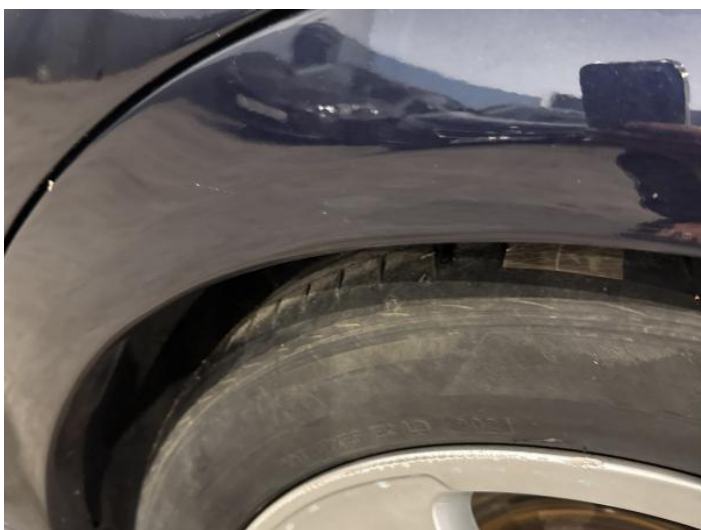
7: Qtr Panel nsr  
Scratched  
Over 25mm Thru Paint

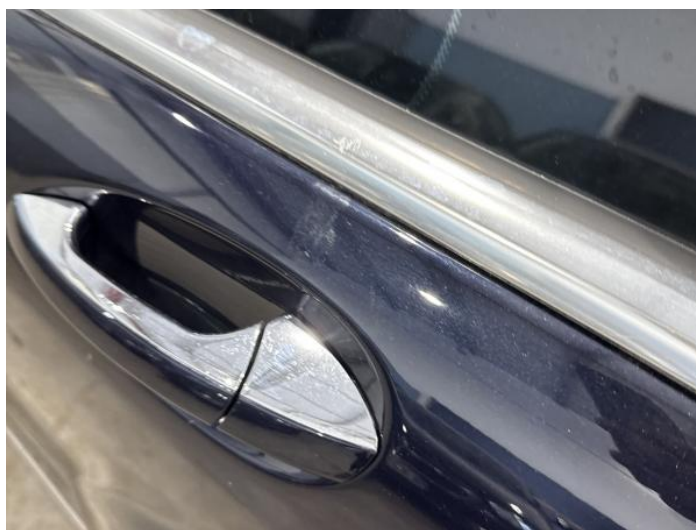
8: Door nsr  
Scratched  
UpTo 25mm Thru Paint

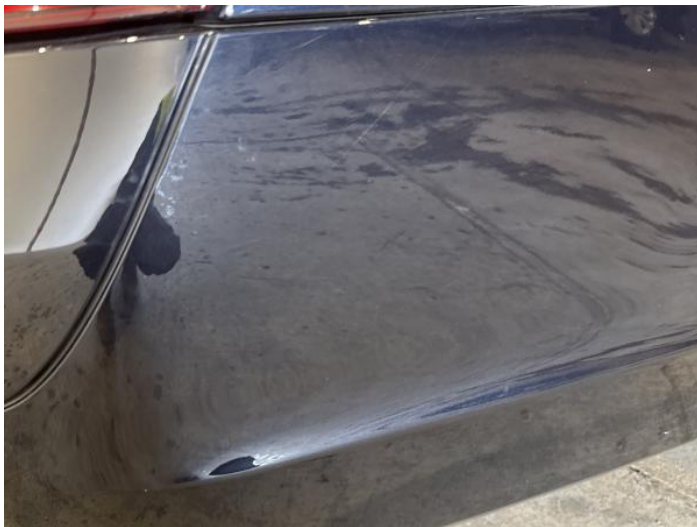
9: Bumper Rear  
Scratched  
Over 100mm Thru Paint

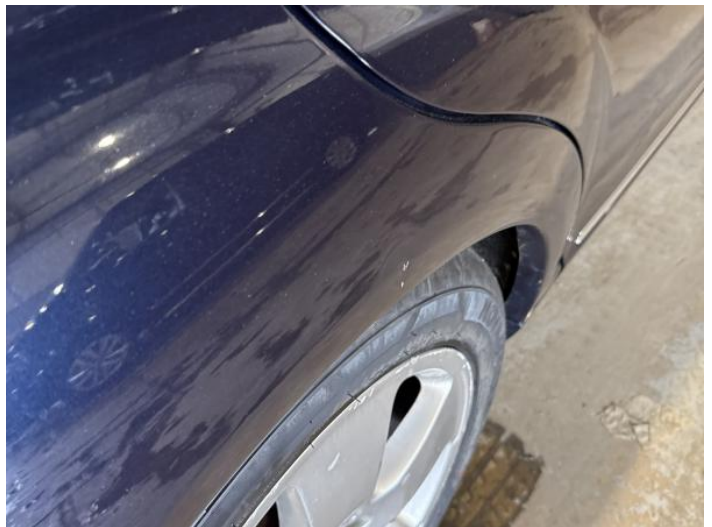
10: Qtr Panel osr  
Dented  
With Paint Damage

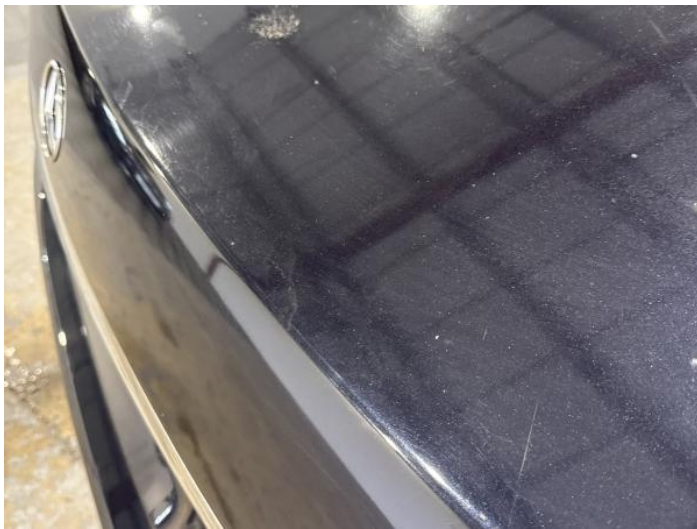
11: Boot Lid  
Scratched  
Over 25mm Thru Paint

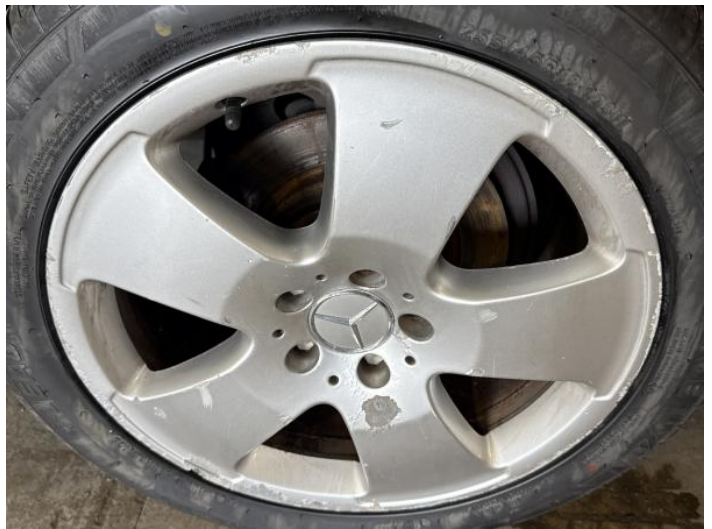
12: Wheel osr  
Scratched  
Over 50mm

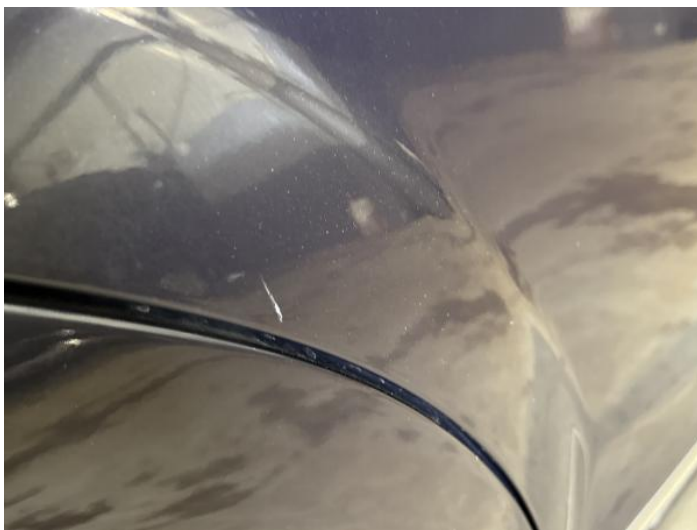
13: Door osr  
Scratched  
Over 25mm Thru Paint

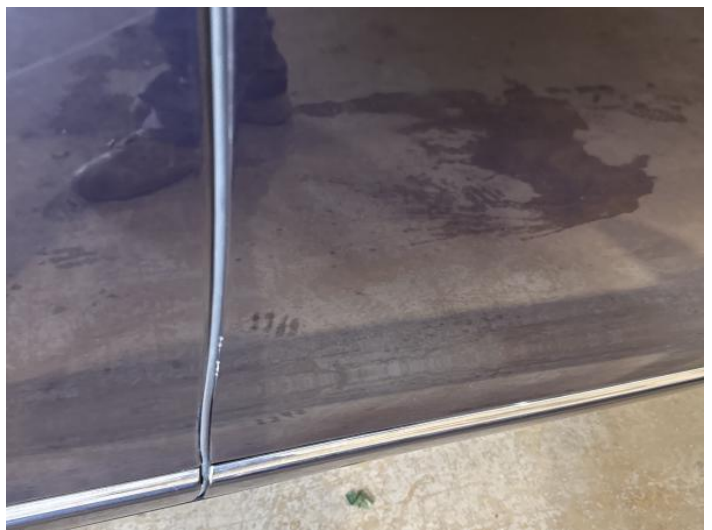
14: Door osf  
Scratched  
Over 25mm Thru Paint

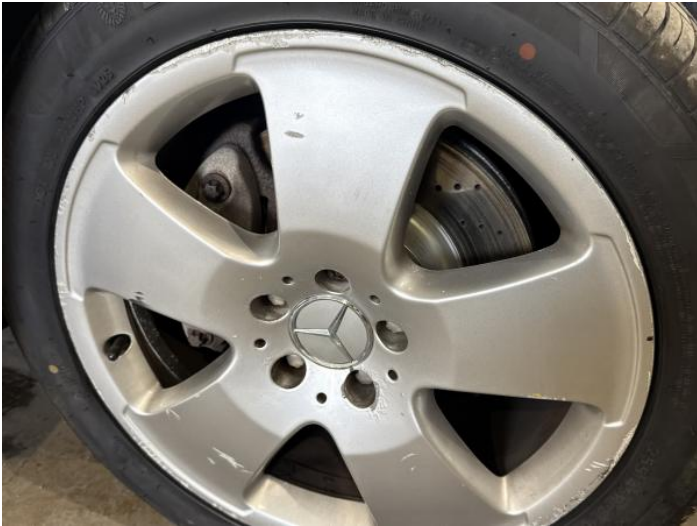
15: Wheel osf  
Scratched  
Over 50mm

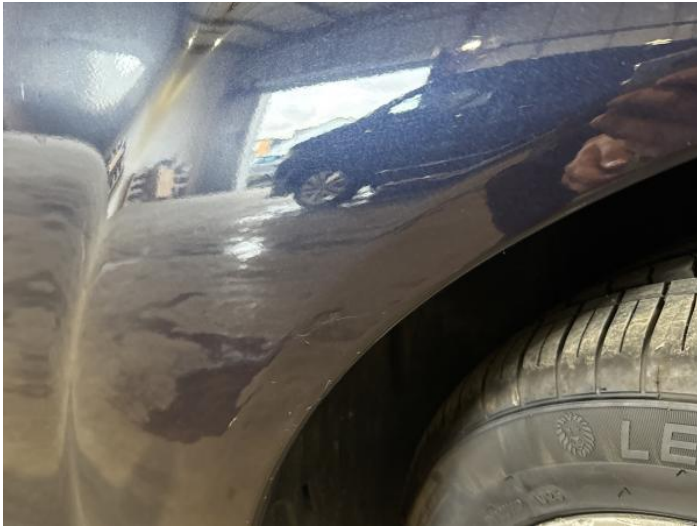
16: Wing osf  
Scratched  
UpTo 25mm Thru Paint

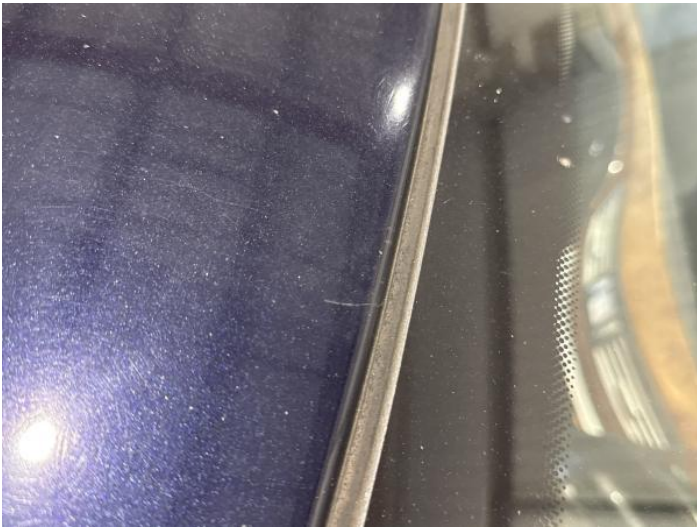
17: Roof  
Scratched  
UpTo 25mm Thru Paint

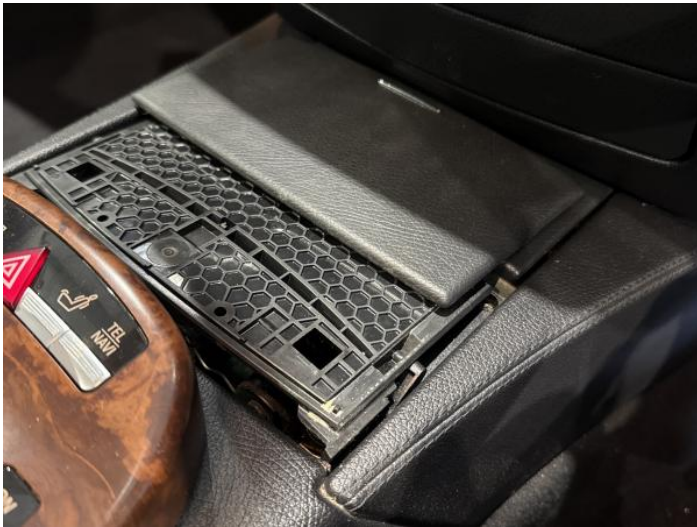
18: Centre Console Front  
Scuffed  
Over 25mm
