# VEHICLE INSPECTION REPORT

**RV69JZP**

## Ford Focus 2.0 EcoBlue Titanium X 5dr

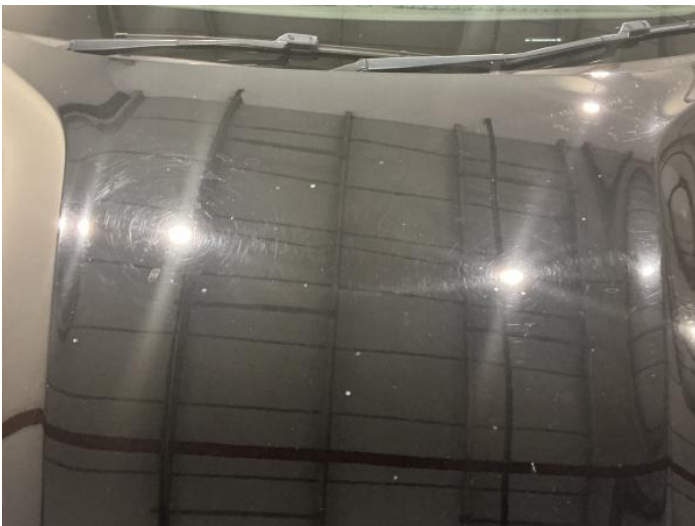
1: Bonnet  
Chipped  
Multiple Chips

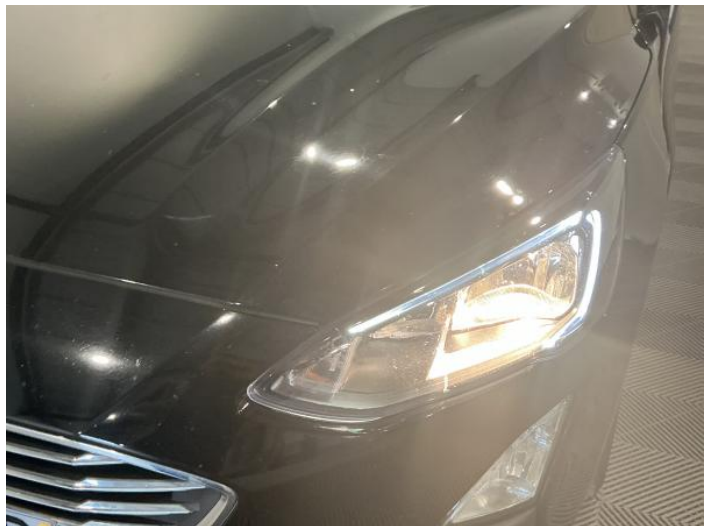
2: Bumper Front  
Poor Previous Repair  
Poor Paint

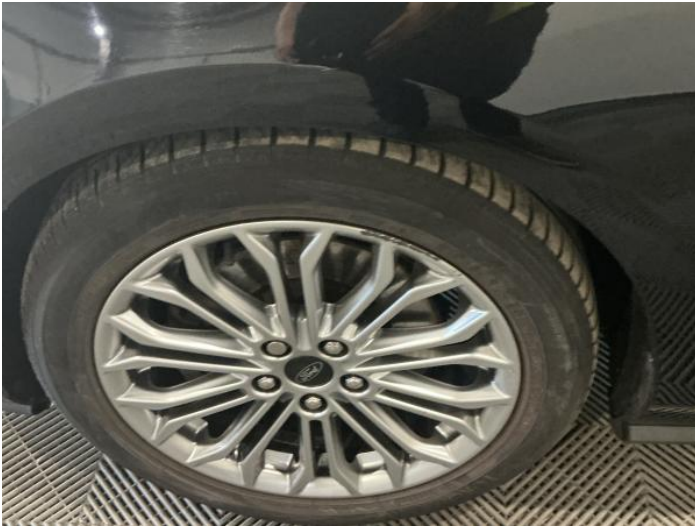
3: Wheel nsf  
Scratched  
Over 50mm

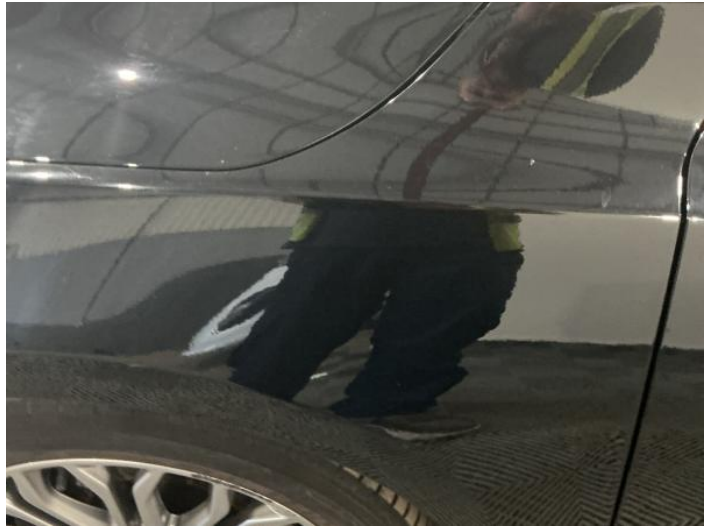
4: Wing nsf  
Dented  
Over 2 UpTo 10mm

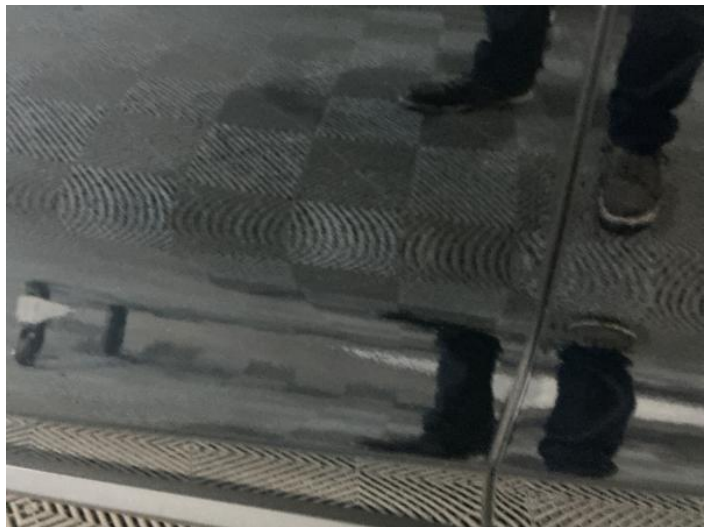
6: Door nsf  
Poor Previous Repair  
Poor Paint

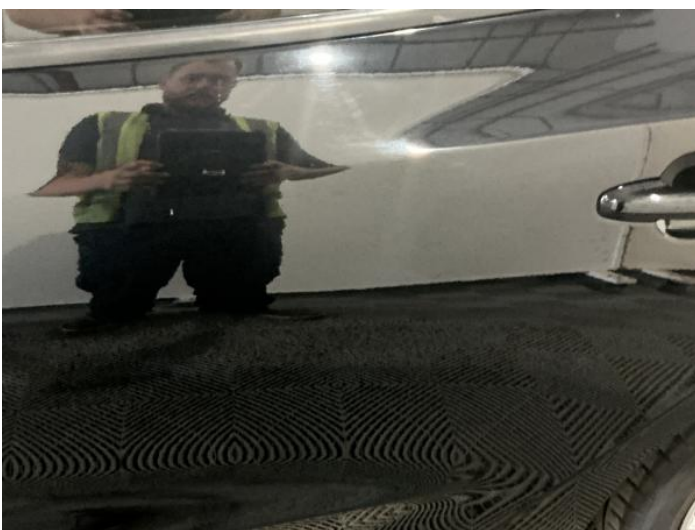
7: Door nsr  
Poor Previous Repair  
Poor Paint

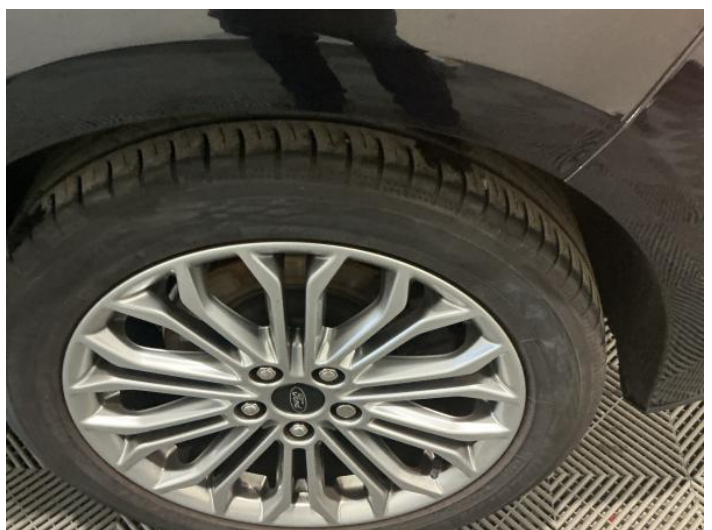
8: Wheel nsr  
Scratched  
Up To 50mm

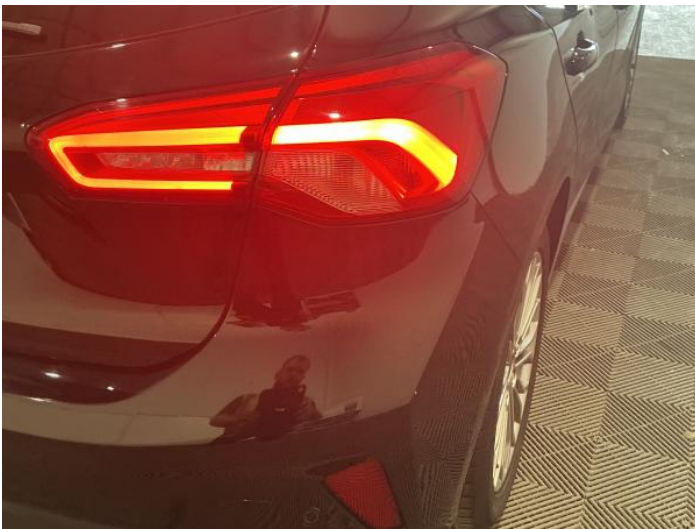
11: Bumper Rear  
Scratched  
Over 100mm Thru Paint

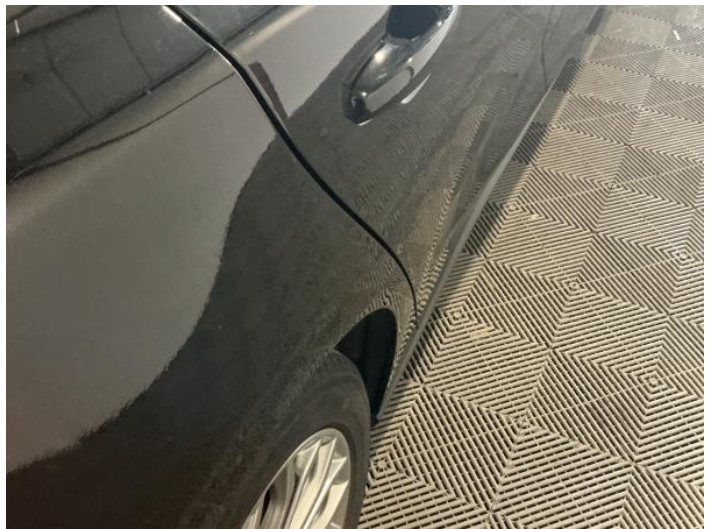
12: Qtr Panel osr  
Dented  
2 Or Less UpTo 10mm

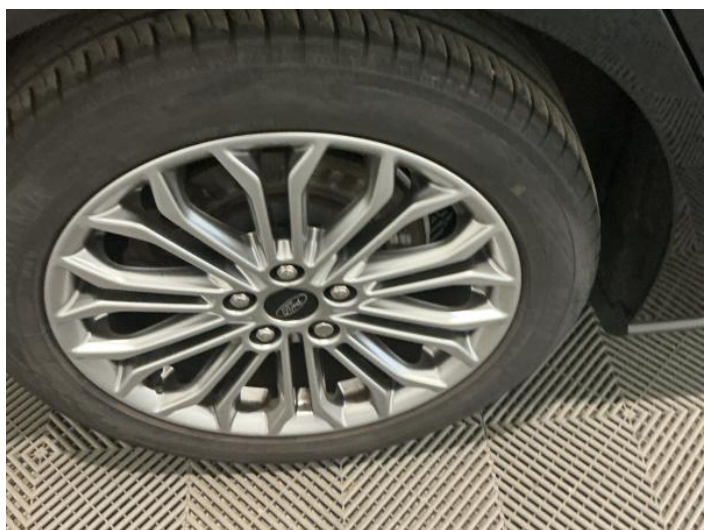
14: Wheel osr  
Scratched  
Up To 50mm

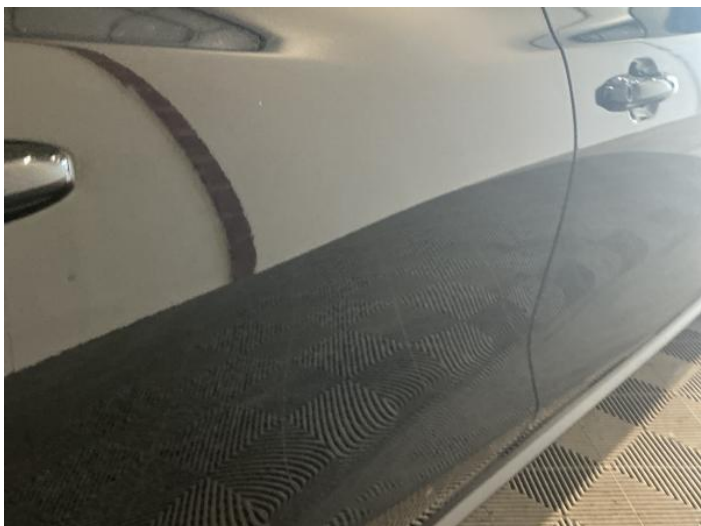
15: Door osr  
Chipped  
1 To 5

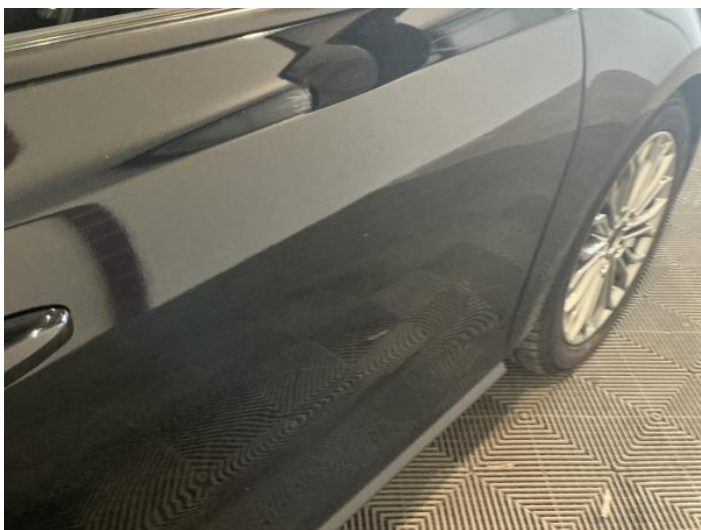
17: Door osf  
Poor Previous Repair  
Poor Paint

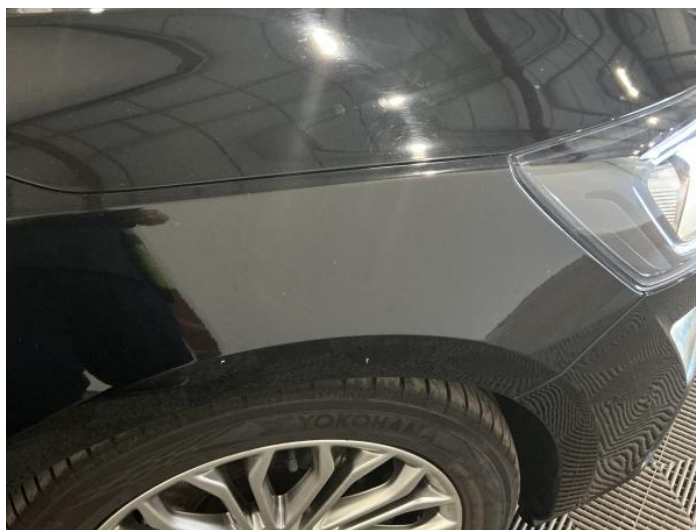
18: Wing osf  
Chipped  
1 To 5

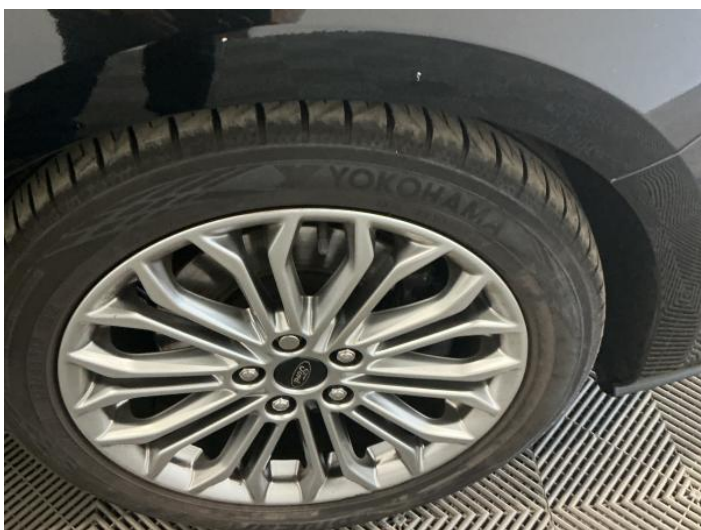
19: Wheel osf  
Scratched  
Up To 50mm

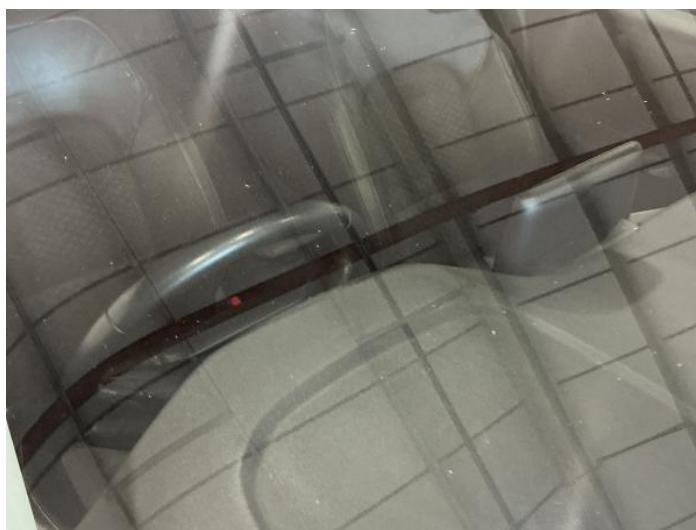
20: Screen Front  
Chipped  
UpTo 10mm
