# VEHICLE INSPECTION REPORT

**SD68KKJ**

## Renault Captur 0.9 TCE 90 GT Line 5dr

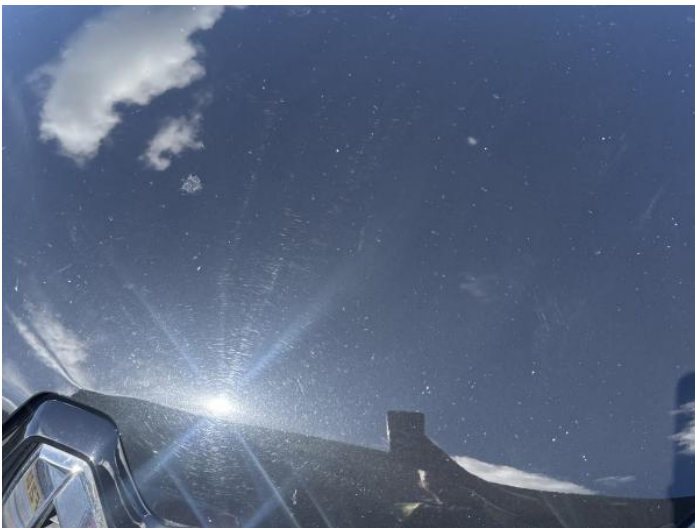
1: Bonnet  
Chipped  
Multiple Chips

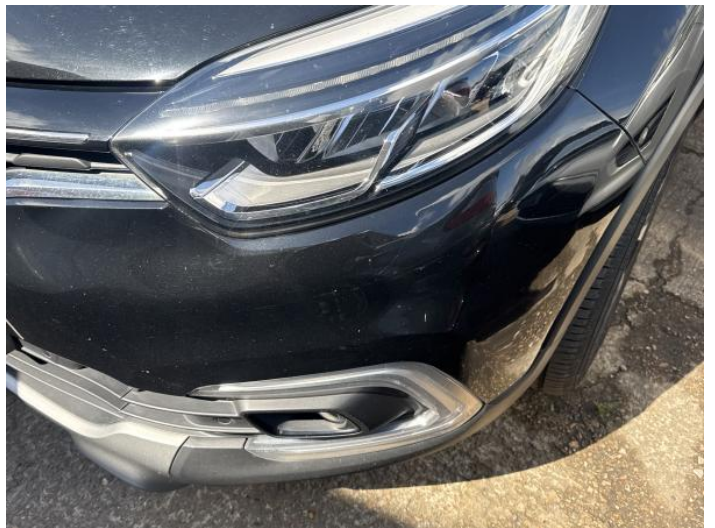
2: Bumper Front  
Chipped  
Multiple Chips

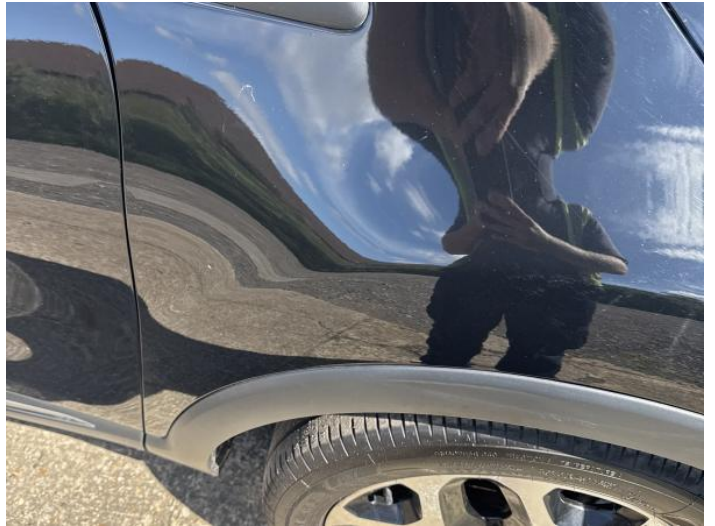
4: Wing osf  
Chipped  
1 To 5

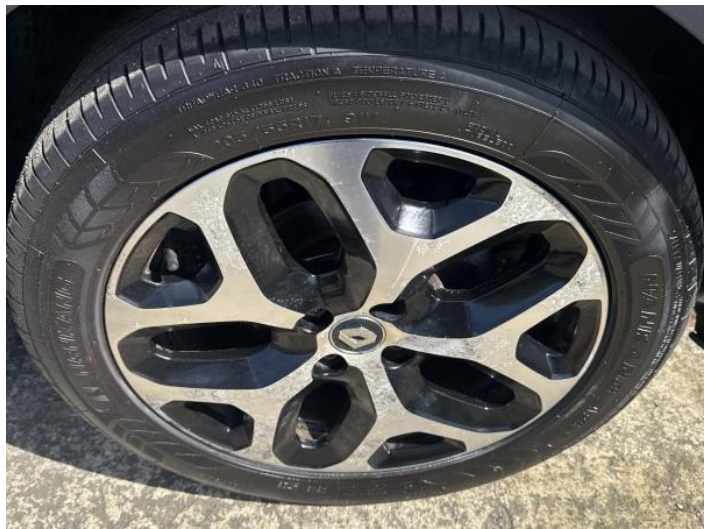
6: Wheel osf  
Scratched  
Over 50mm

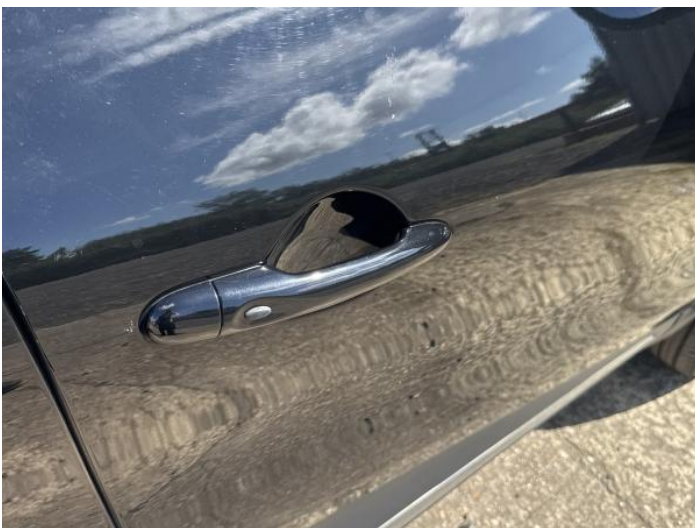
7: Door osf  
Chipped  
1 To 5

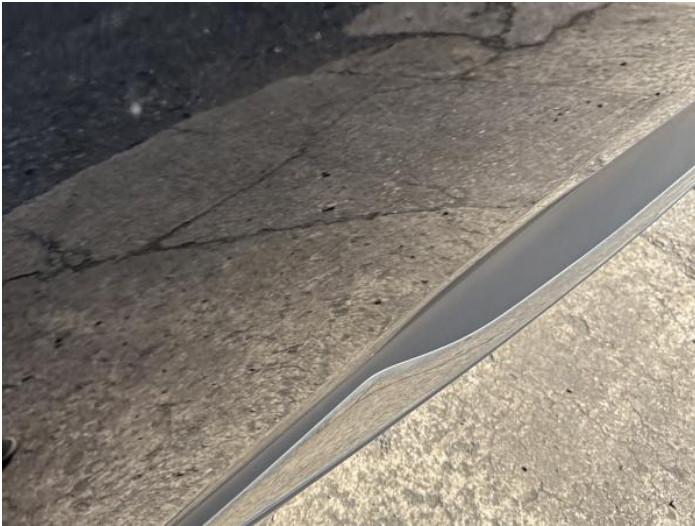
9: Door osr  
Dented  
Between 10mm + 30mm

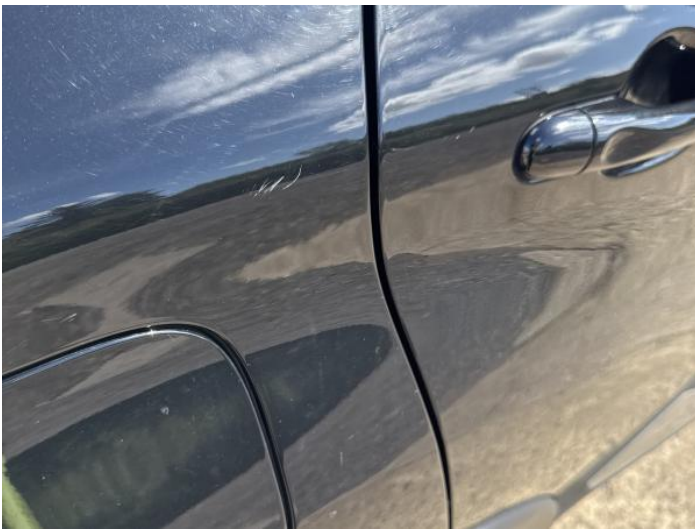
11: Qtr Panel osr  
Dented  
2 Or Less UpTo 10mm

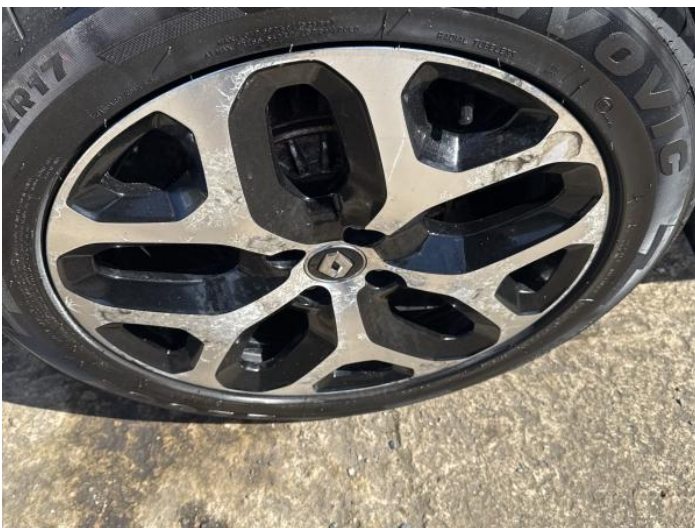
13: Wheel osr  
Scratched  
Over 50mm

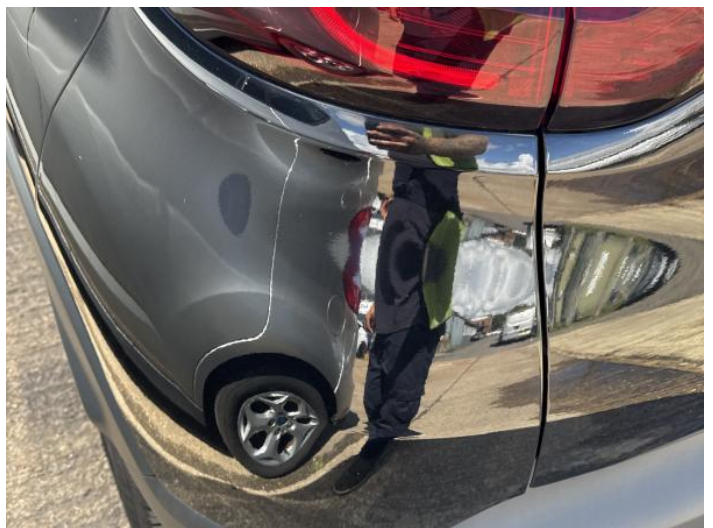
14: Bumper Rear  
Chipped  
Multiple Chips

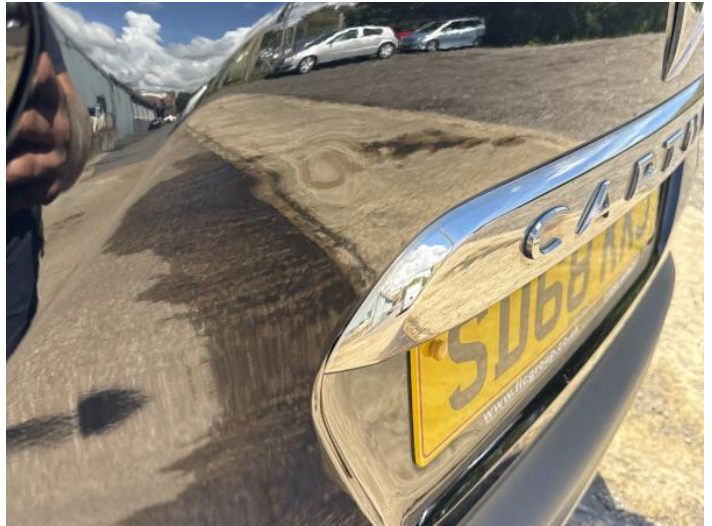
16: Boot Lid  
Dented  
Between 10mm + 30mm

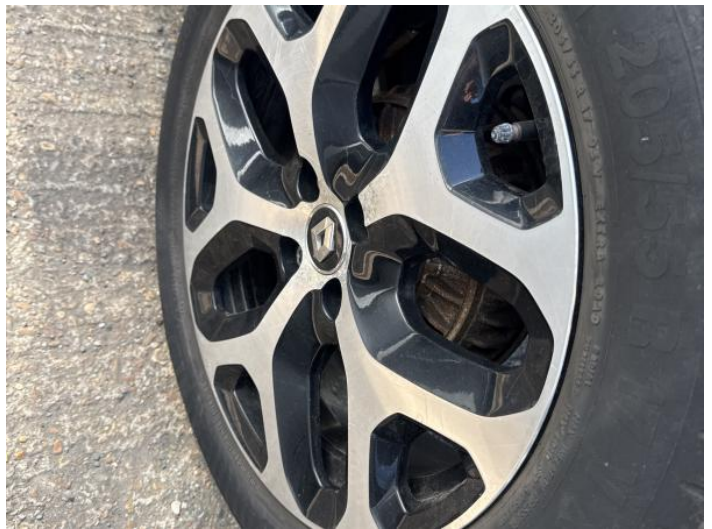
18: Wheel nsr  
Scratched  
Over 50mm

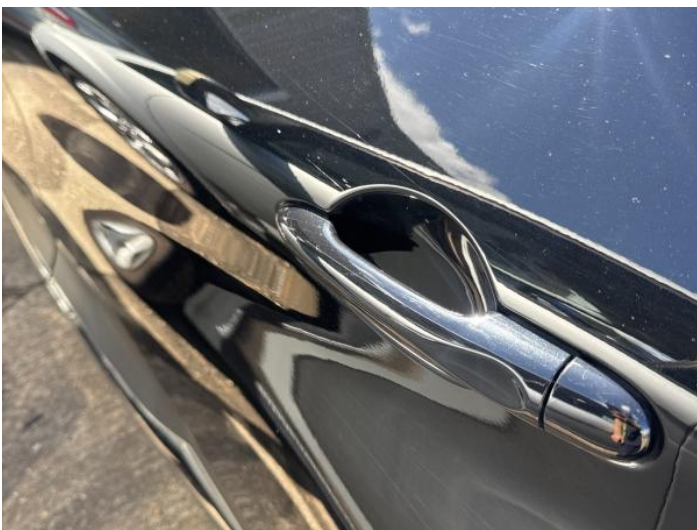
19: Door nsr  
Chipped  
1 To 5

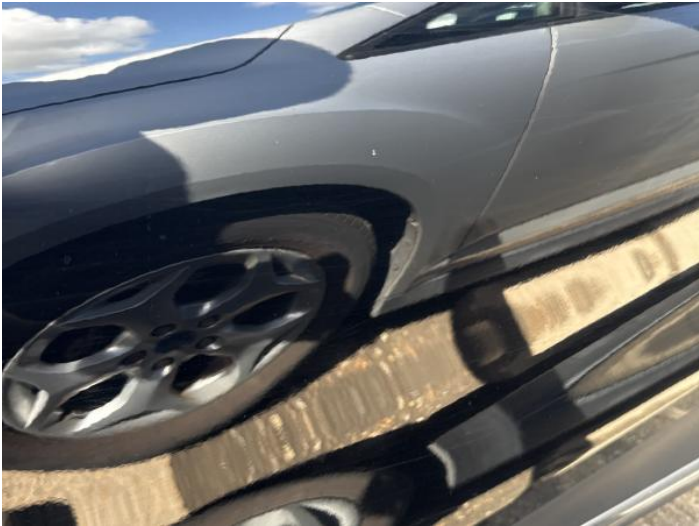
21: Door nsf  
Chipped  
Multiple Chips

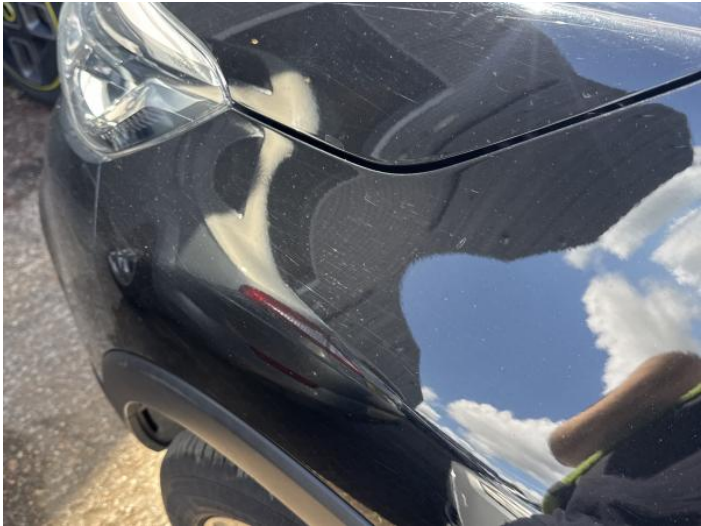
22: Wing nsf  
Chipped  
1 To 5

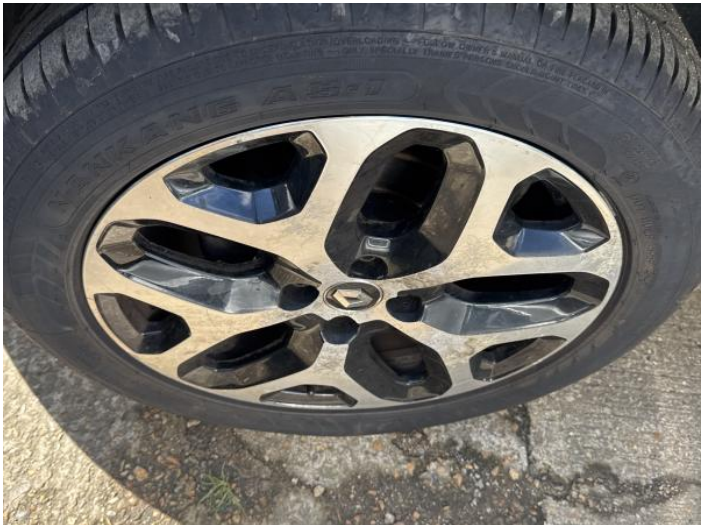
24: Wheel nsf  
Scratched  
Over 50mm
