# VEHICLE INSPECTION REPORT

**KY12KXL**

## Seat Alhambra 2.0 TDI CR Ecomotive SE 5dr

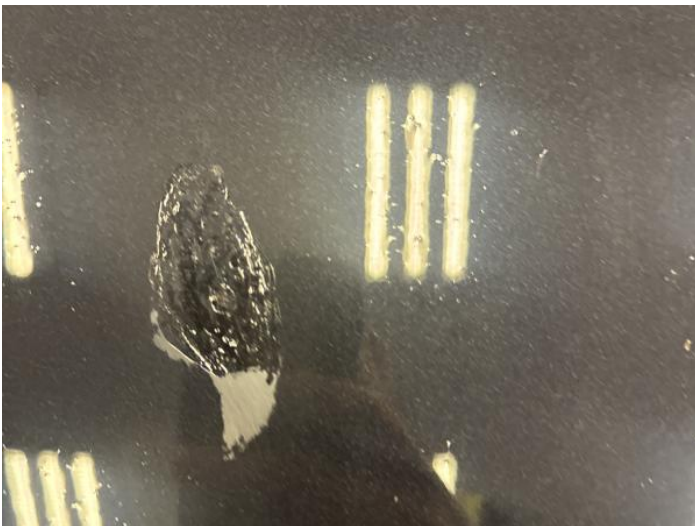
1: Bonnet  
Poor Previous Repair  
Poor Paint

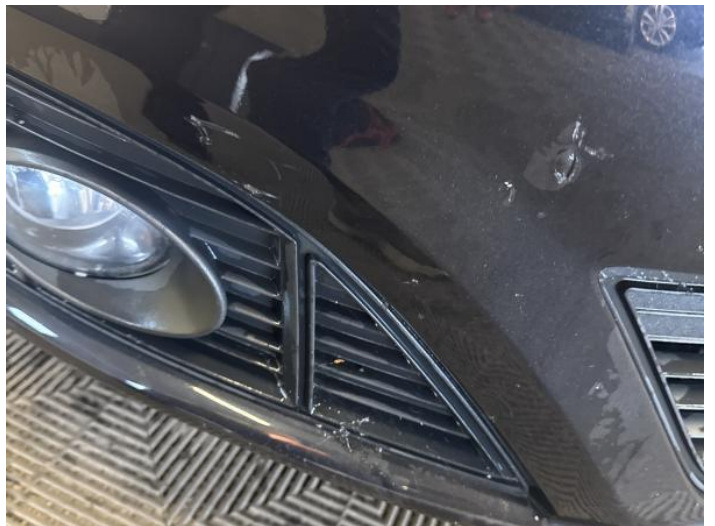
2: Bumper Front  
Scratched  
Over 100mm Thru Paint

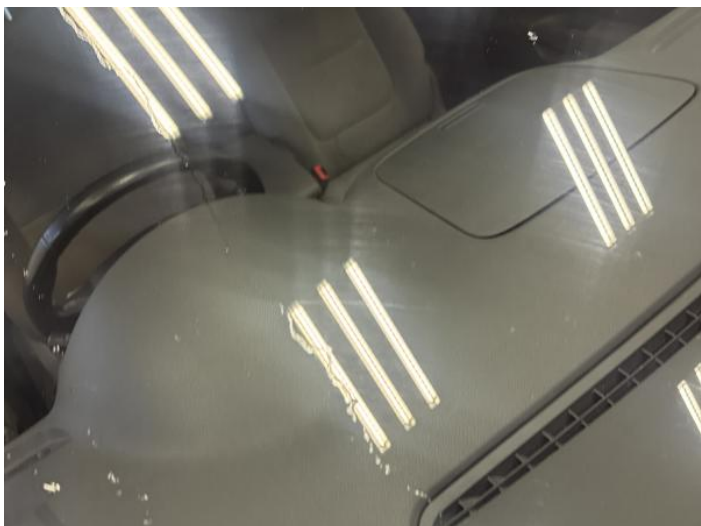
3: Screen Front  
Chipped  
UpTo 10mm

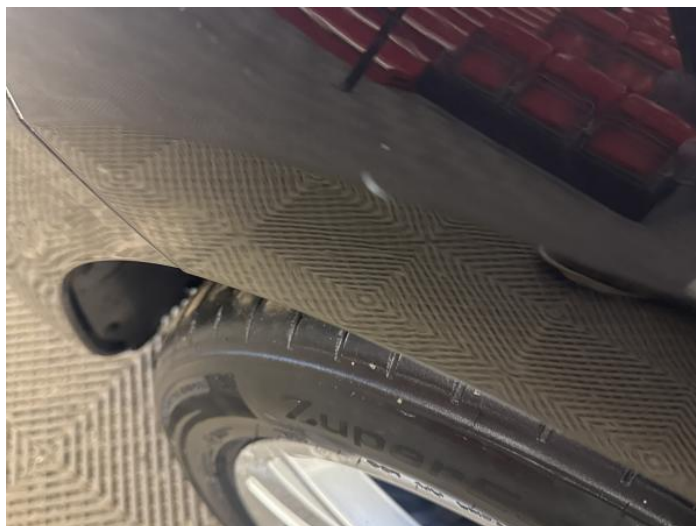
4: Wing nsf  
Chipped  
1 To 5

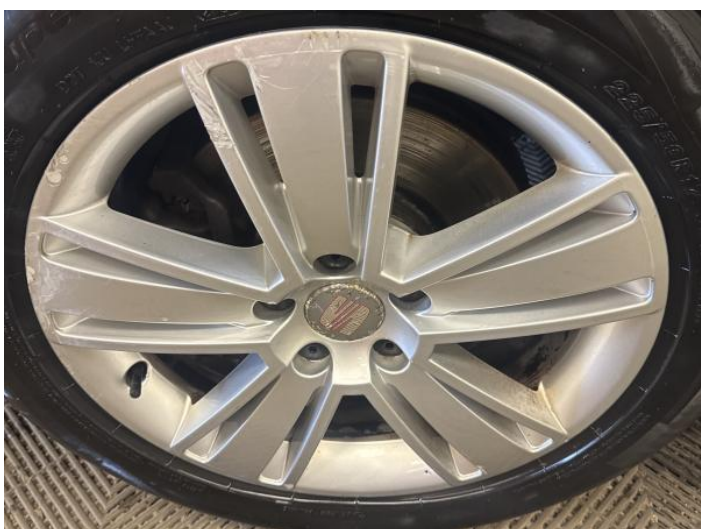
5: Wheel nsf  
Scratched  
Over 50mm

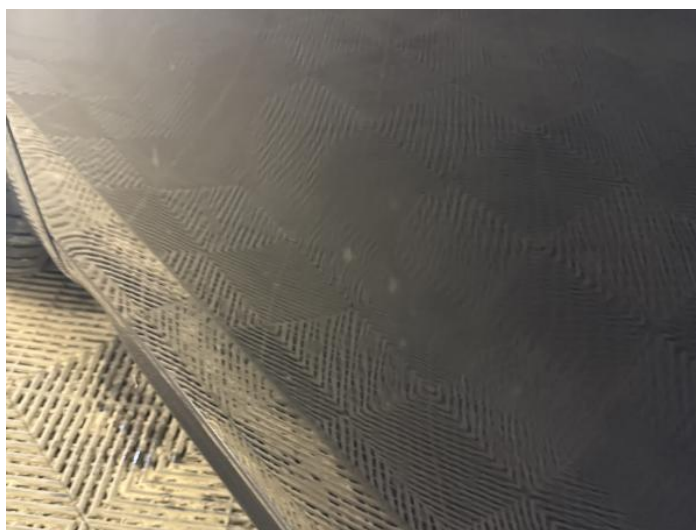
8: Door nsf  
Dented  
Over 2 UpTo 10mm

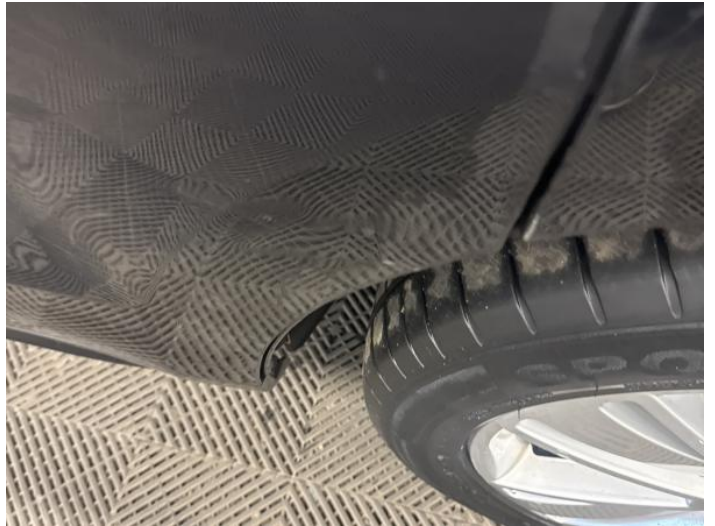
9: Door nsf  
Scratched  
Over 25mm Not Thru Paint

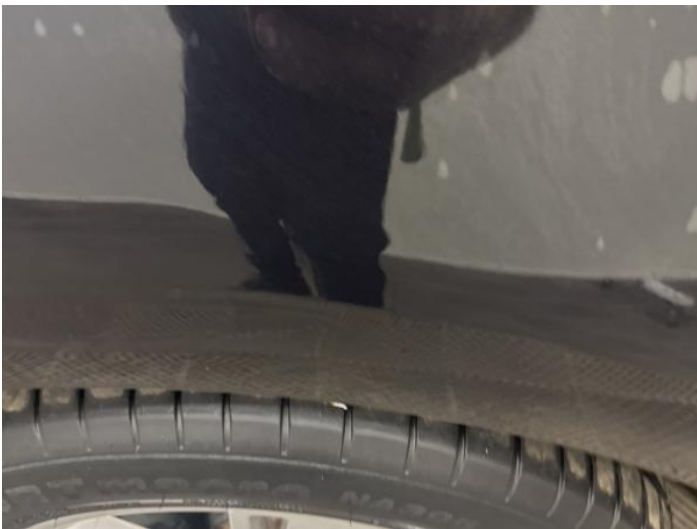
11: Qtr Panel nsr  
Dented  
Over 30mm

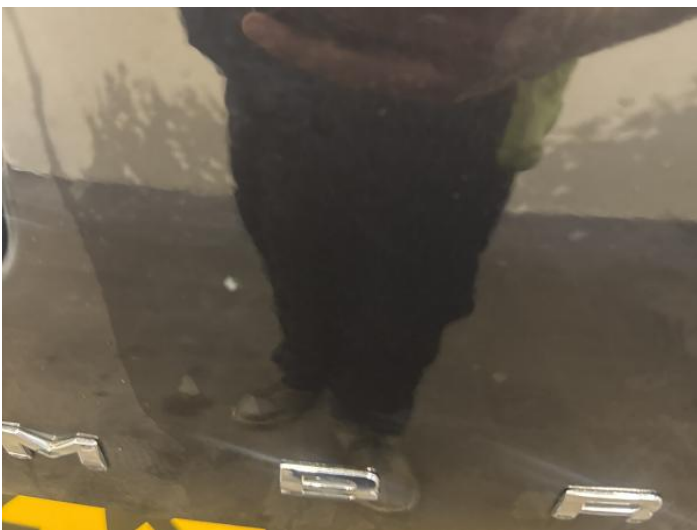
13: Boot Lid  
Chipped  
1 To 5

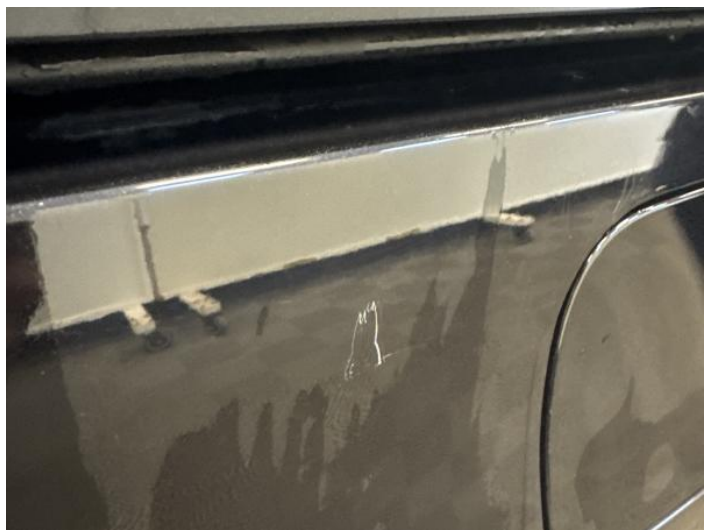
14: Qtr Panel osr  
Chipped  
1 To 5

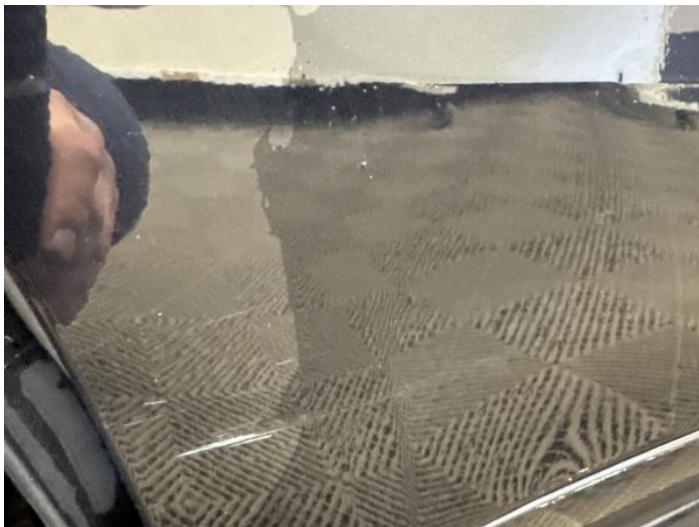
15: Door osr  
Dented  
With Paint Damage

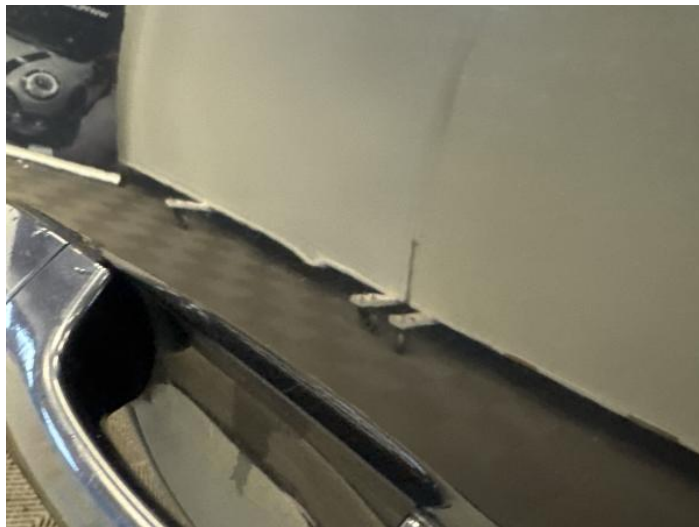
16: Door osf  
Dented  
Over 2 UpTo 10mm

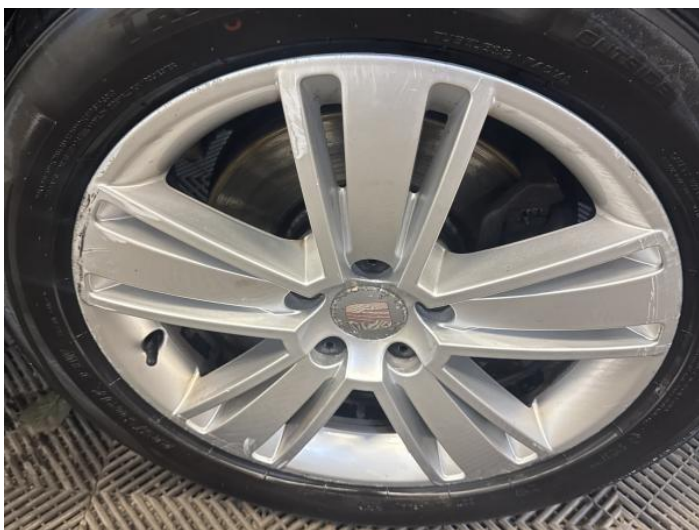
17: Wheel osf  
Scratched  
Over 50mm

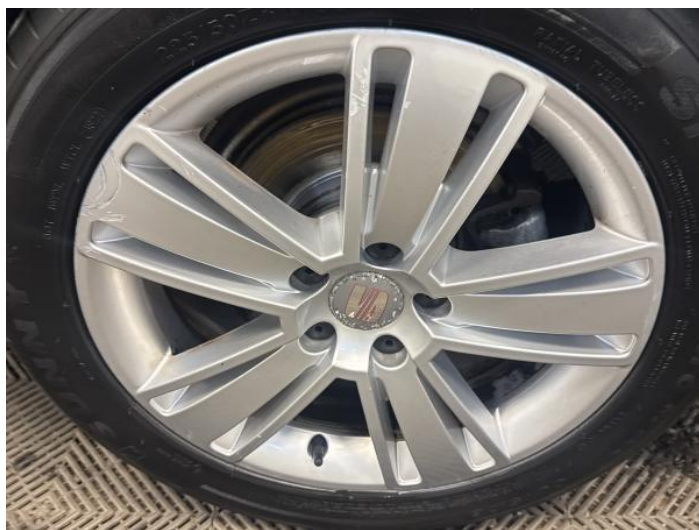
18: Wheel osr  
Scratched  
Over 50mm

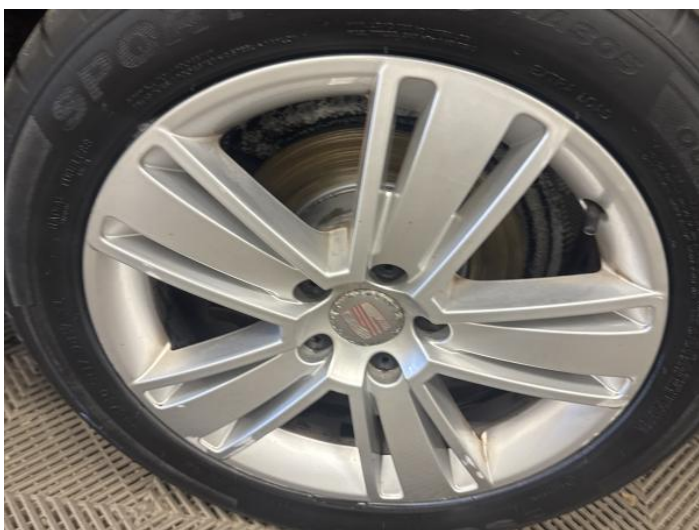
19: Wheel nsr  
Scratched  
Over 50mm

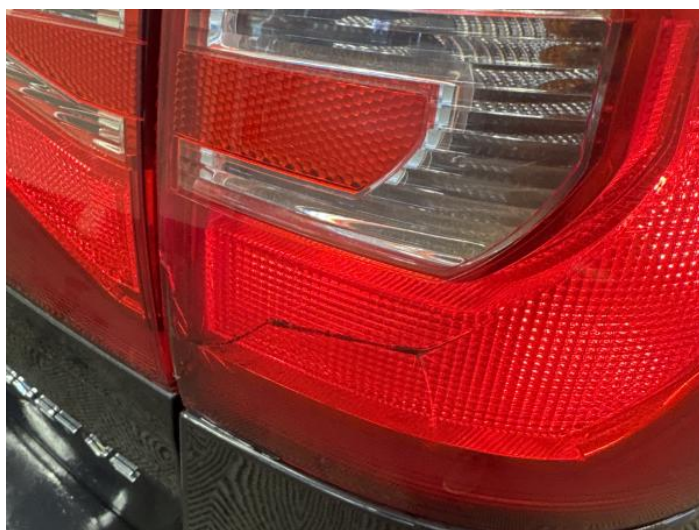
20: Lamp osr  
Broken  
Replace
