VEHICLE INSPECTION REPORT

EY66UUE

Subaru XV 2.0i SE 5dr Lineartronic

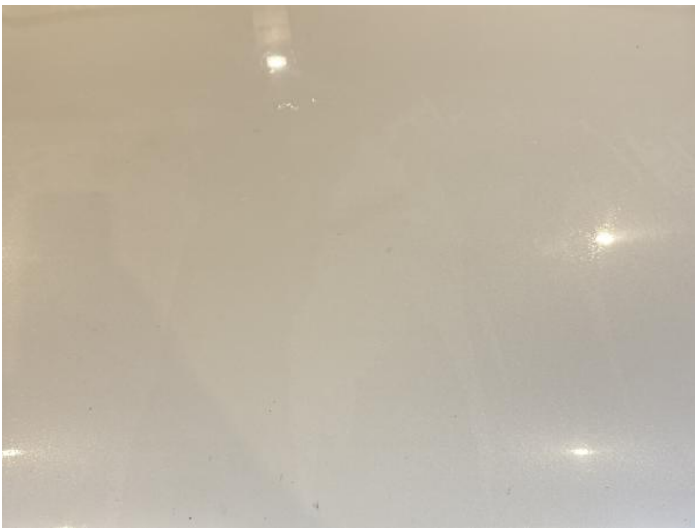
1: Bonnet
Chipped
Multiple Chips

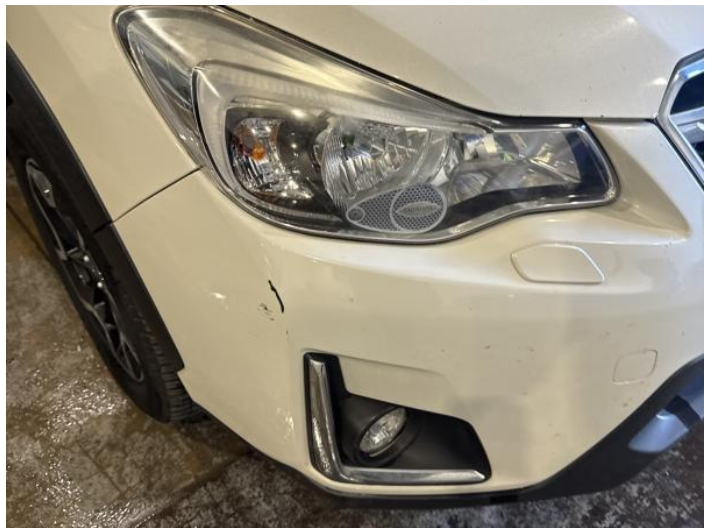
2: Bumper Front
Scratched
Over 100mm Thru Paint

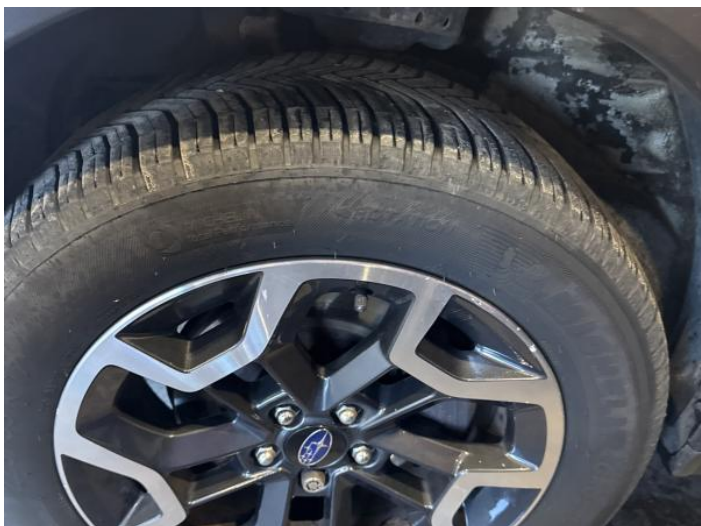
3: Wheel nsf
Scratched
Over 50mm

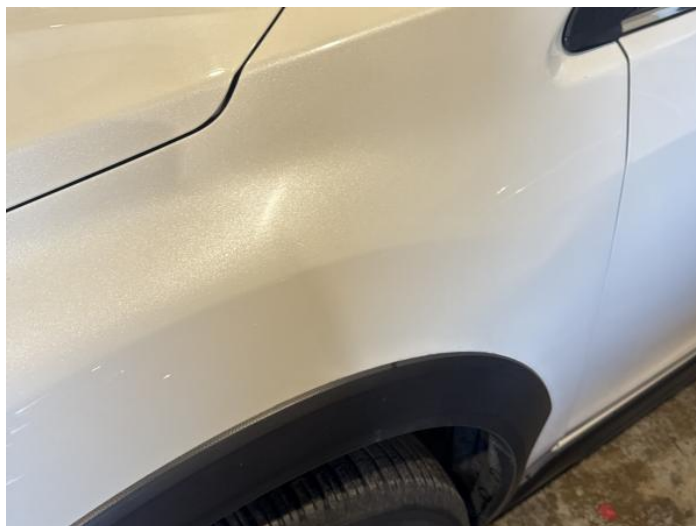
4: Wing nsf
Chipped
1 To 5

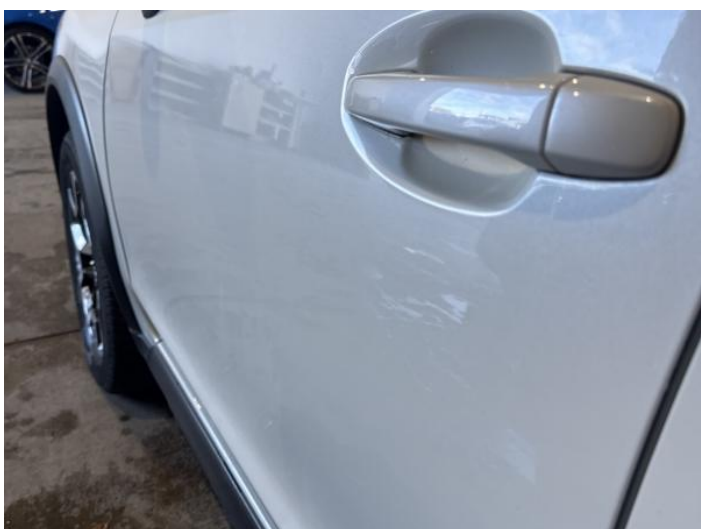
5: Door nsf
Dented
Over 2 UpTo 10mm

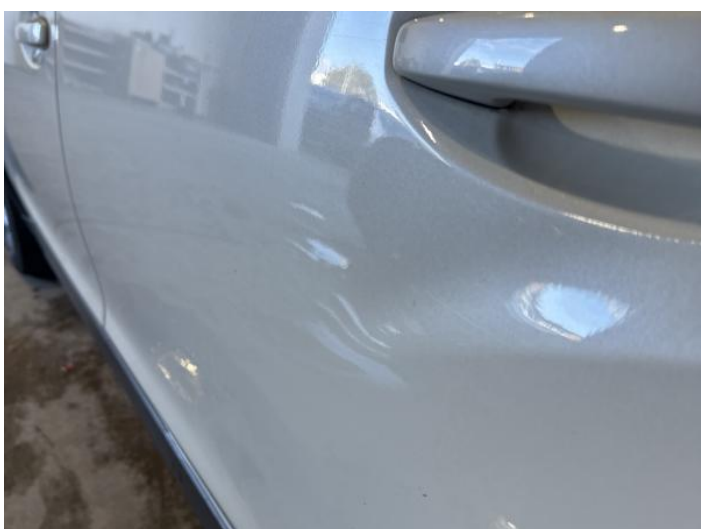
7: Door nsr
Chipped
1 To 5

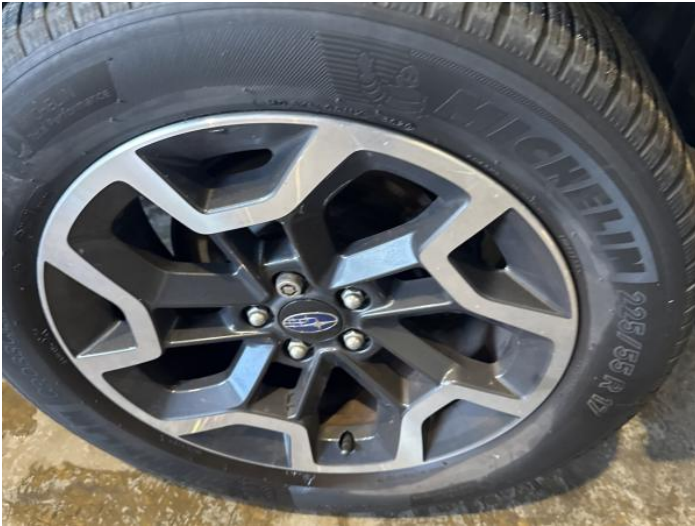
9: Wheel nsr
Scratched
Up To 50mm

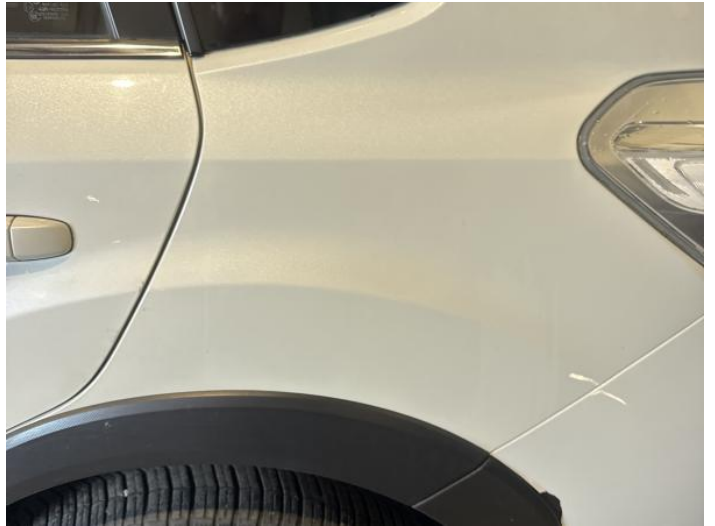
10: Qtr Panel nsr
Chipped
1 To 5

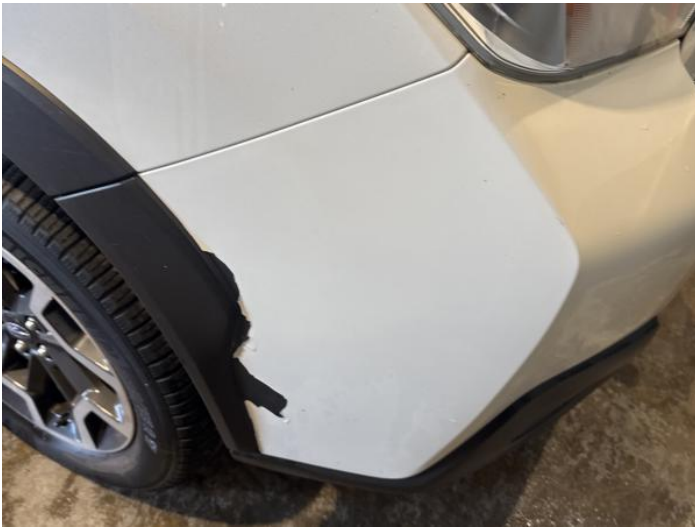
11: Bumper Rear
Poor Previous Repair
Paint Flake

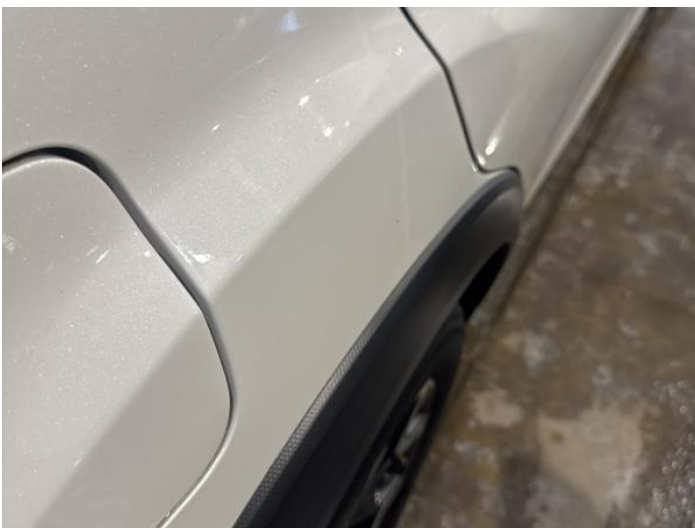
13: Qtr Panel osr
Chipped
1 To 5

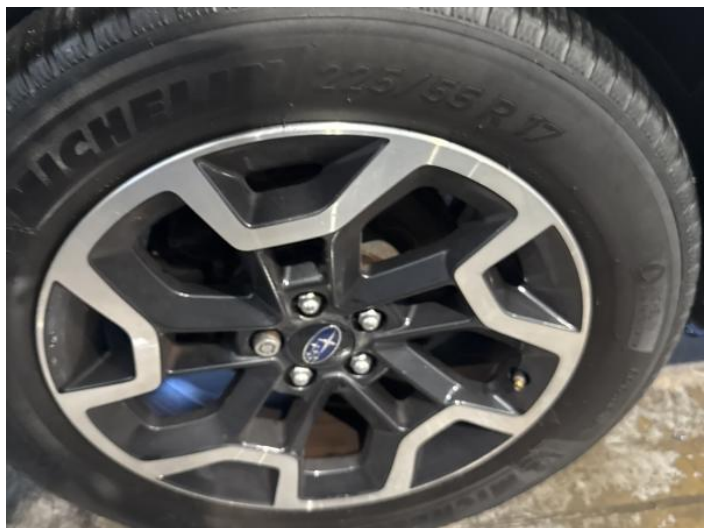
14: Wheel osr
Scratched
Up To 50mm

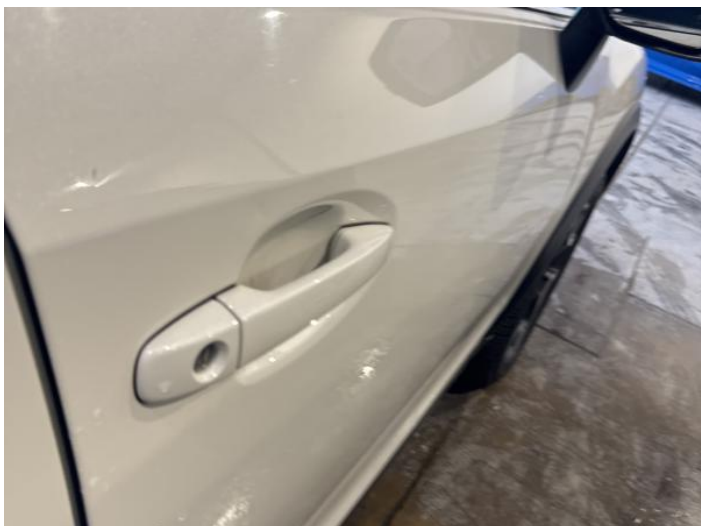
15: Door osf
Dented
Over 2 UpTo 10mm

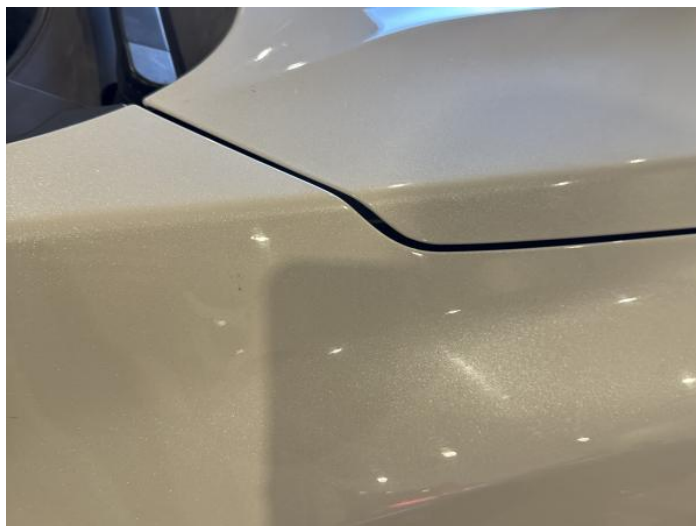
16: Wing osf
Chipped
1 To 5

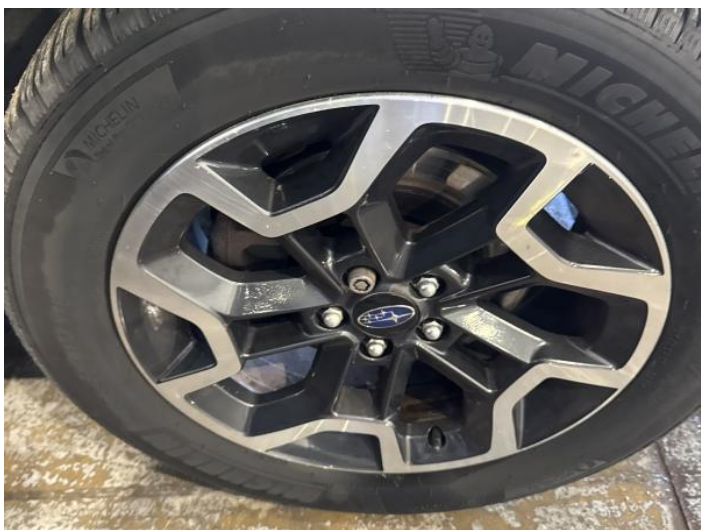
17: Wheel osf
Scratched
Up To 50mm

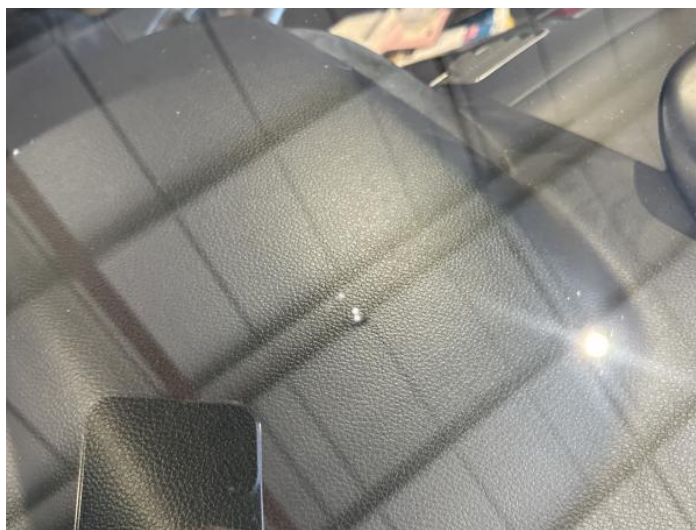
18: Screen Front
Chipped
UpTo 10mm
