# VEHICLE INSPECTION REPORT

**KS66BFV**

## Skoda Fabia 1.2 TSI 90 SE 5dr

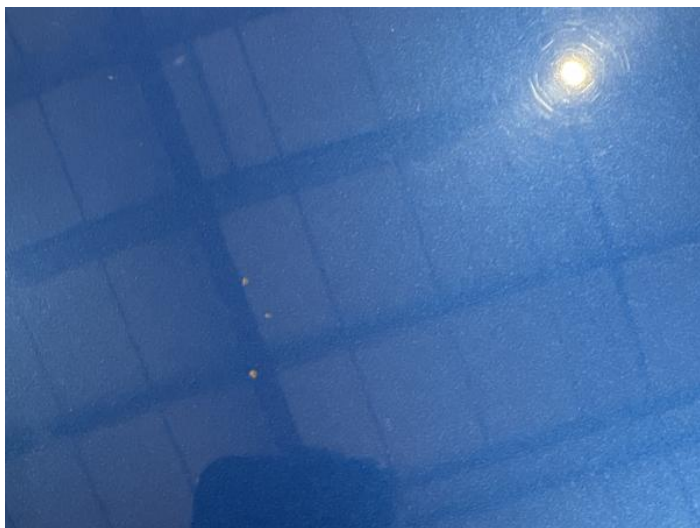
1: Bonnet  
Chipped  
1 To 5

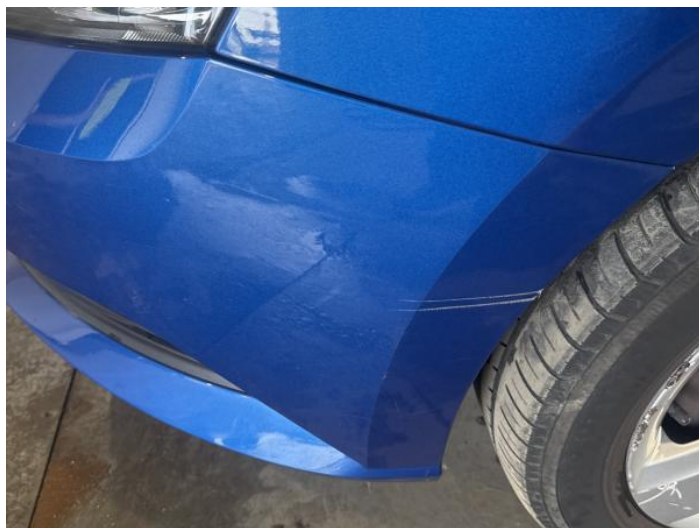
2: Bumper Front  
Scratched  
Over 100mm Thru Paint

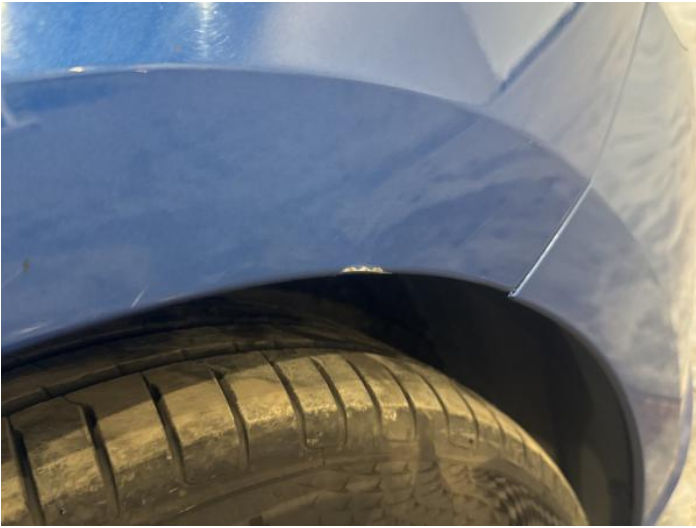
3: Wing osf  
Scratched  
Over 25mm Thru Paint

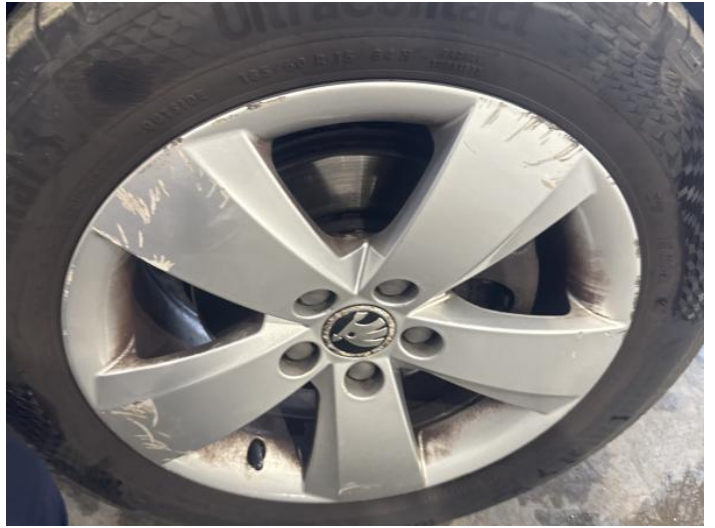
4: Wheel osf  
Scratched  
Over 50mm

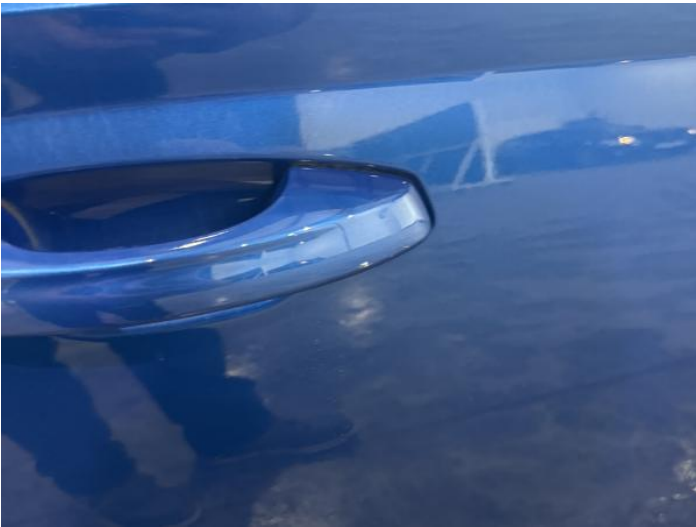
5: Door osf  
Chipped  
1 To 5

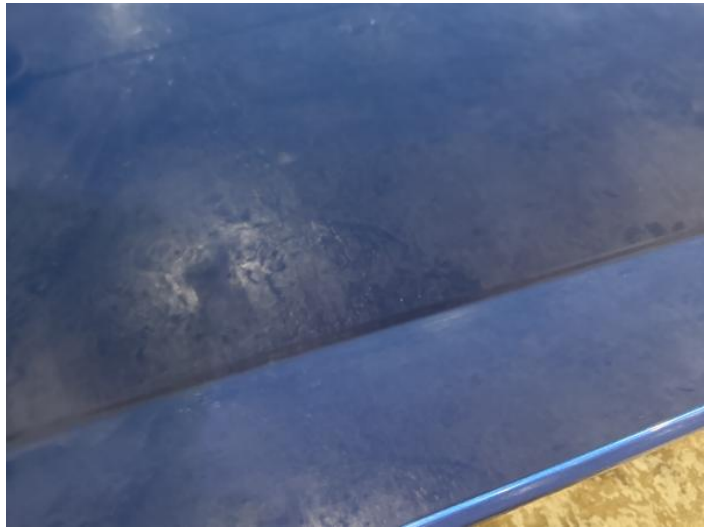
6: Door osr  
Chipped  
1 To 5

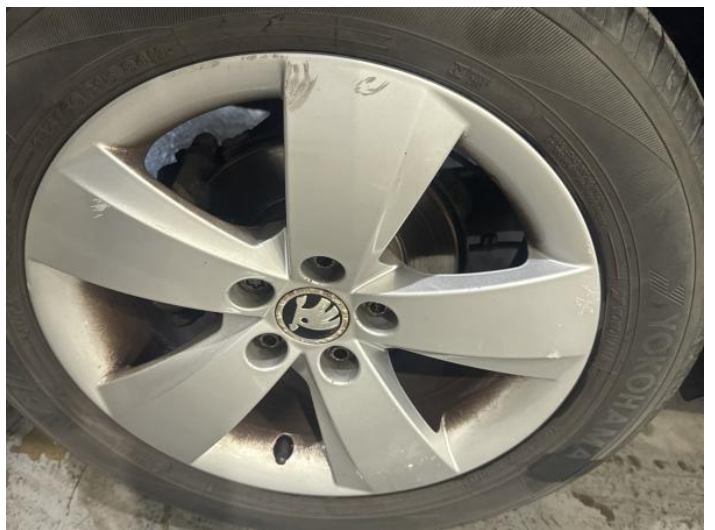
8: Wheel osr  
Scratched  
Over 50mm

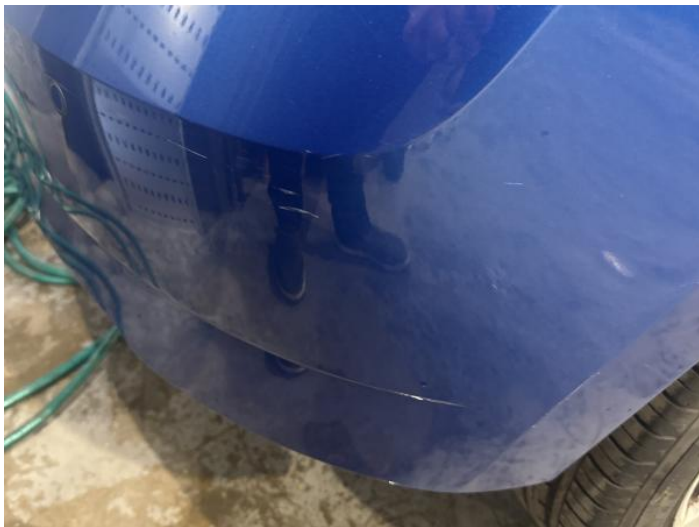
9: Bumper Rear  
Scratched  
Over 100mm Thru Paint

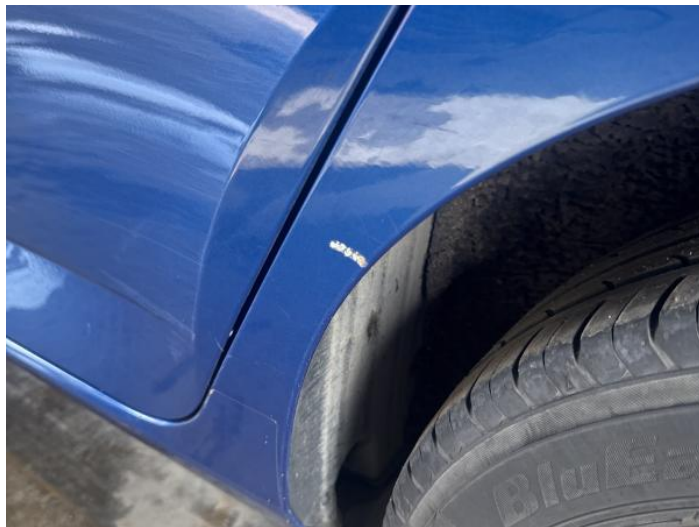
10: Qtr Panel nsr  
Scratched  
Over 25mm Thru Paint

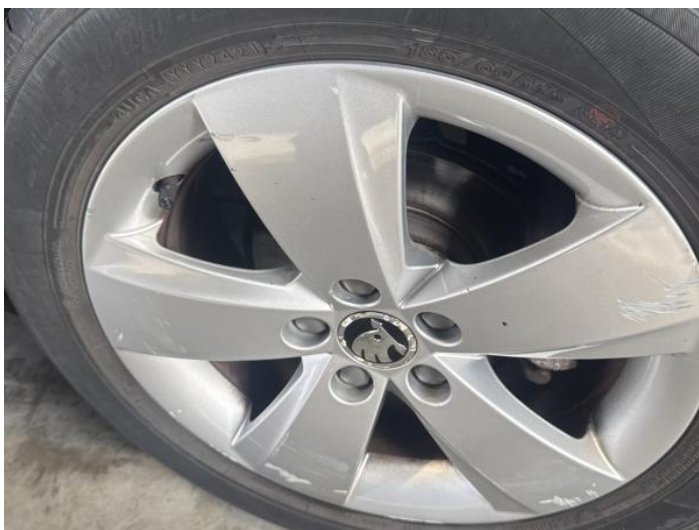
11: Wheel nsr  
Scratched  
Over 50mm

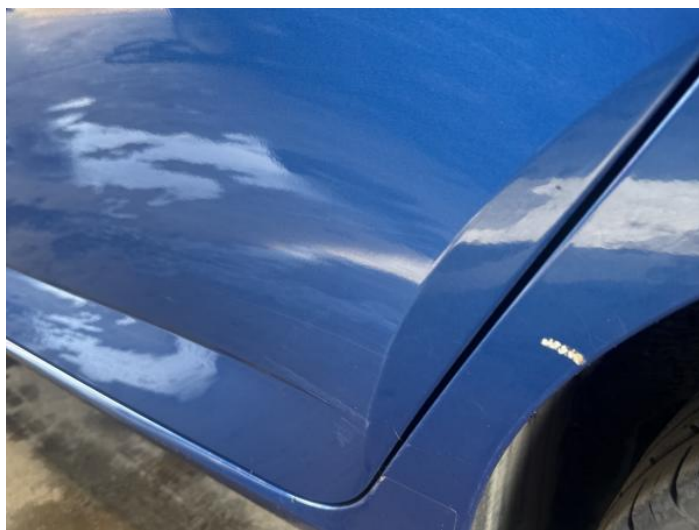
12: Door nsr  
Dented  
With Paint Damage

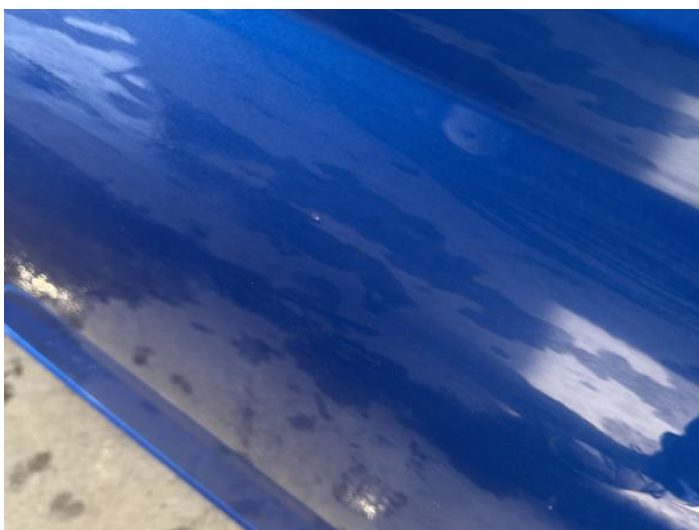
13: Door nsf  
Chipped  
1 To 5

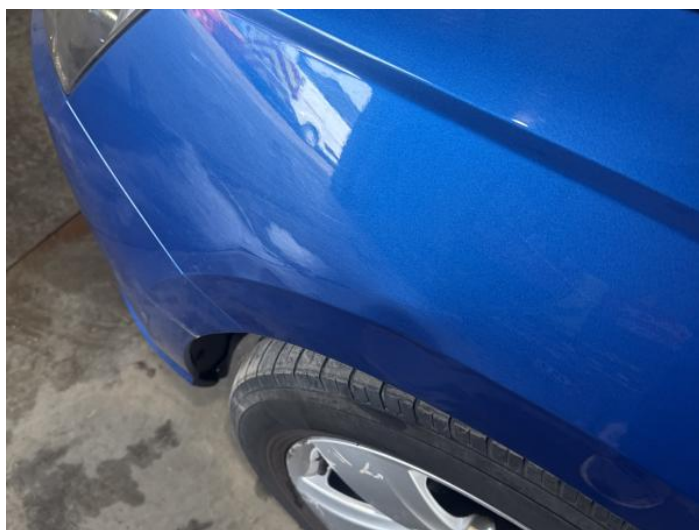
14: Wing nsf  
Dented  
Over 30mm

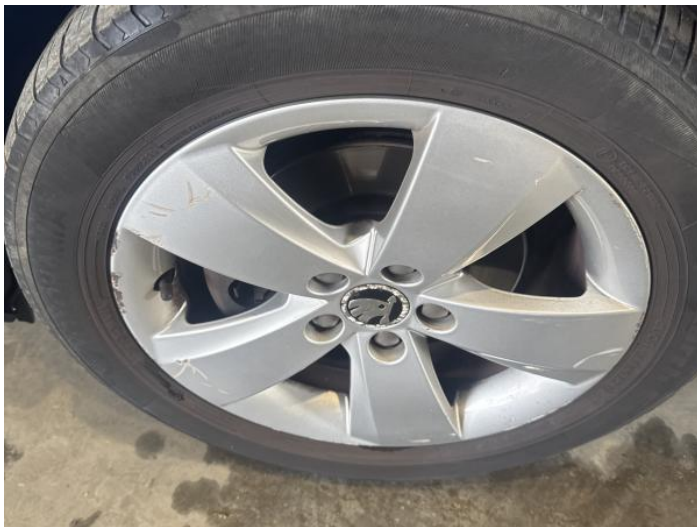
15: Wheel nsf  
Scratched  
Over 50mm

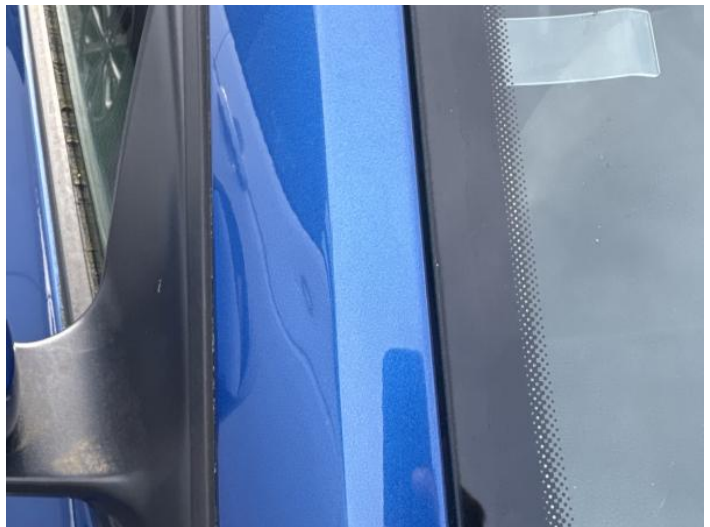
16: A Post os  
Dented  
Between 10mm + 30mm
