VEHICLE INSPECTION REPORT

LL66PDK

Renault Captur 0.9 TCE 90 Dynamique S Nav 5dr

nama
GRADE
3

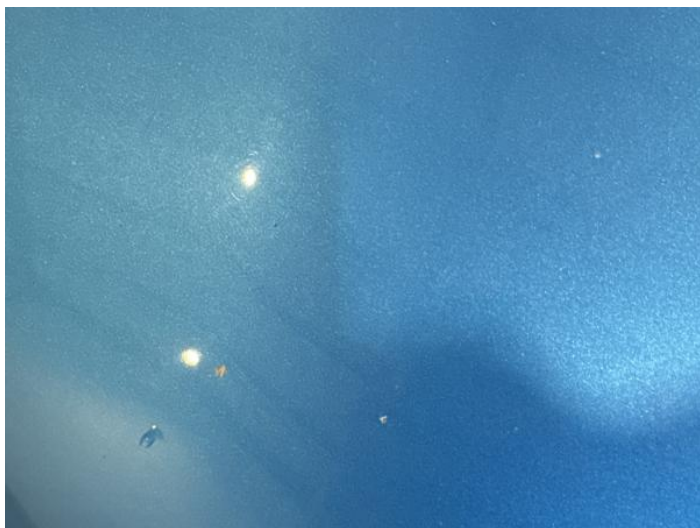
1: Bonnet
Chipped
1 To 5

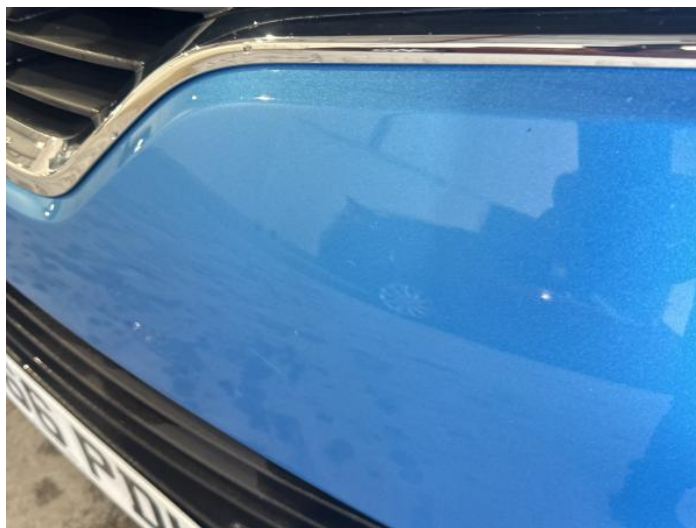
2: Bumper Front
Chipped
Multiple Chips

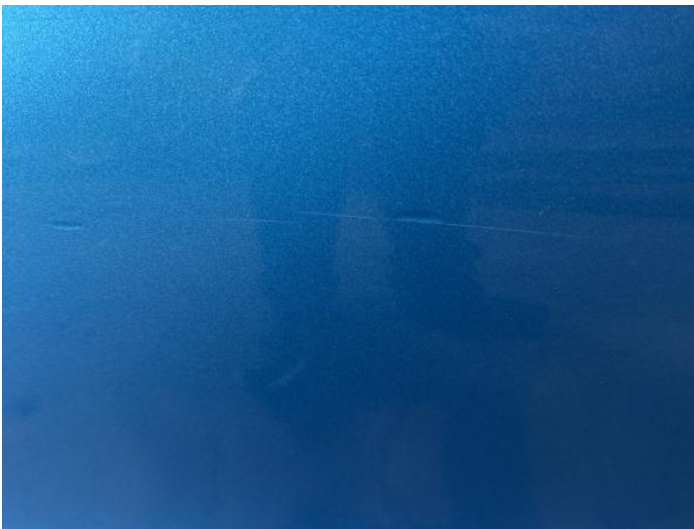
5: Door nsf
Scratched
Over 25mm Thru Paint

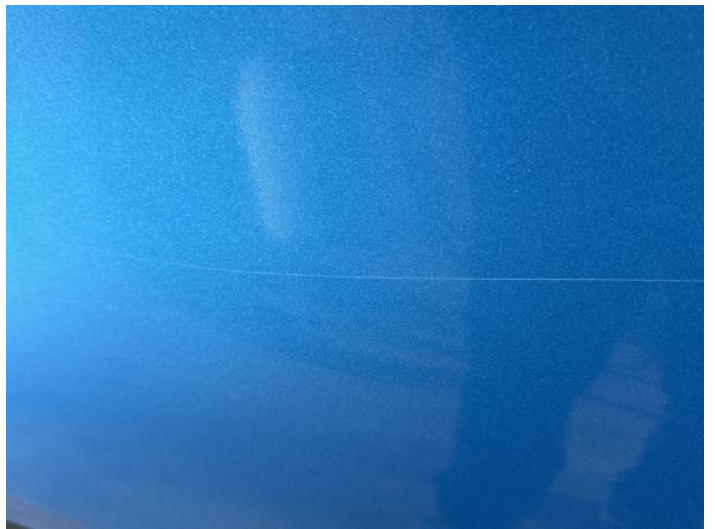
6: Door nsr
Scratched
Over 25mm Thru Paint

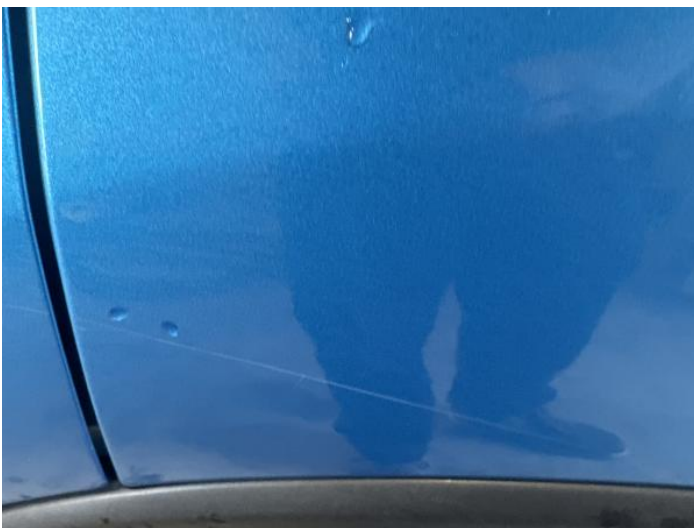
7: Qtr Panel nsr
Scratched
Over 25mm Thru Paint

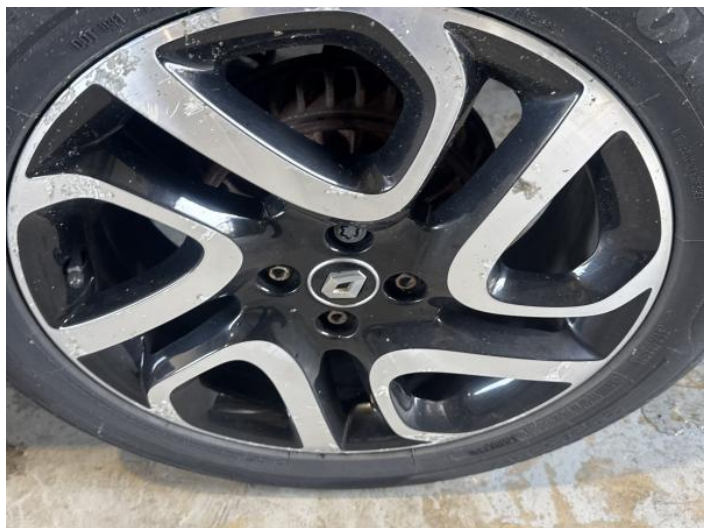
8: Wheel nsr
Corroded
Light
