VEHICLE INSPECTION REPORT

GV610PG

Volkswagen Golf 1.4 TSI SE 5dr

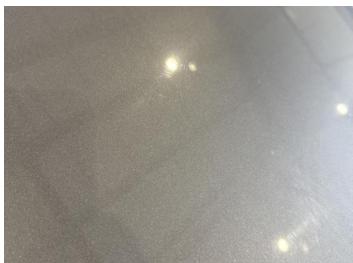
1: Bonnet Scratched Over 25mm Thru Paint

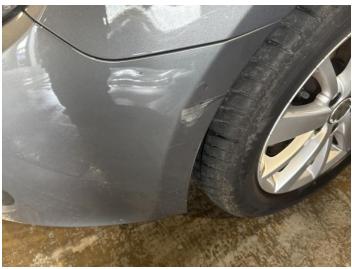
2: Bumper Front Dented With Paint Damage

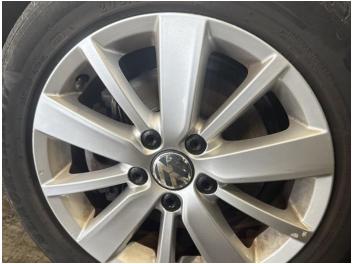
3: Wheel nsf Scratched Over 50mm

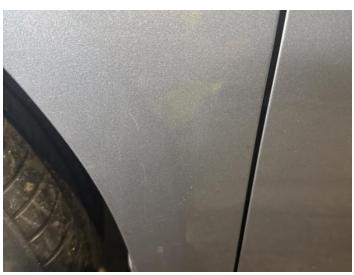
4: Wing nsf Scratched UpTo 25mm Thru Paint

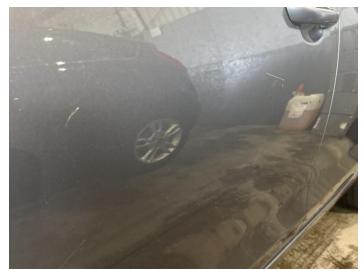
5: Door nsf Scratched Over 25mm Thru Paint

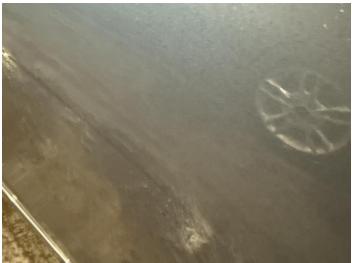
6: Door nsr Scratched UpTo 25mm Thru Paint

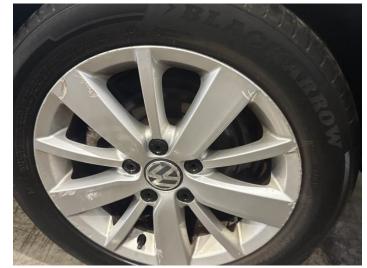
7: Wheel nsr Scratched Over 50mm

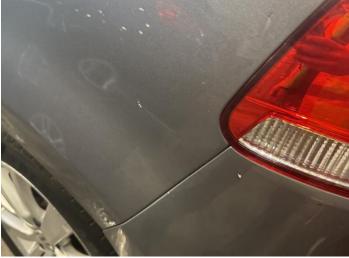
8: Qtr Panel nsr Scratched Over 25mm Thru Paint

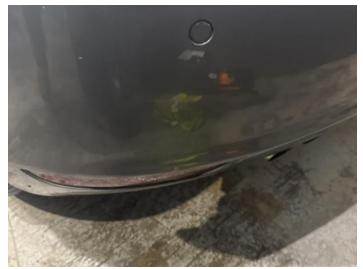
9: Bumper Rear Scratched 25 to 100mm Thru Paint

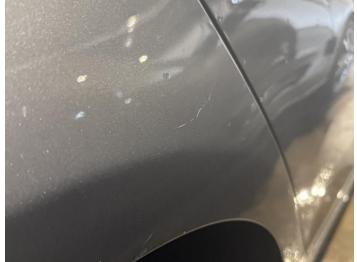
11: Qtr Panel osr Scratched Over 25mm Thru Paint

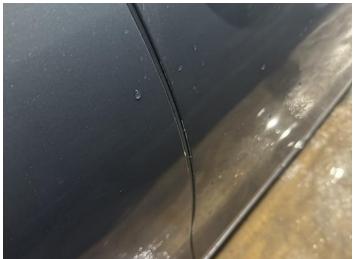
12: Door osr Scratched UpTo 25mm Thru Paint

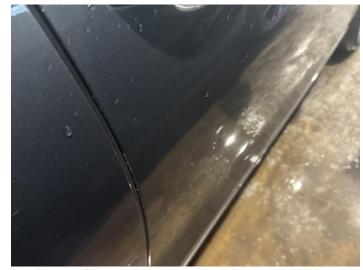
13: Door osf Chipped Edge Chip

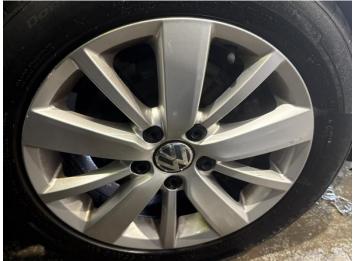
14: Wheel osf Scratched Over 50mm

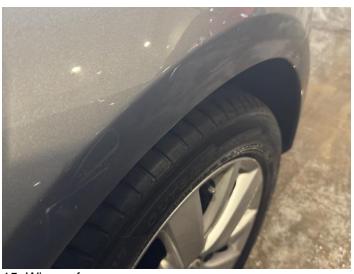
15: Wing osf Scratched Over 25mm Thru Paint
