# VEHICLE INSPECTION REPORT

**GX20KPV**

## Volvo XC40 1.5 T3 [163] Momentum 5dr

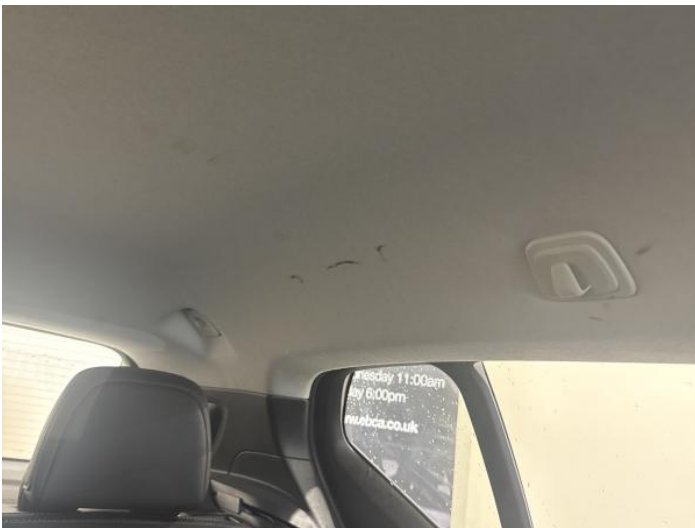
1: Roof Lining  
Soiled  
Light

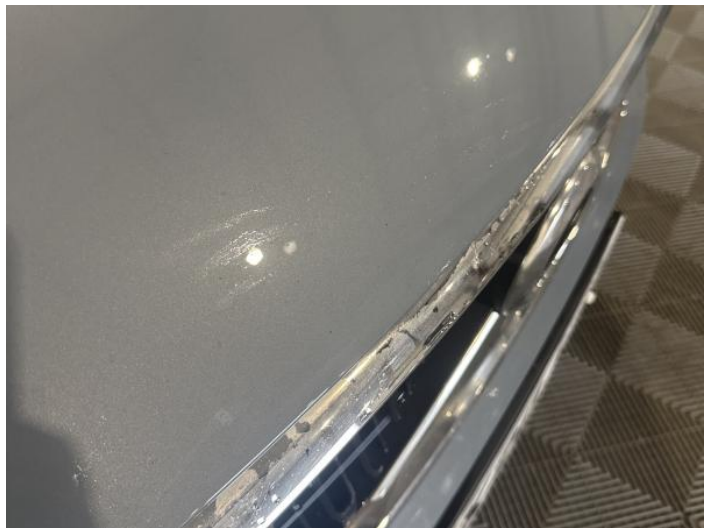
2: Bonnet  
Chipped  
1 To 5

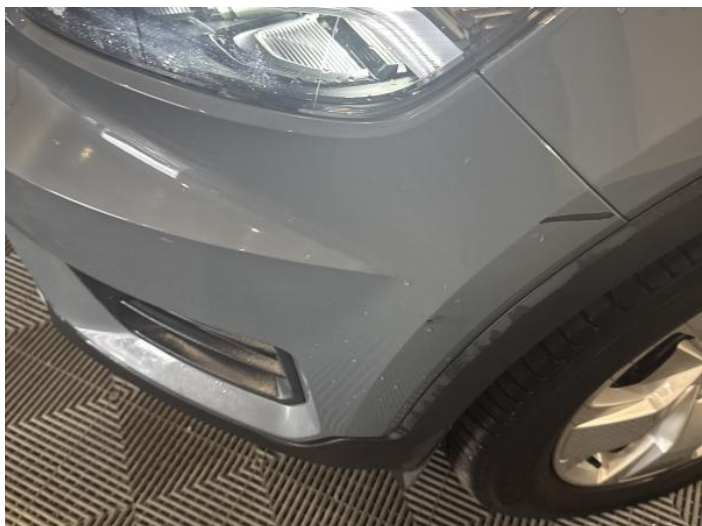
3: Bumper Front  
Scratched  
Over 100mm Thru Paint

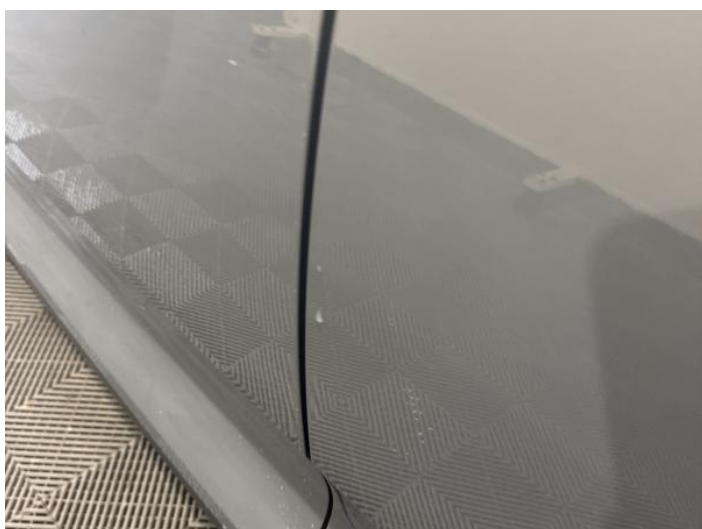
5: Door nsf  
Chipped  
Edge Chip

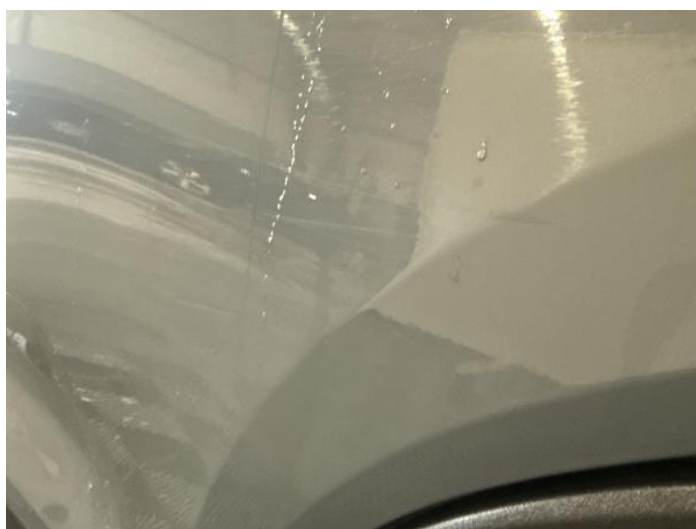
6: Door nsr  
Scratched  
Over 25mm Thru Paint

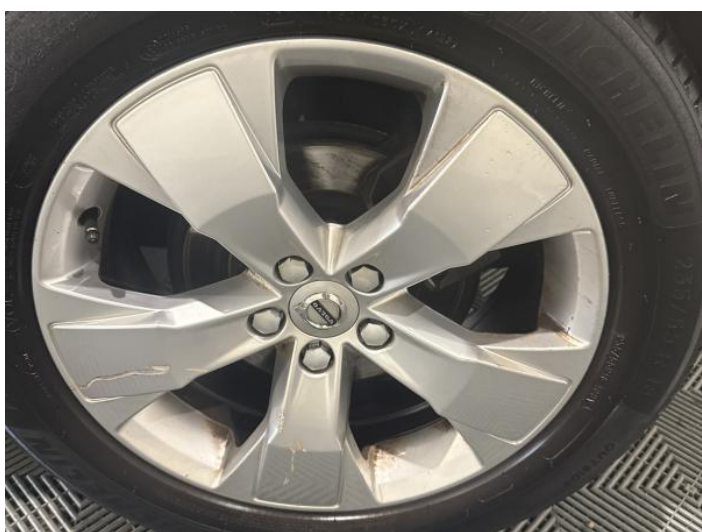
7: Wheel nsr  
Scratched  
Over 50mm

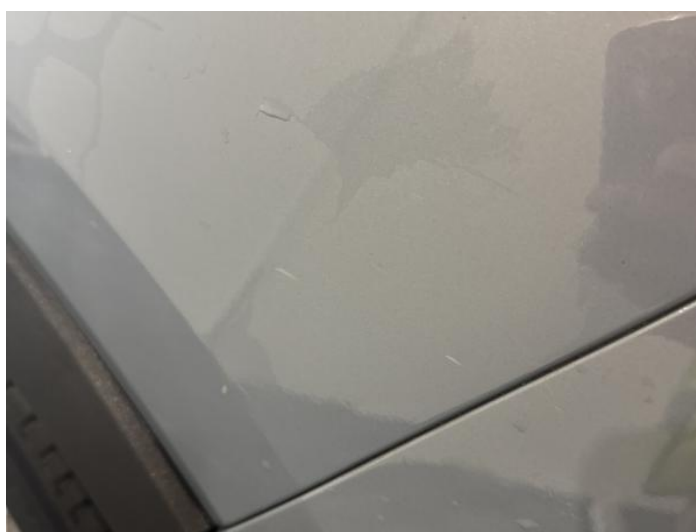
8: Qtr Panel nsr  
Scratched  
UpTo 25mm Thru Paint

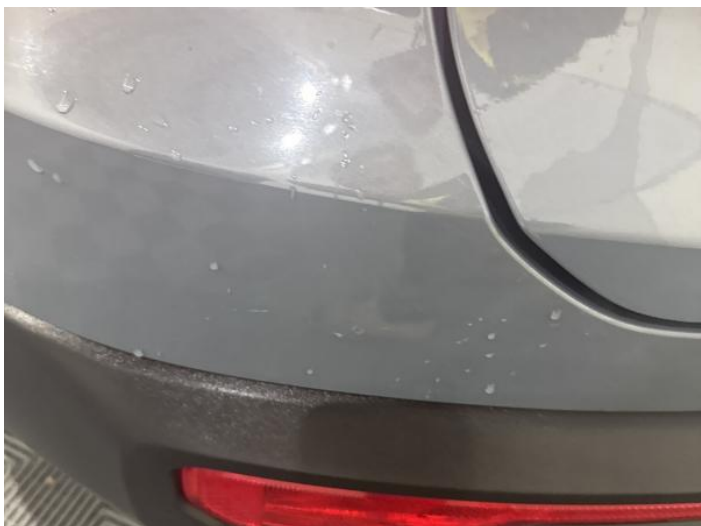
9: Bumper Rear  
Scratched  
Up To 25mm Thru Paint

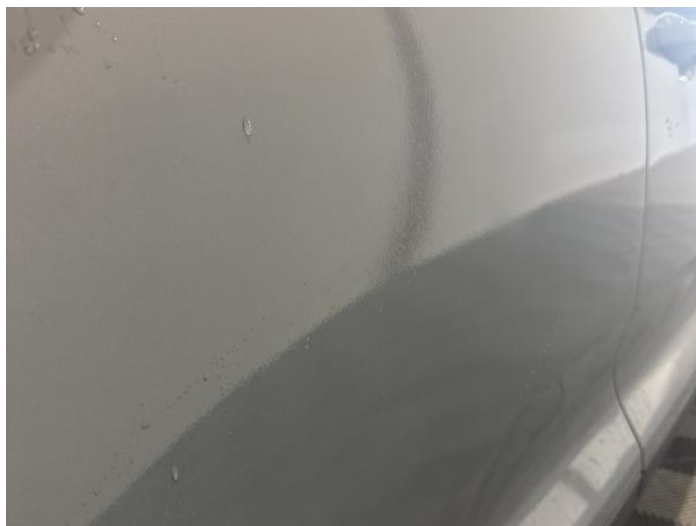
10: Door osr  
Poor Previous Repair  
Rippled UpTo 30%

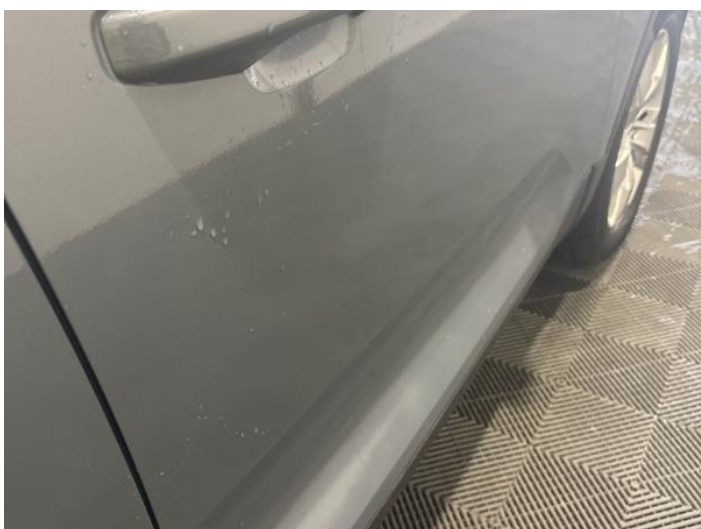
11: Door osf  
Poor Previous Repair  
Poor Paint

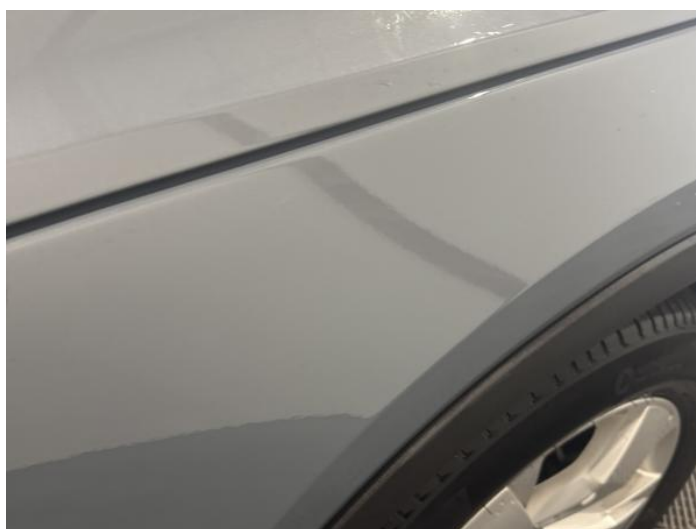
12: Wing osf  
Scratched  
UpTo 25mm Thru Paint

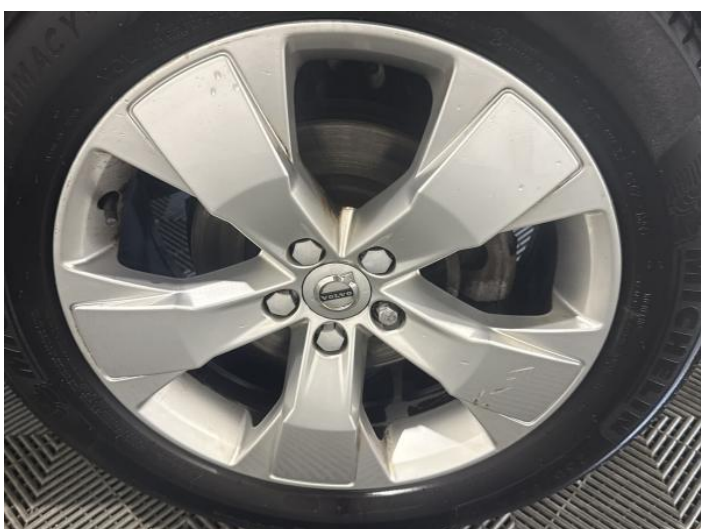
13: Wheel osf  
Scratched  
Over 50mm

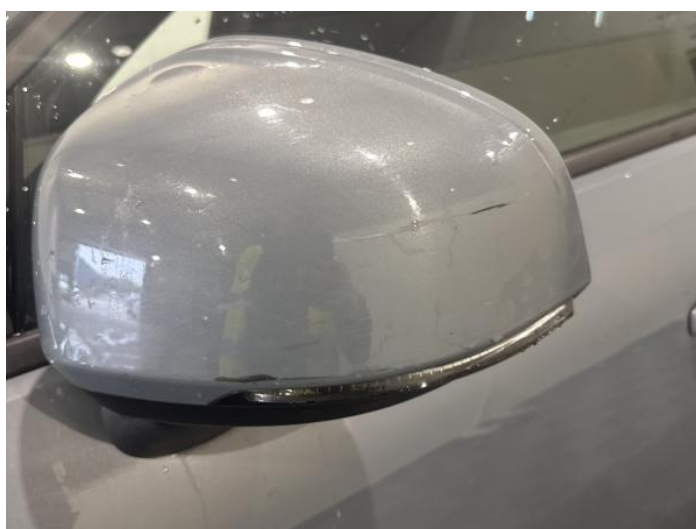
14: Door Mirror Assy nsf  
Scratched (Painted)  
Over 25mm Thru Paint

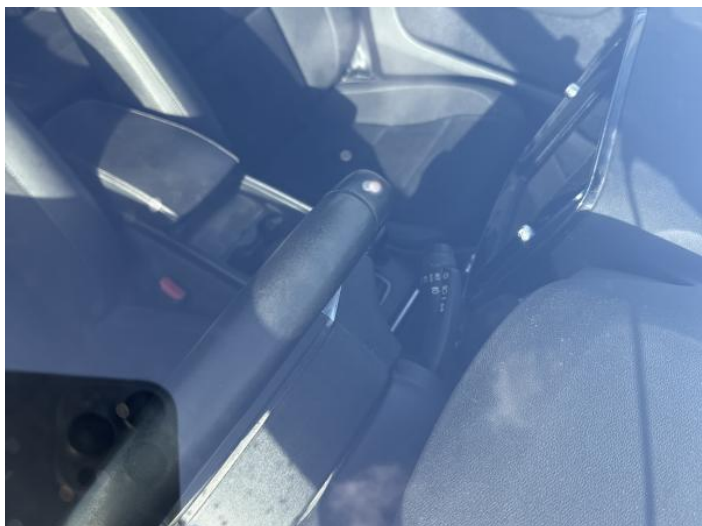
15: Screen Front  
Chipped  
UpTo 10mm
