VEHICLE INSPECTION REPORT

WJ66XRD

Ford B-Max 1.6 Zetec 5dr Powershift

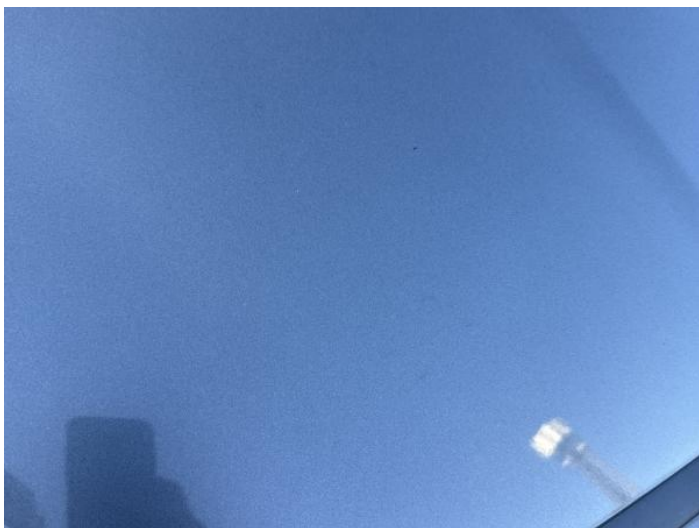
1: Bonnet
Chipped
1 To 5

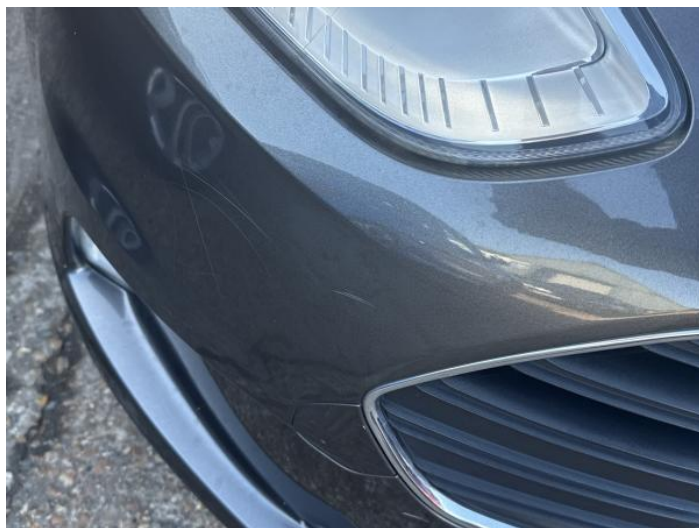
2: Bumper Front
Scratched
Over 100mm Thru Paint

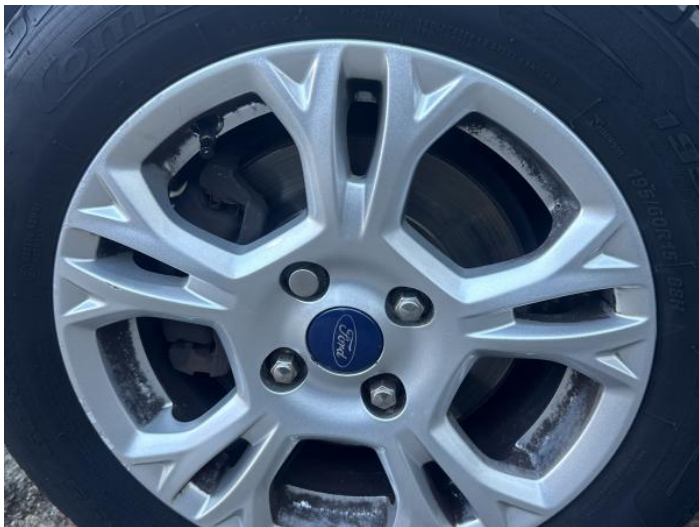
3: Wheel nsf
Scratched
Over 50mm

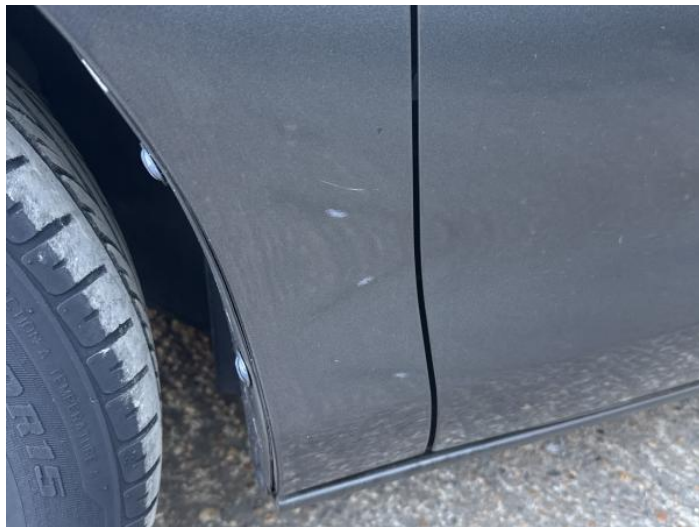
4: Wing nsf
Scratched
UpTo 25mm Thru Paint

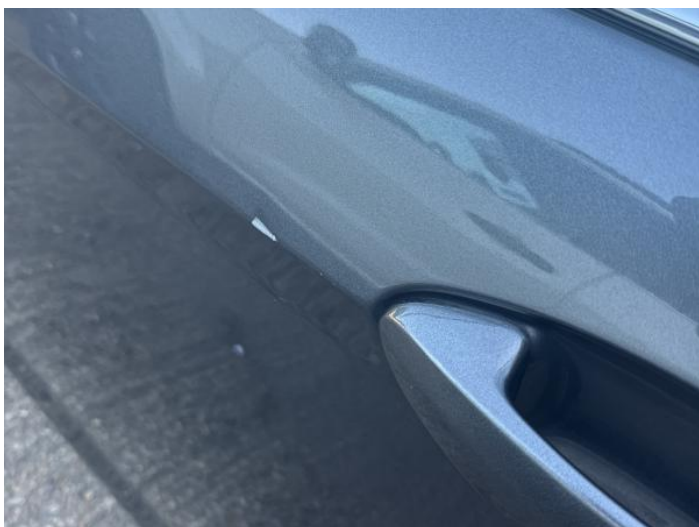
5: Door nsf
Dented
With Paint Damage

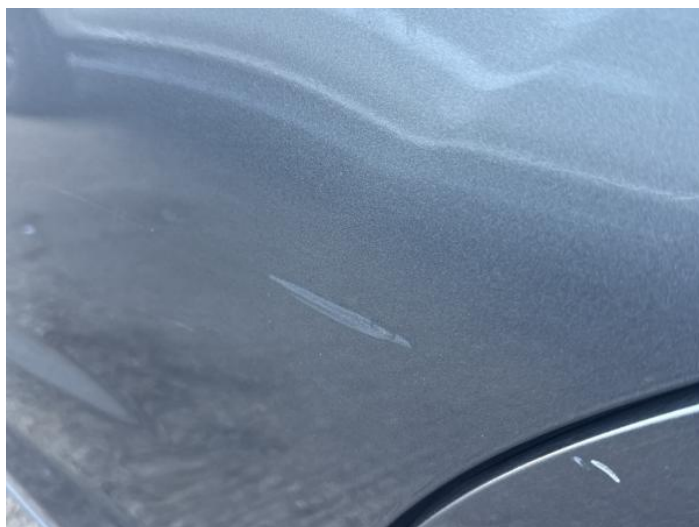
6: Door nsr
Scratched
Over 25mm Thru Paint

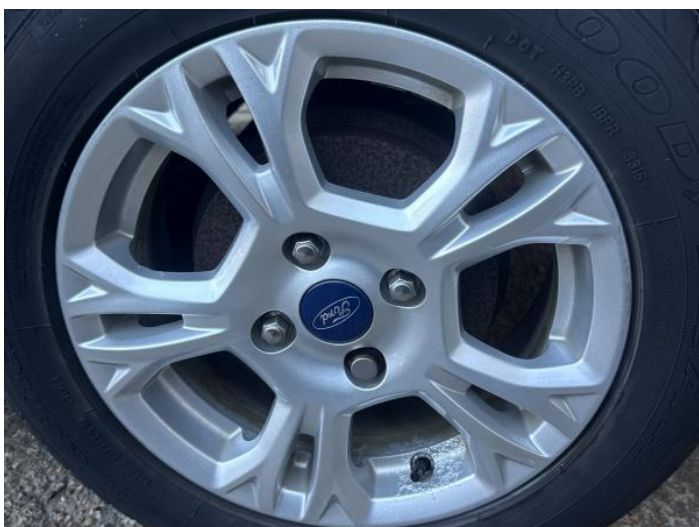
7: Wheel nsr
Scratched
Over 50mm

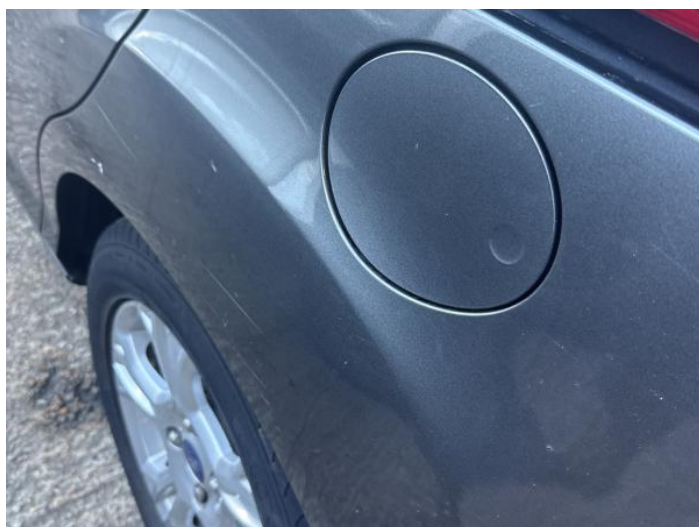
8: Qtr Panel nsr
Scratched
Over 25mm Thru Paint

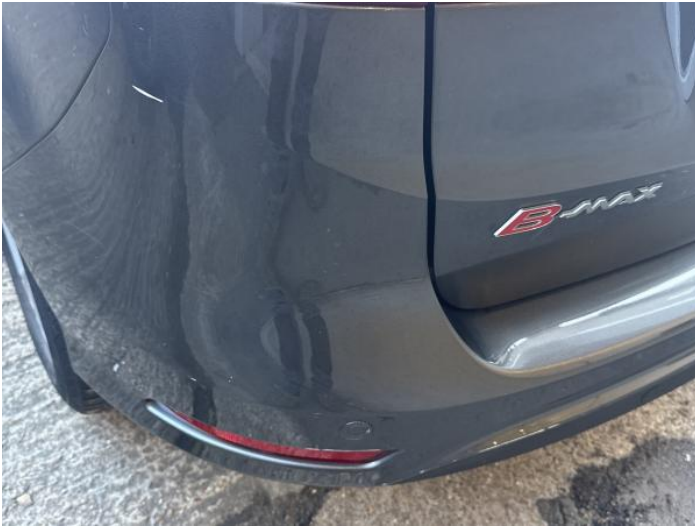
9: Bumper Rear
Scratched
Over 100mm Thru Paint

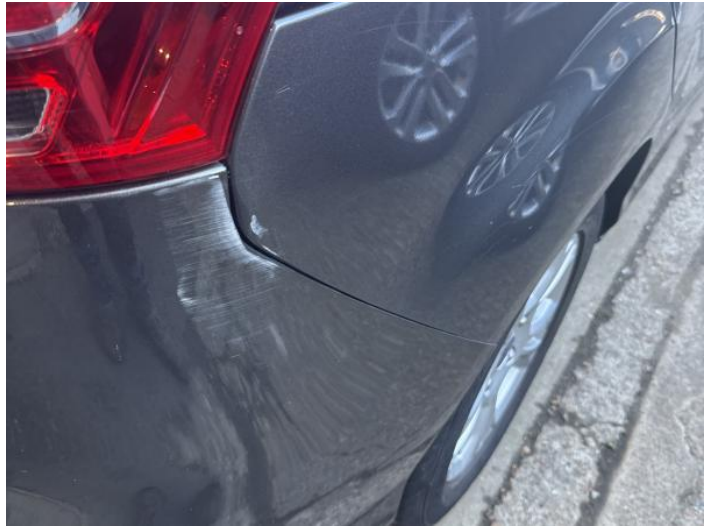
10: Qtr Panel osr
Dented
With Paint Damage

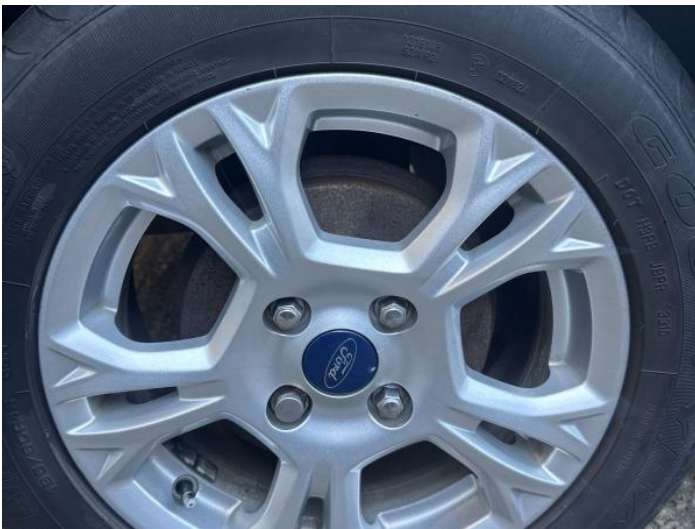
11: Wheel osr
Scratched
Up To 50mm

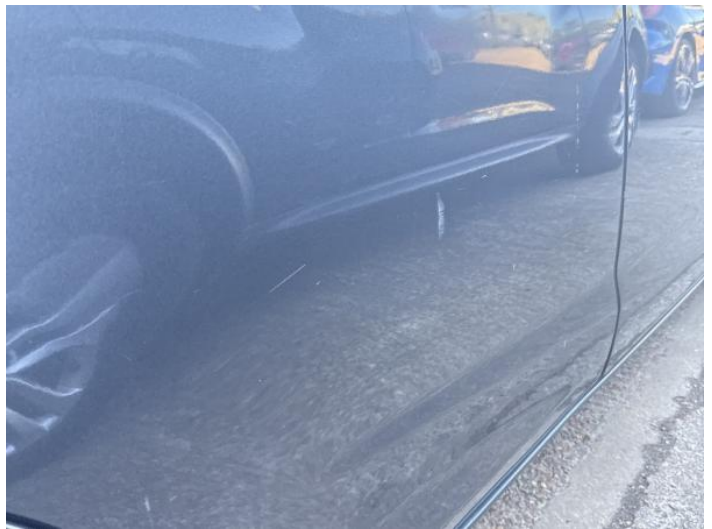
12: Door osr
Scratched
Over 25mm Thru Paint

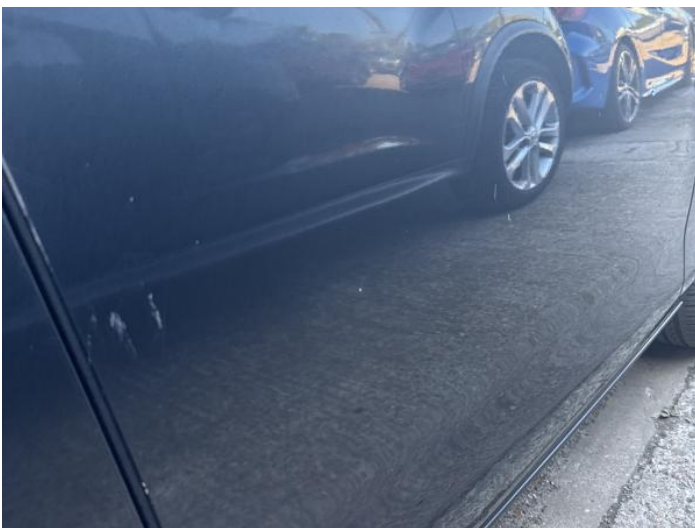
13: Door osf
Dented
With Paint Damage

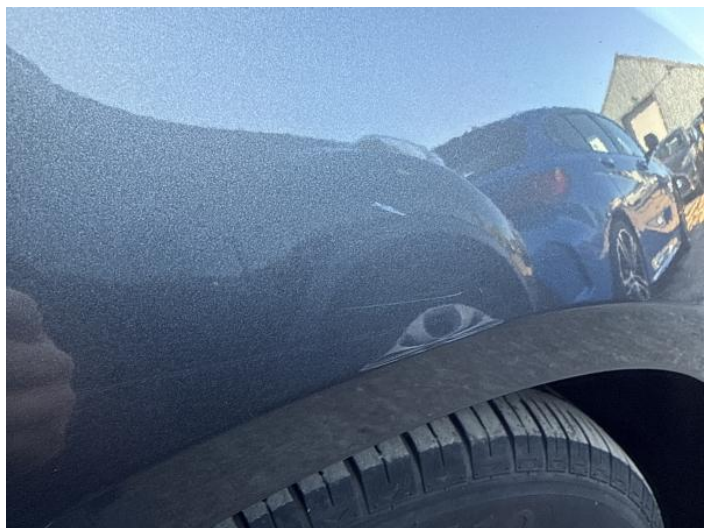
14: Wing osf
Scratched
UpTo 25mm Thru Paint

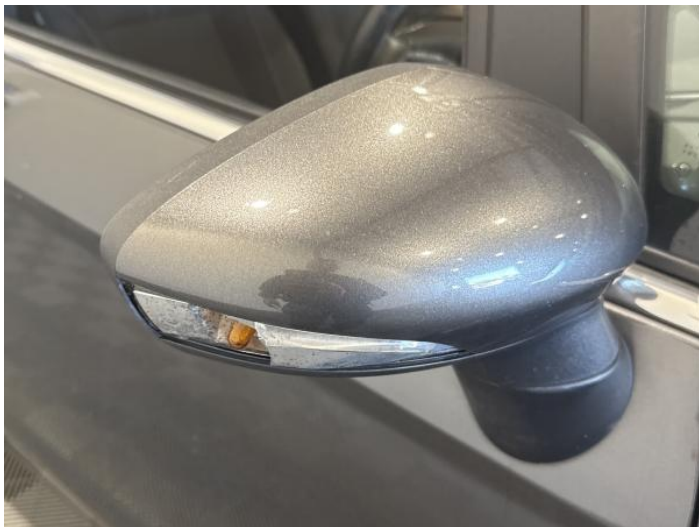
15: Flasher Side Repeater os
Broken
Replace
