## **VEHICLE INSPECTION REPORT**

DG24ECY

## Seat Ateca 1.5 TSI EVO Xperience Lux 5dr DSG

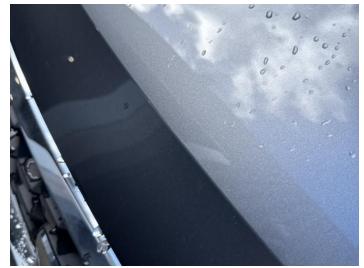
1: Bonnet Chipped 1 To 5

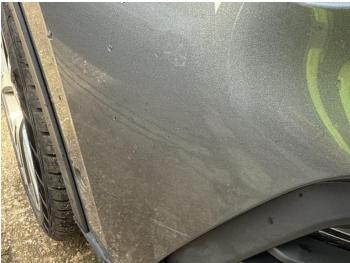
2: Bumper Front Scratched 25 to 100mm Thru Paint

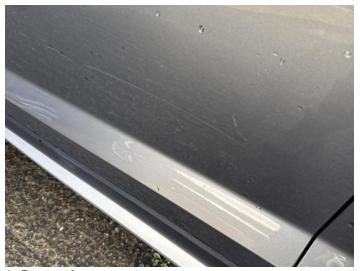
3: Door nsf Scratched Over 25mm Thru Paint

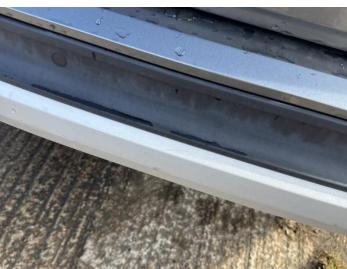
4: Bumper Rear Moulding Scuffed (Unpainted) UpTo 100mm

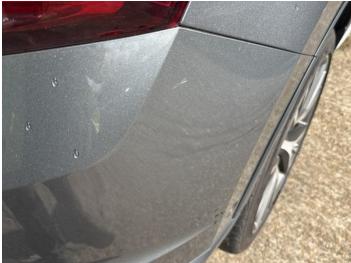
5: Bumper Rear Scratched Up To 25mm Thru Paint

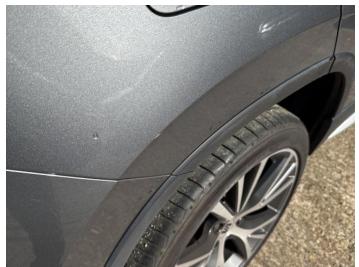
6: Qtr Panel osr Scratched UpTo 25mm Thru Paint

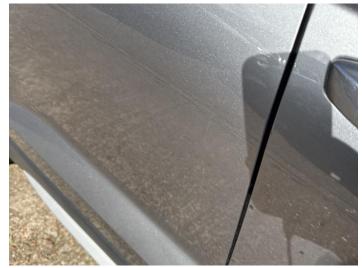
7: Door osr Scratched Over 25mm Thru Paint

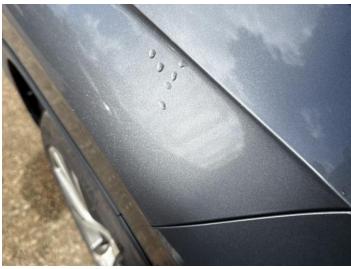
9: Wing osf Scratched UpTo 25mm Thru Paint
