### **VEHICLE INSPECTION REPORT**

# **RE68HNA**

## Mitsubishi Eclipse Cross 1.5 3 5dr

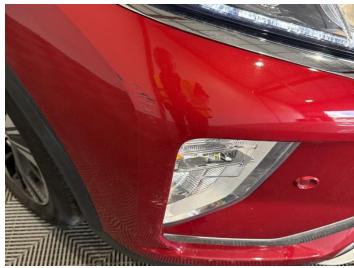
1: Bumper Front Scratched Over 100mm Thru Paint

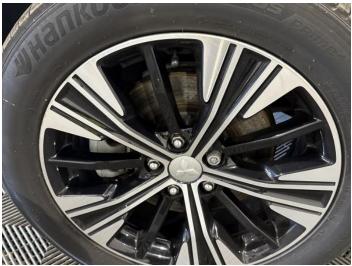
2: Wheel nsf Scratched Over 50mm

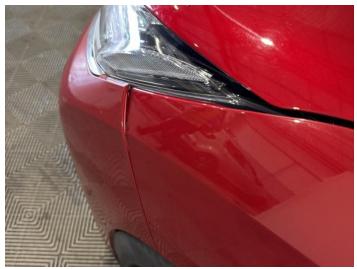
3: Bumper Front Insecure Action Required

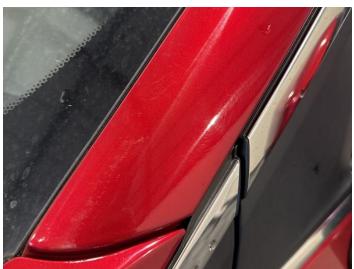
4: A Post ns Scratched UpTo 25mm Thru Paint

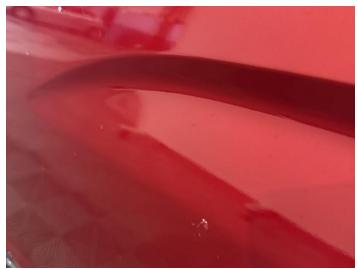
5: Door nsf Dented Between 10mm + 30mm

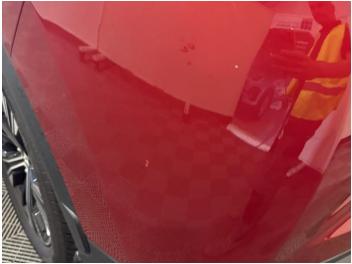
6: Bumper Rear Scratched Up To 25mm Thru Paint

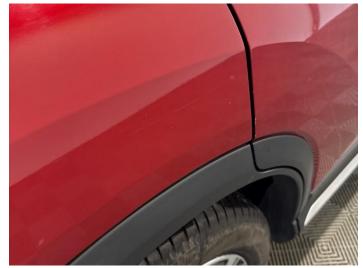
7: Qtr Panel osr Scratched Over 25mm Thru Paint

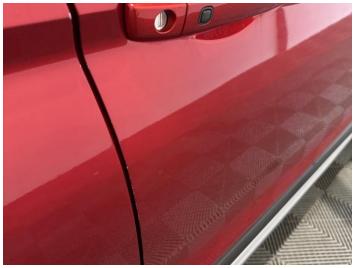
9: Door osf Chipped Edge Chip

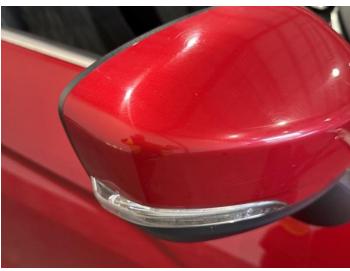
10: Door Mirror Assy osf Scratched (Painted) UpTo 25mm Thru Paint

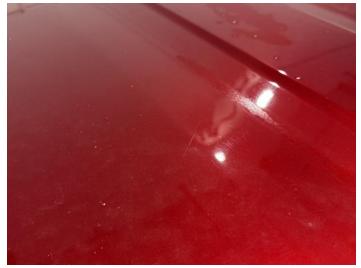
11: Roof Scratched Over 25mm Thru Paint
