# VEHICLE INSPECTION REPORT

**GU63BZG**

## BMW 1 Series 116i Sport 5dr

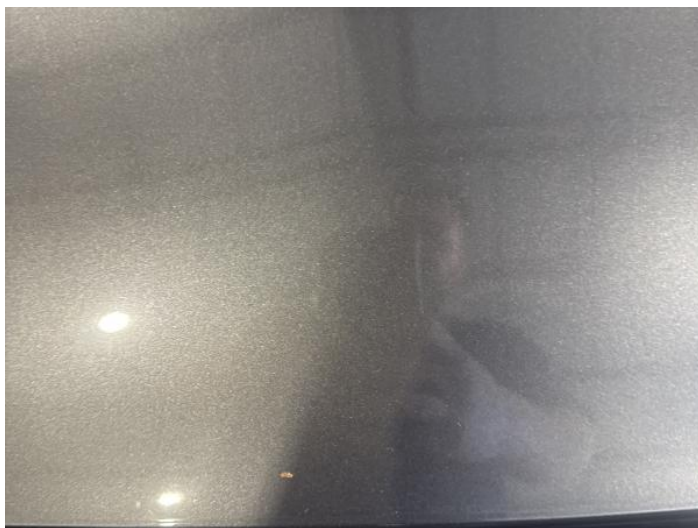
1: Bonnet  
Chipped  
1 To 5

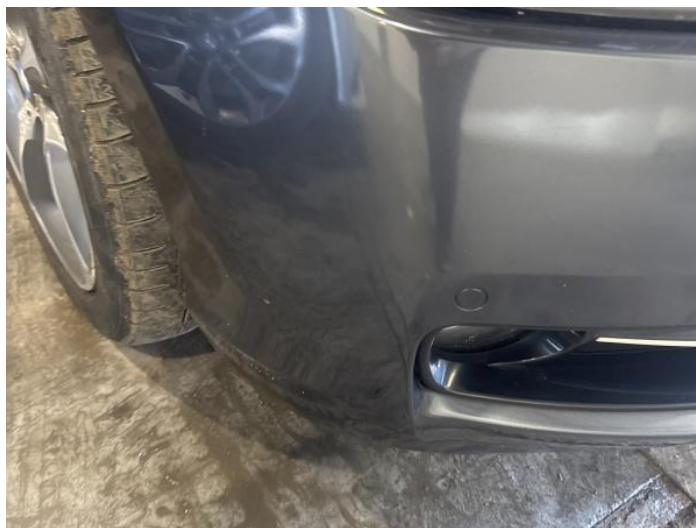
2: Bumper Front  
Scratched  
Over 100mm Thru Paint

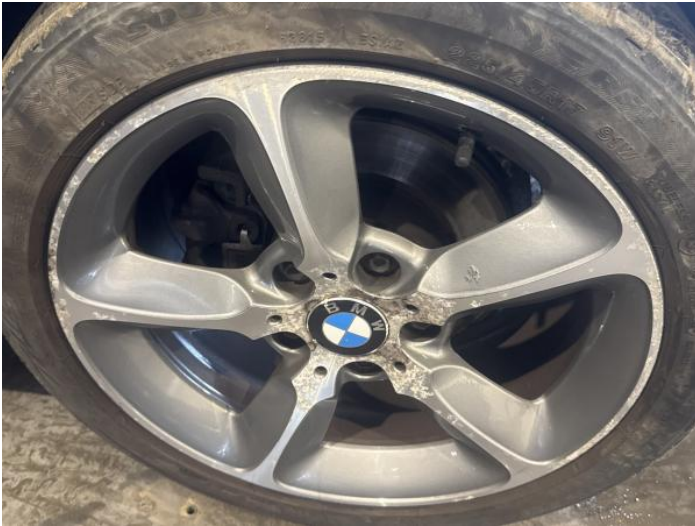
3: Wheel osf  
Scratched  
Over 50mm

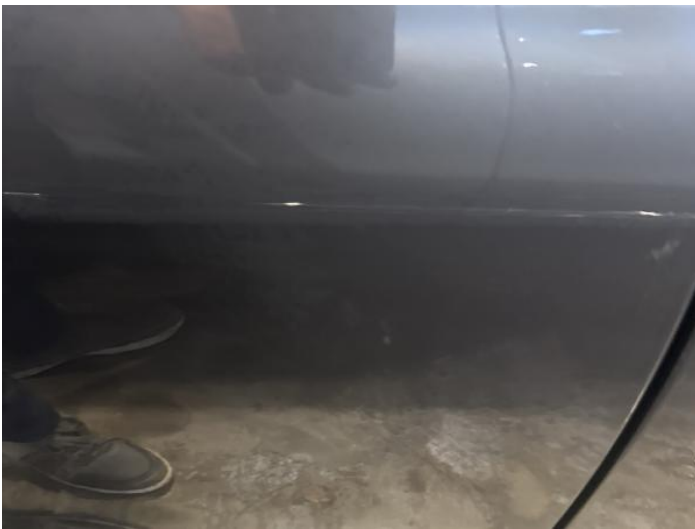
5: Door osr  
Chipped  
1 To 5

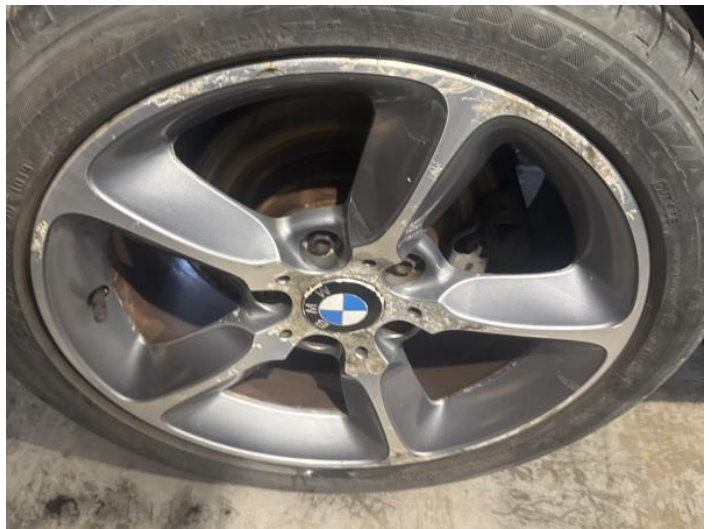
6: Wheel osr  
Scratched  
Over 50mm

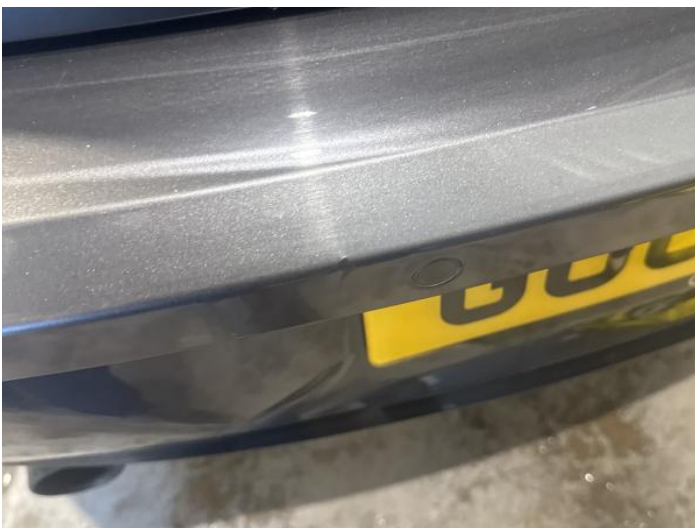
7: Bumper Rear  
Chipped  
Multiple Chips

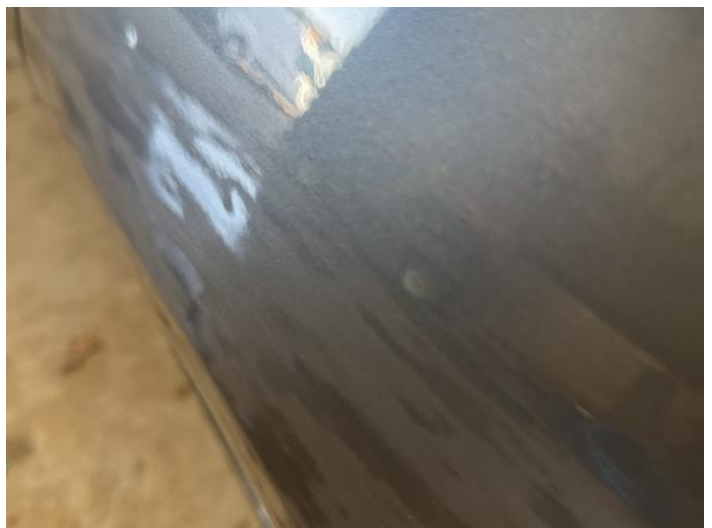
8: Qtr Panel nsr  
Dented  
Over 2 UpTo 10mm

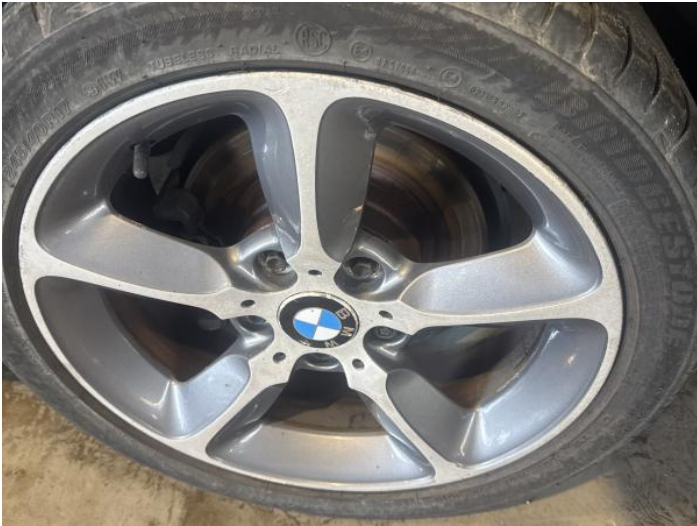
9: Wheel nsr  
Scratched  
Over 50mm

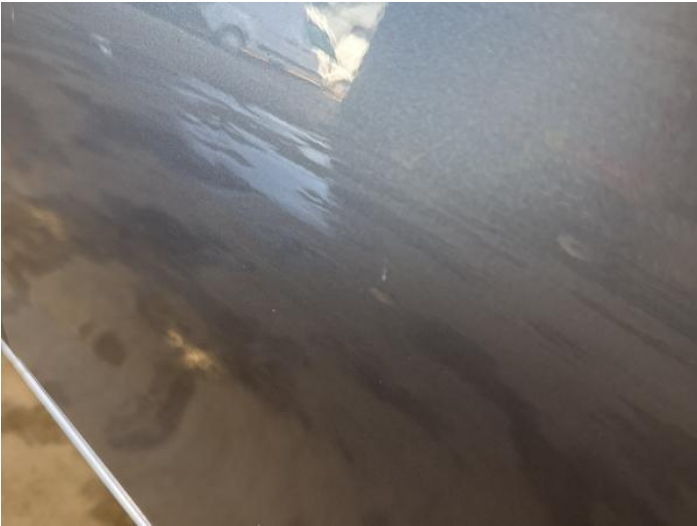
10: Door nsr  
Chipped  
1 To 5

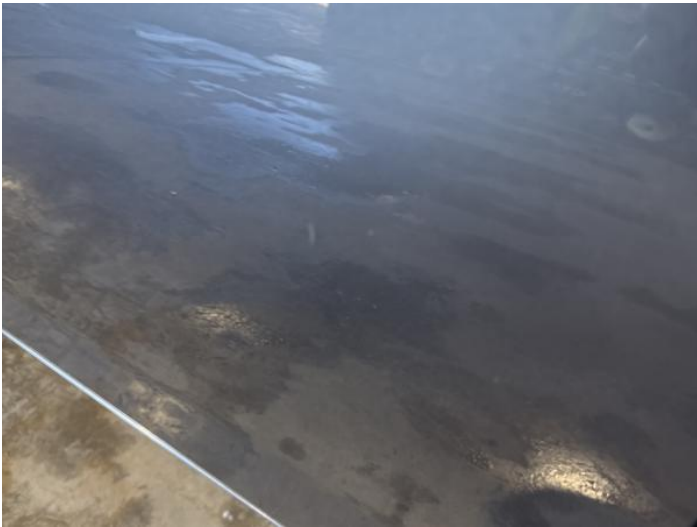
11: Door nsr  
Chipped  
1 To 5

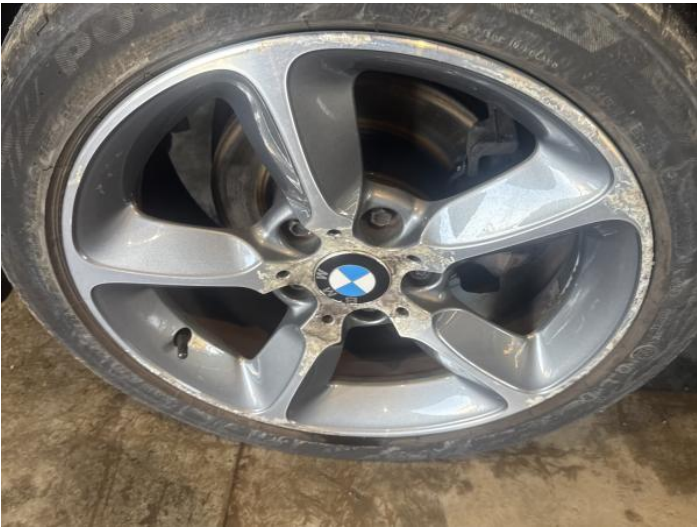
12: Wheel nsf  
Scratched  
Over 50mm
