VEHICLE INSPECTION REPORT

HD62AOB

Land Rover Freelander 2.2 SD4 HSE LUX 5dr Auto

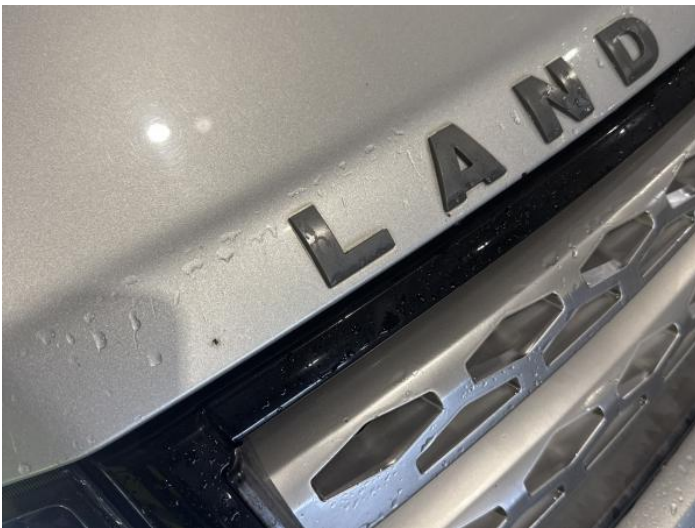
1: Bonnet
Chipped
Multiple Chips

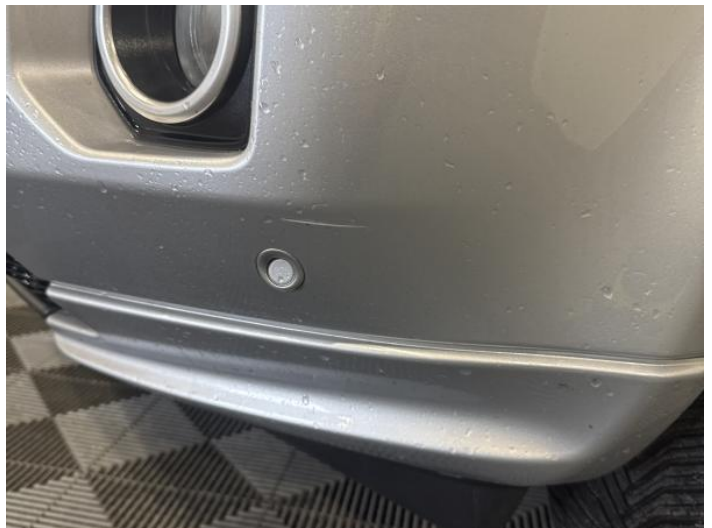
2: Bumper Front
Scratched
25 to 100mm Thru Paint

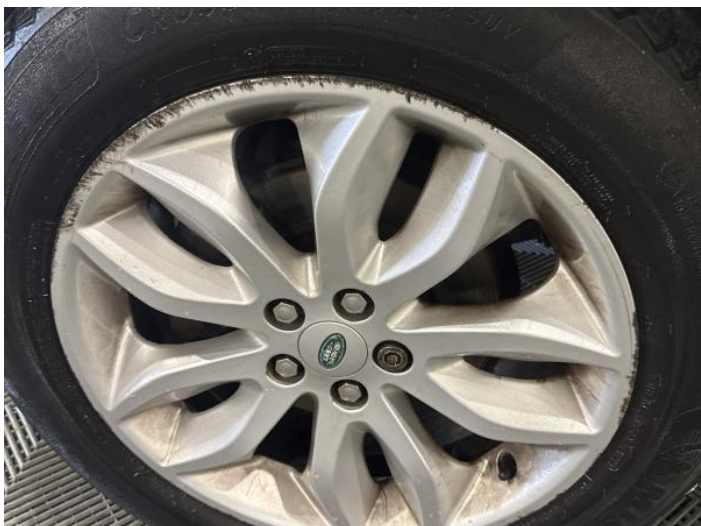
3: Wheel nsf
Scratched
Over 50mm

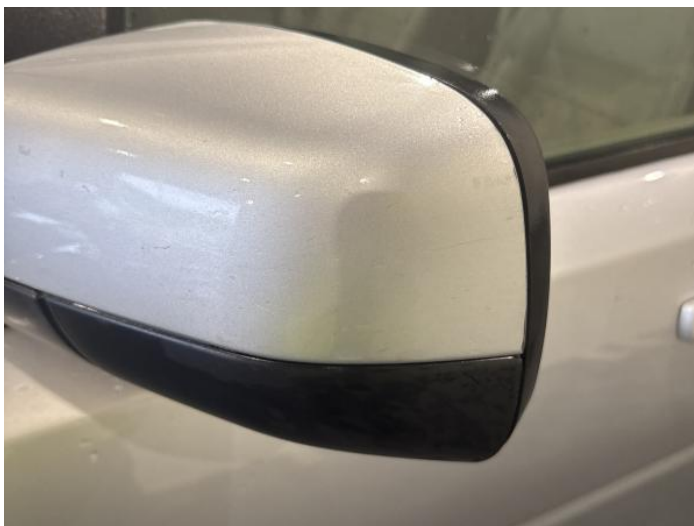
4: Door Mirror Assy nsf
Scratched (Painted)
UpTo 25mm Thru Paint

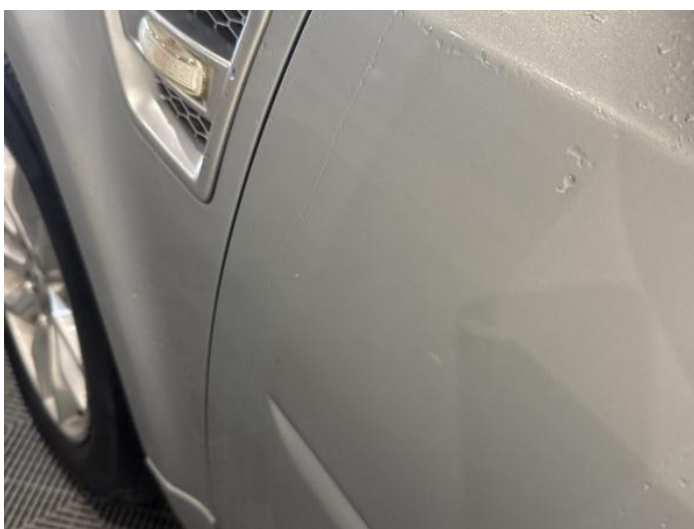
6: Door nsf
Dented
Between 10mm + 30mm

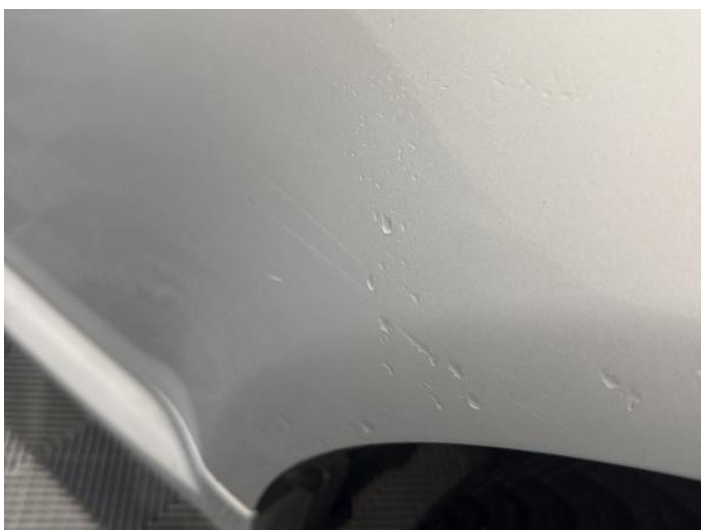
7: Door nsr
Scratched
Over 25mm Thru Paint

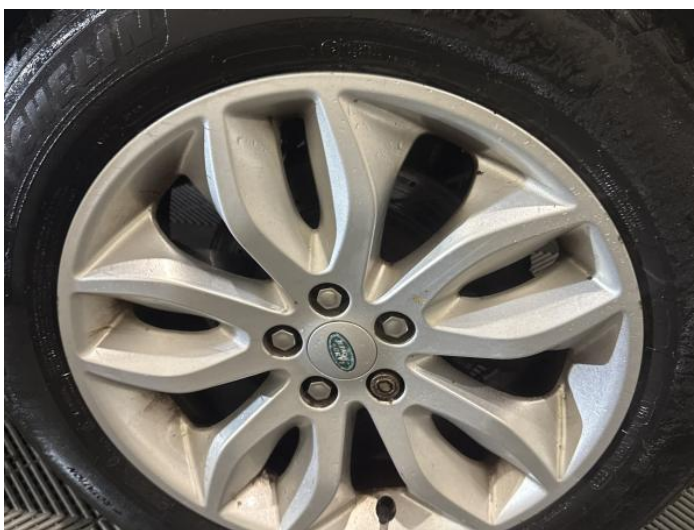
8: Wheel nsr
Scratched
Over 50mm

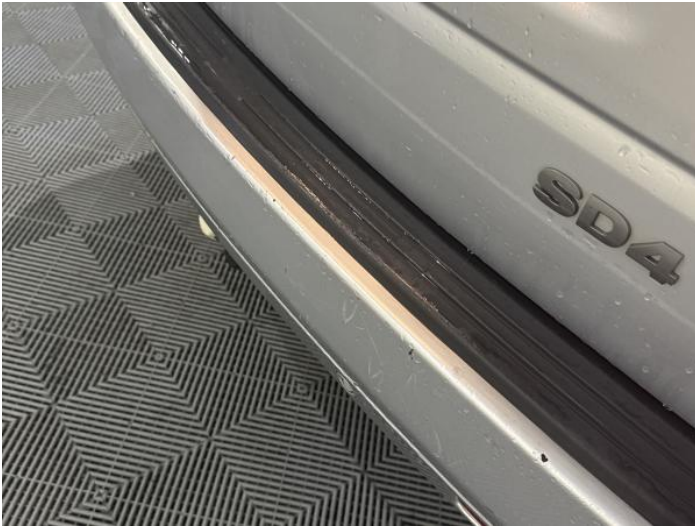
9: Bumper Rear
Scratched
Over 100mm Thru Paint

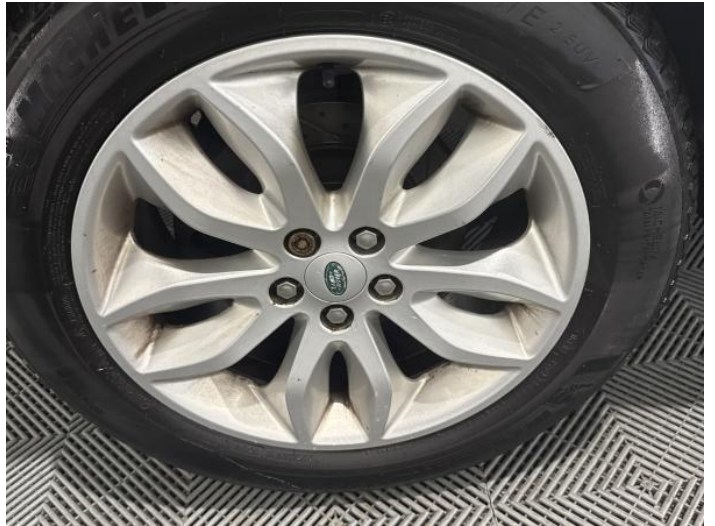
10: Wheel osr
Scratched
Up To 50mm

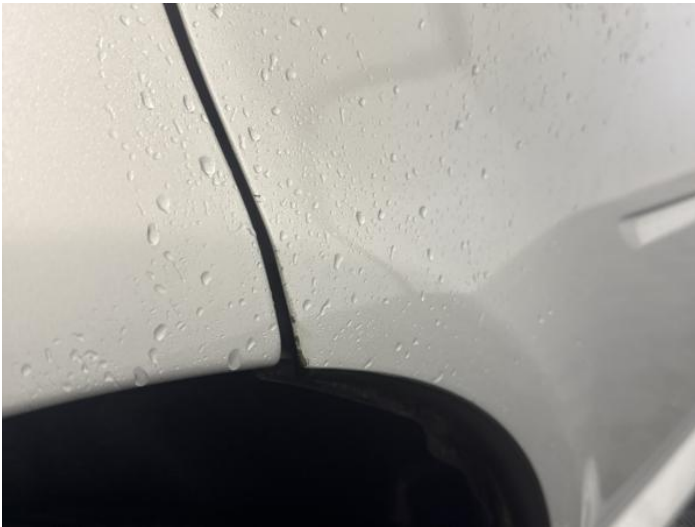
11: Door osr
Chipped
Edge Chip

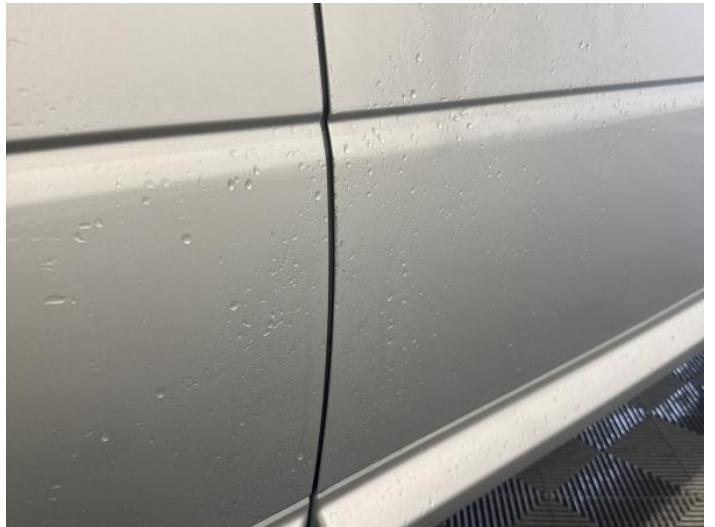
12: Door osf
Chipped
Edge Chip

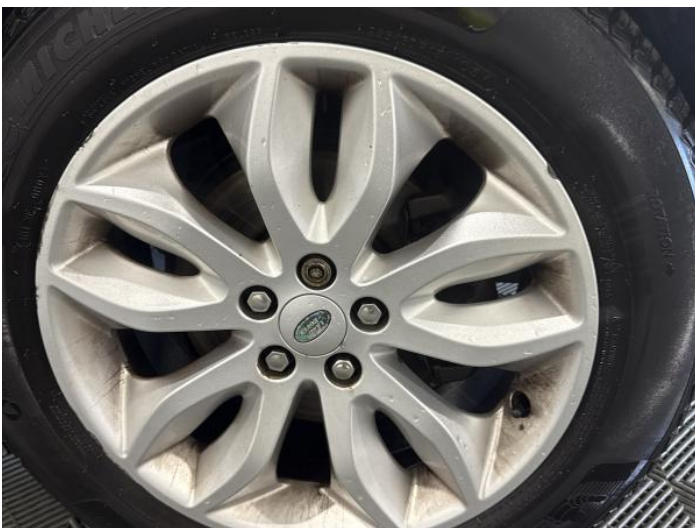
13: Wheel osf
Dented
Up To 30mm (Alloy)

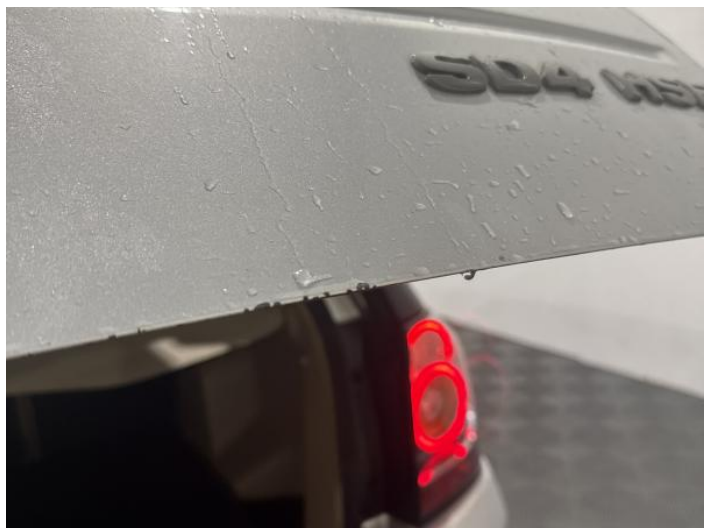
14: Tailgate
Chipped
Edge Chip
