VEHICLE INSPECTION REPORT

E071JGZ

Ford Puma 1.0 EcoBoost Hybr mHEV 155 ST-Line Vignale 5dr DCT

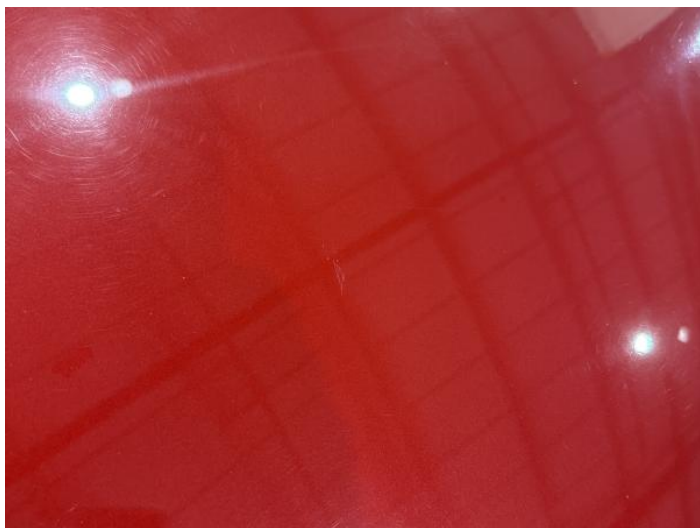
1: Bonnet
Scratched
UpTo 25mm Thru Paint

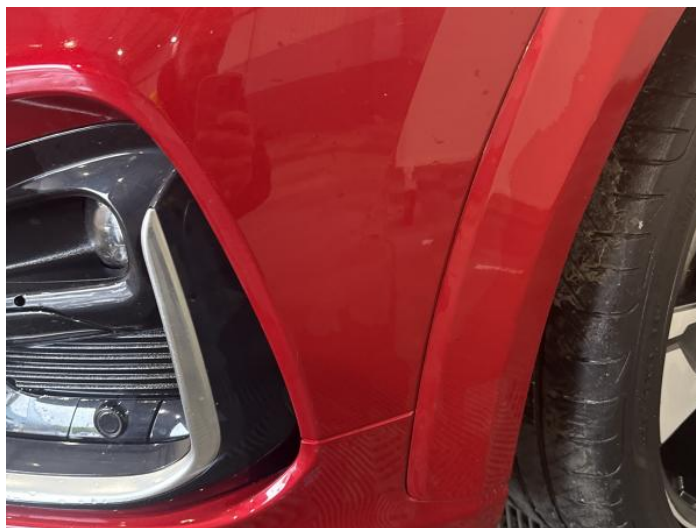
2: Bumper Front
Scratched
25 to 100mm Thru Paint

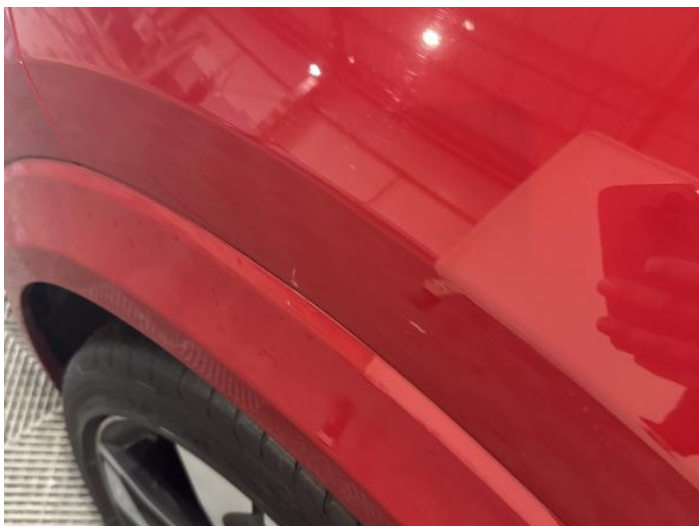
3: Wing nsf
Scratched
UpTo 25mm Thru Paint

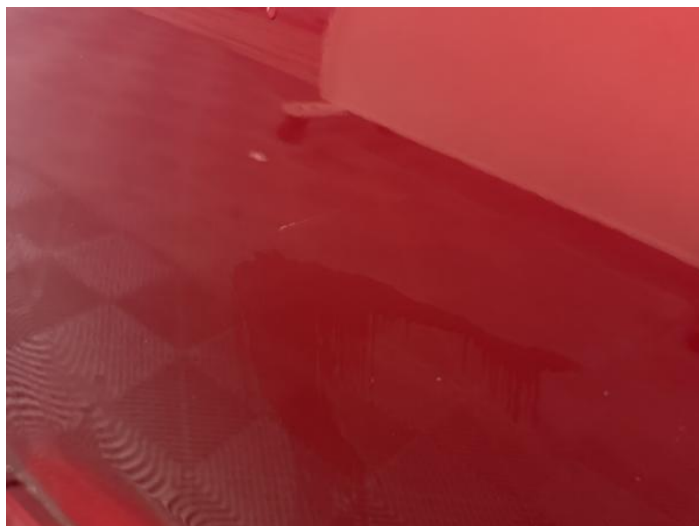
4: Door osf
Scratched
Over 25mm Thru Paint

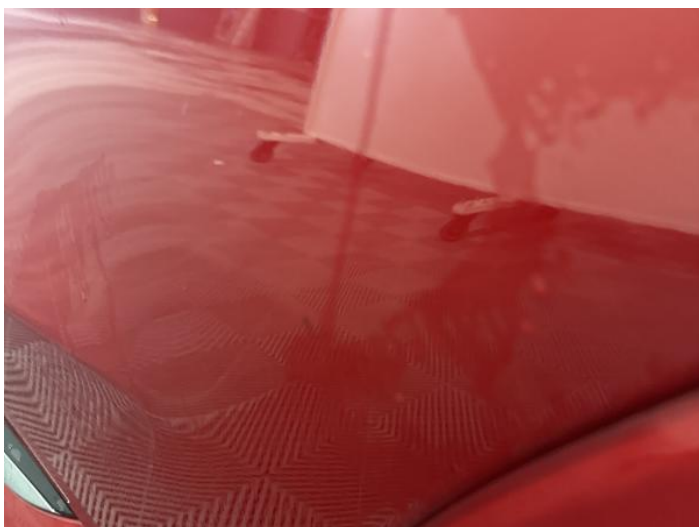
5: Door nsr
Scratched
UpTo 25mm Thru Paint

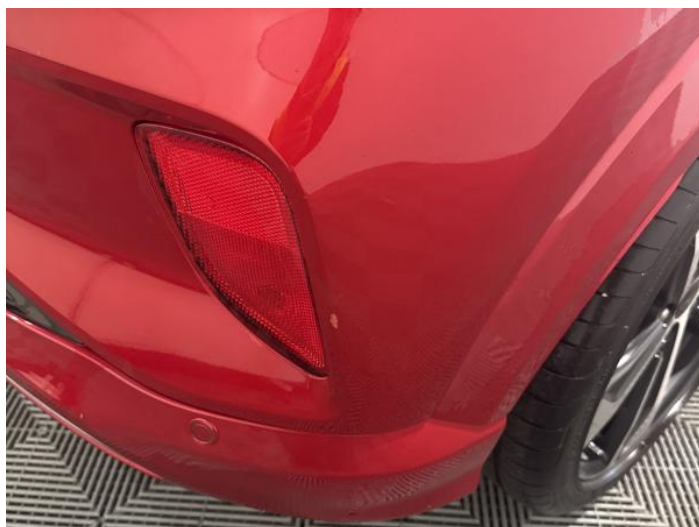
6: Bumper Rear
Scratched
25 to 100mm Thru Paint

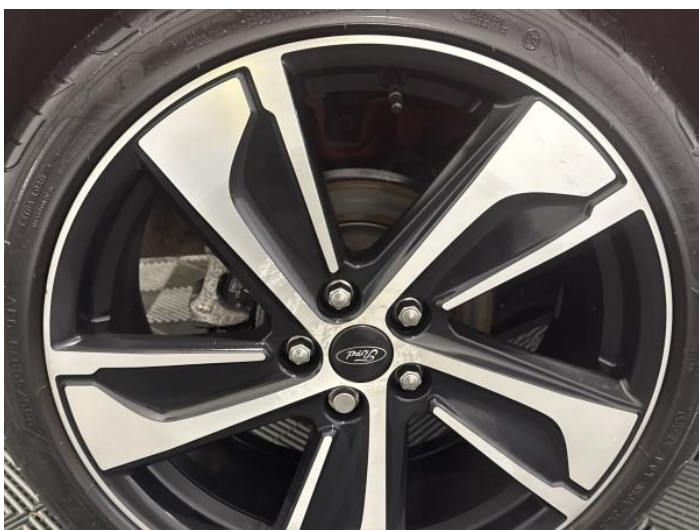
7: Wheel osr
Scratched
Over 50mm

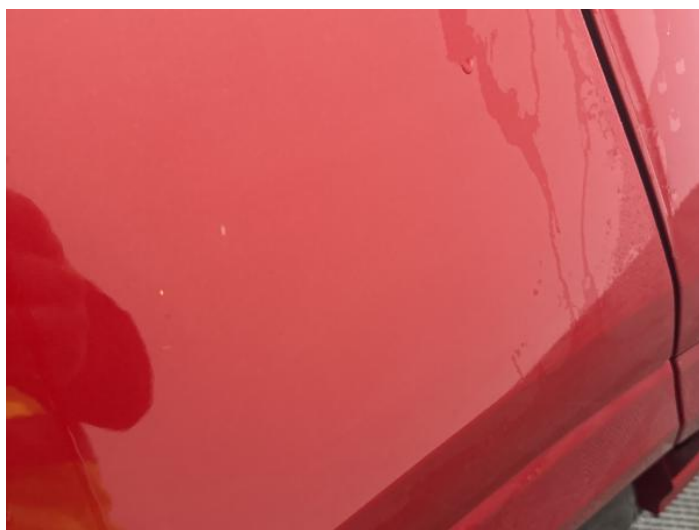
8: Qtr Panel osr
Scratched
UpTo 25mm Thru Paint

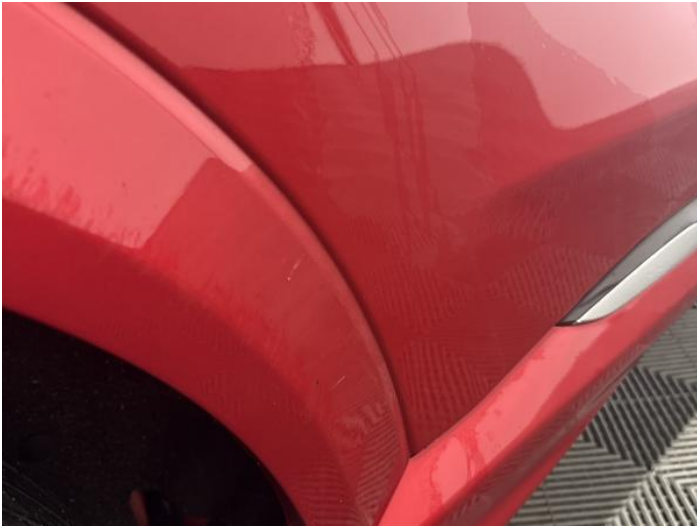
9: Door osr
 Scratched
 UpTo 25mm Thru Paint

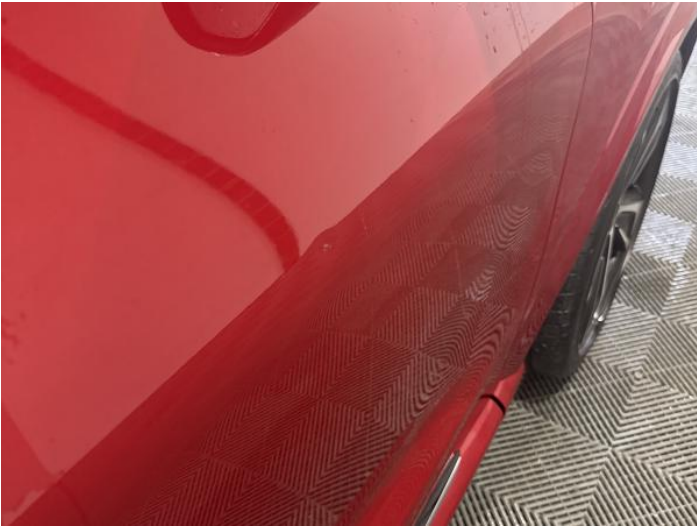
10: Door osf
 Dented
 Between 10mm + 30mm

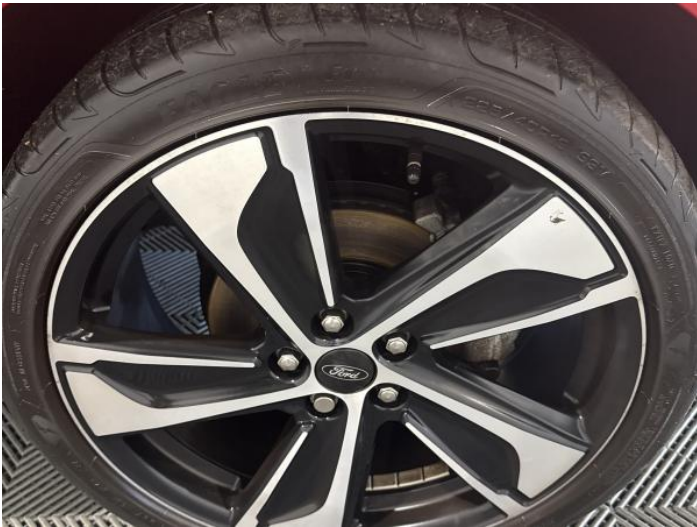
11: Wheel osf
 Scratched
 Up To 50mm
