# VEHICLE INSPECTION REPORT

LO22UUN

## Kia Stonic 1.0T GDi 48V GT-Line 5dr DCT

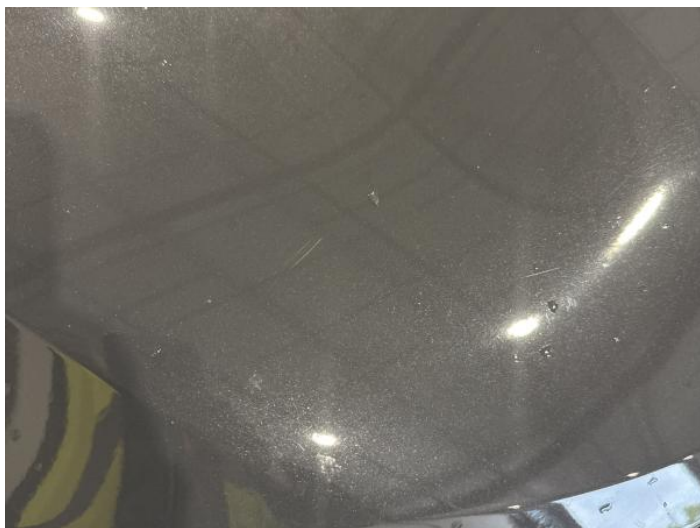
1: Bonnet  
Scratched  
UpTo 25mm Thru Paint

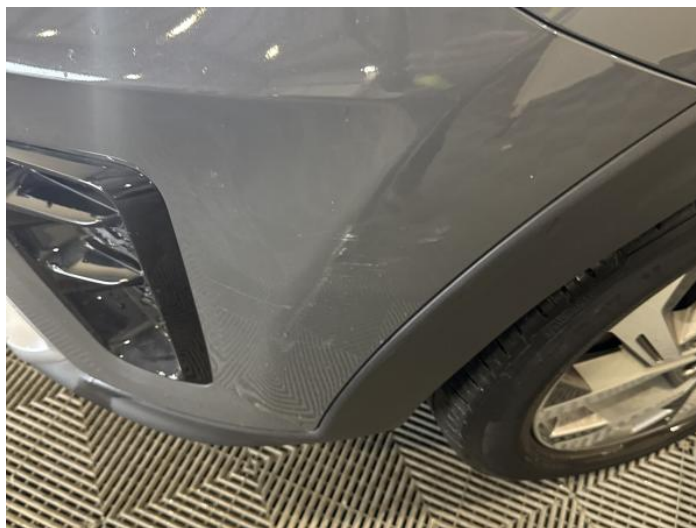
2: Bumper Front  
Scratched  
Over 100mm Thru Paint

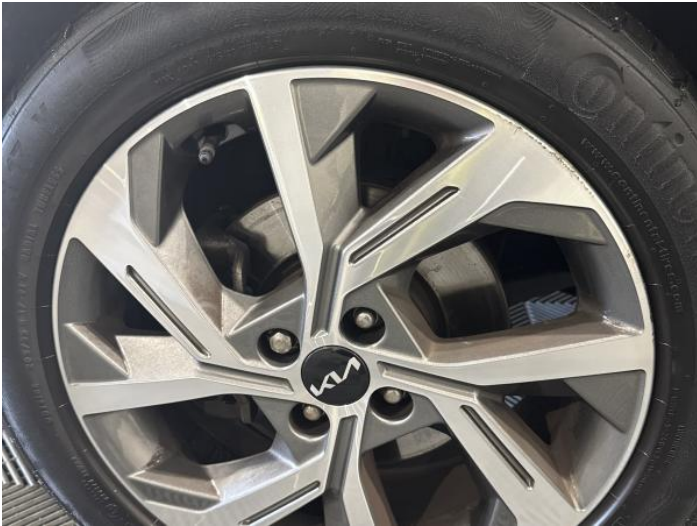
3: Wheel nsf  
Scratched  
Over 50mm

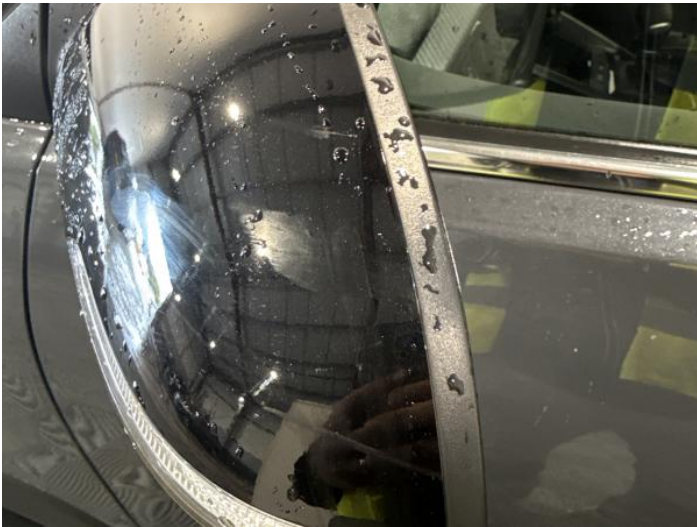
5: Door Mirror Assy nsf  
Scratched (Painted)  
Over 25mm Thru Paint

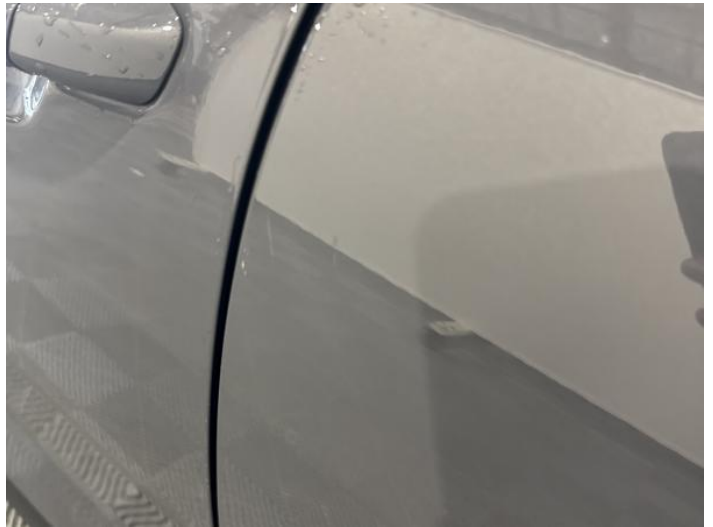
6: Door nsr  
Scratched  
UpTo 25mm Thru Paint

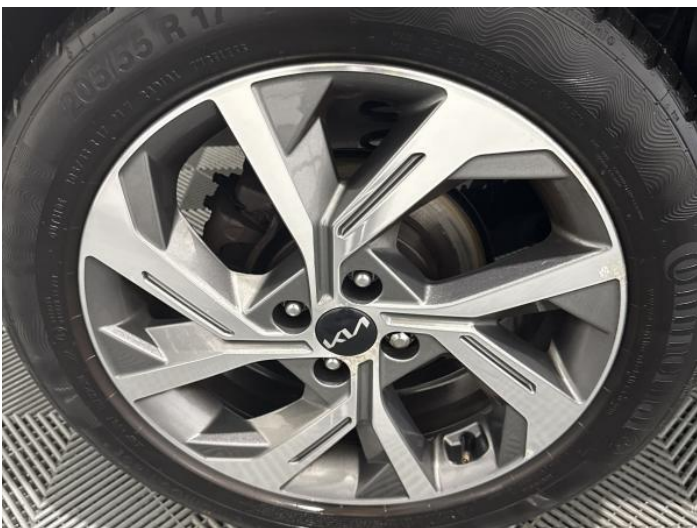
7: Wheel osr  
Scratched  
Over 50mm

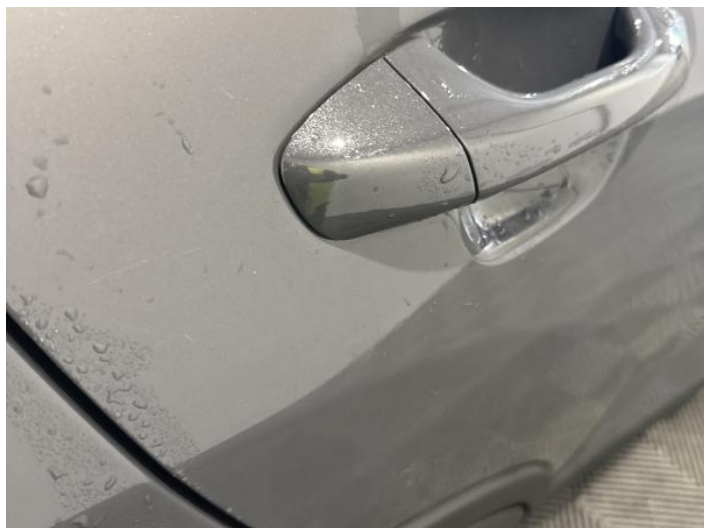
8: Door osr  
Scratched  
UpTo 25mm Thru Paint

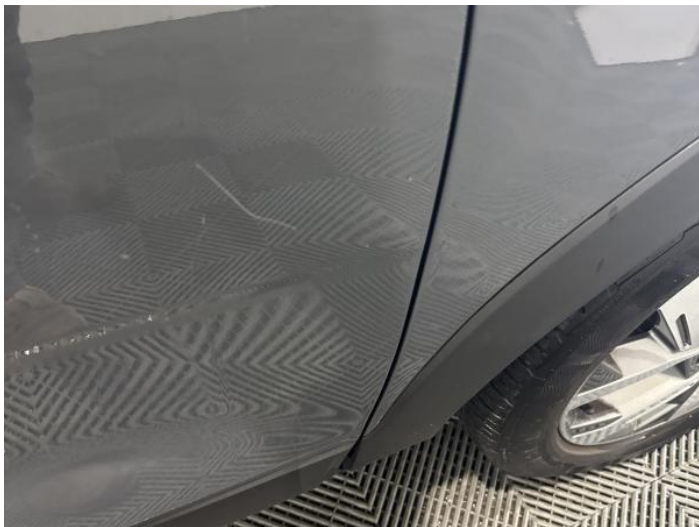
9: Door osf  
Scratched  
Over 25mm Thru Paint

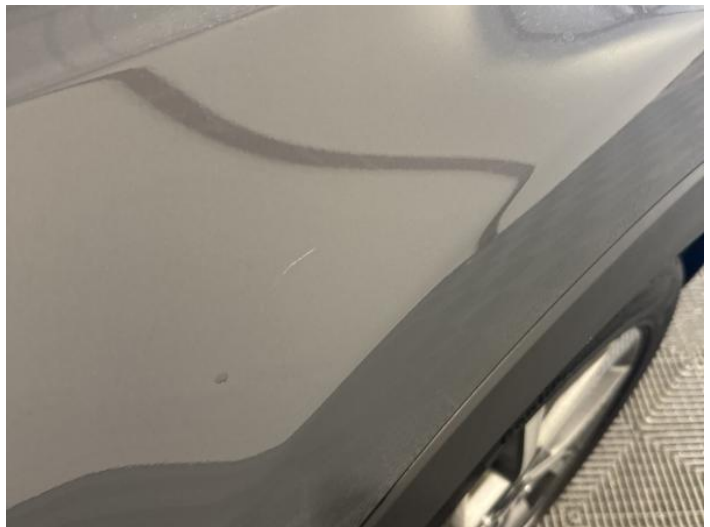
10: Wing osf  
Scratched  
UpTo 25mm Thru Paint

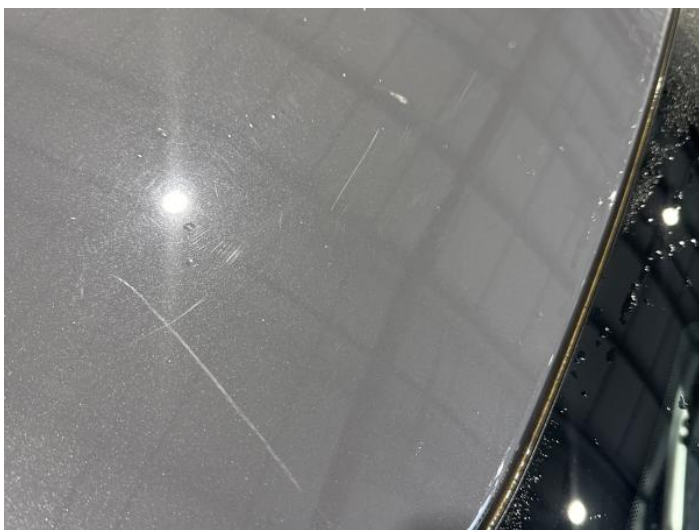
11: Roof  
Scratched  
Over 25mm Thru Paint
