## **VEHICLE INSPECTION REPORT**

**EP19BZU**

### Ford Fiesta 1.0 EcoBoost 125 ST-Line X 5dr

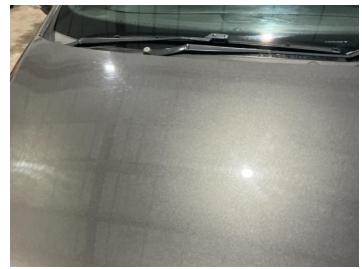
1: Bonnet Chipped 1 To 5

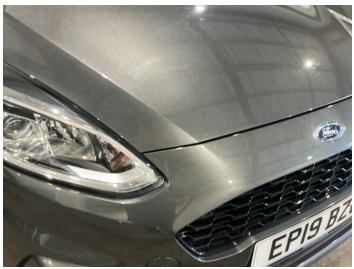
2: Bumper Front Chipped Multiple Chips

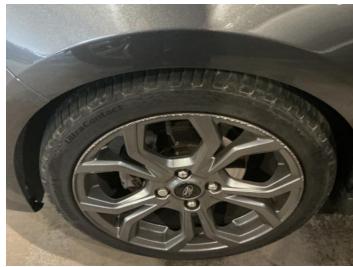
4: Wheel nsf Scratched Over 50mm

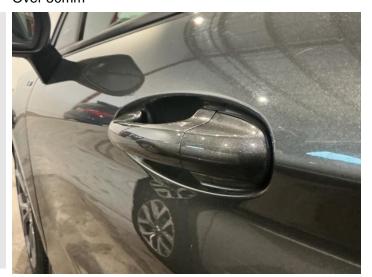
6: Door nsf Dented Between 10mm + 30mm

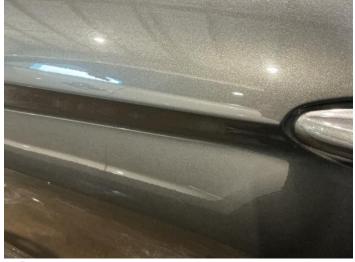
7: Door nsr Scratched UpTo 25mm Thru Paint

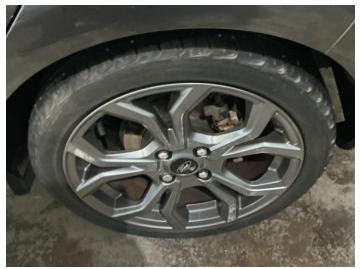
9: Wheel nsr Scratched Up To 50mm

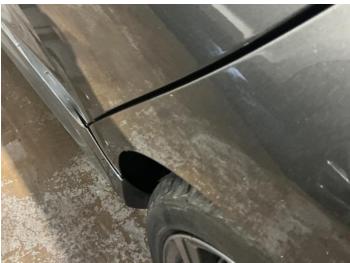
10: Qtr Panel nsr Dented 2 Or Less UpTo 10mm

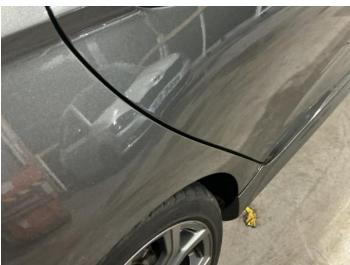
12: Qtr Panel osr Dented 2 Or Less UpTo 10mm

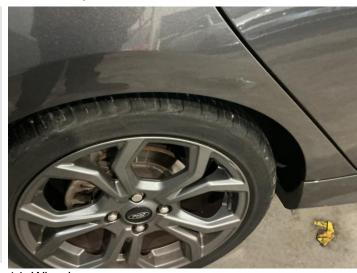
14: Wheel osr Scratched Up To 50mm

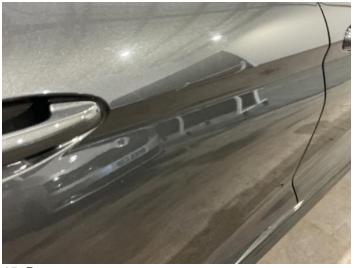
15: Door osr Chipped 1 To 5

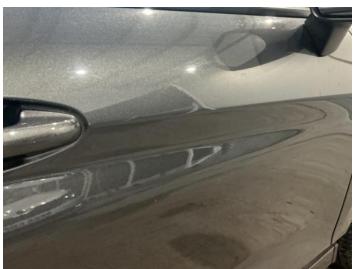
16: Door osf Chipped 1 To 5

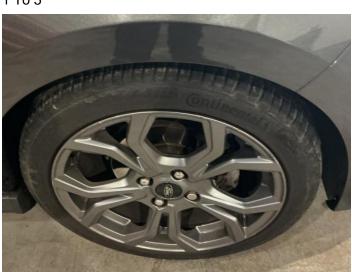
18: Wheel osf Scratched Up To 50mm
