VEHICLE INSPECTION REPORT

AO65OYU

Nissan Qashqai 1.2 DiG-T N-Tec+ 5dr

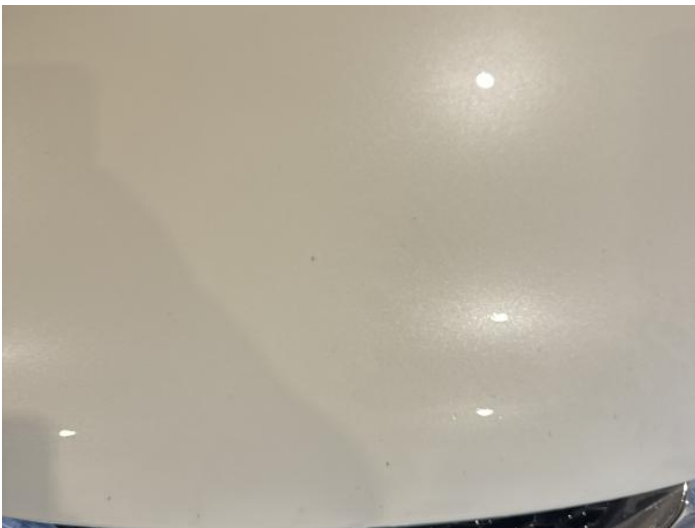
1: Bonnet
Chipped
Multiple Chips

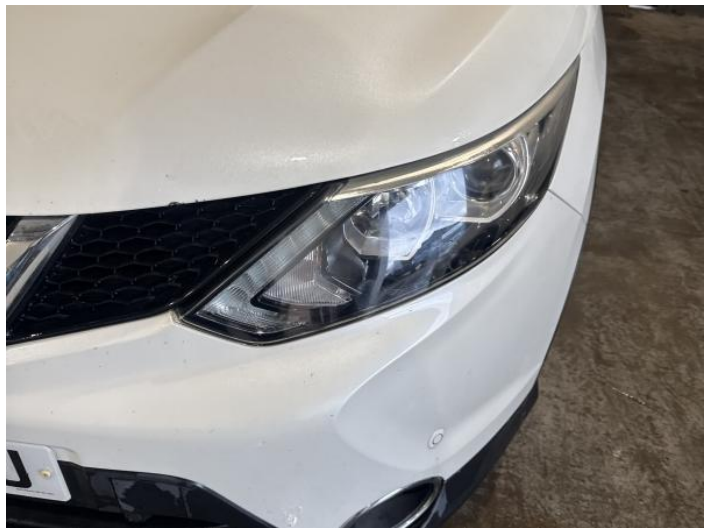
2: Bumper Front
Chipped
Multiple Chips

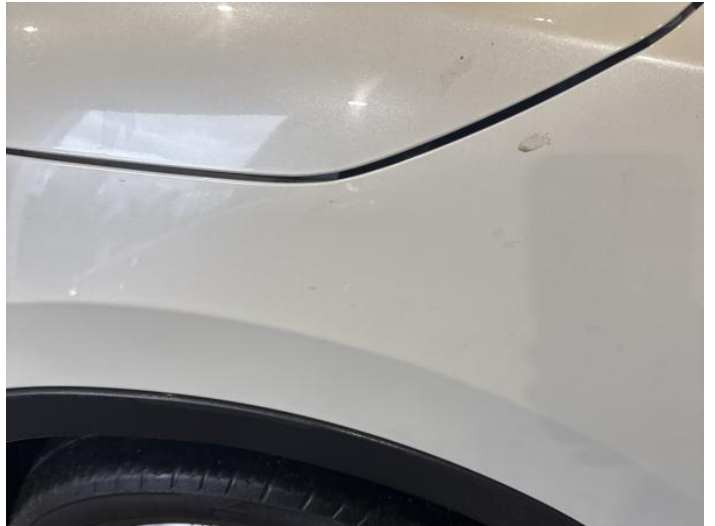
3: Bumper Front
Scratched
Over 25mm Not Thru Paint

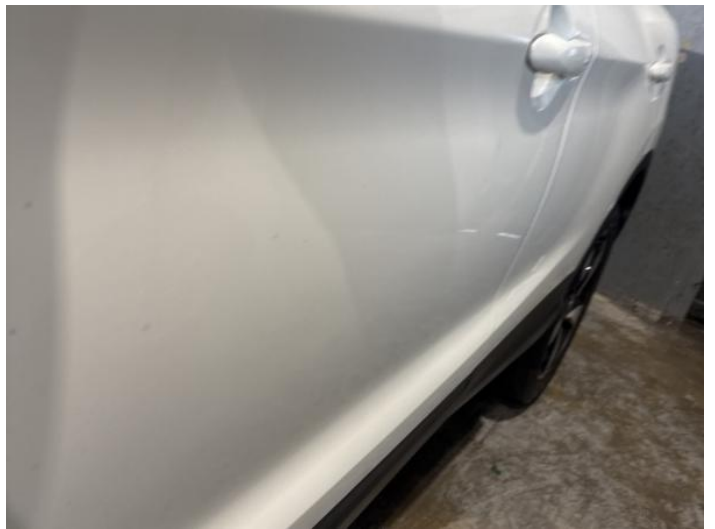
5: Wing nsf
Scratched
Over 25mm Not Thru Paint

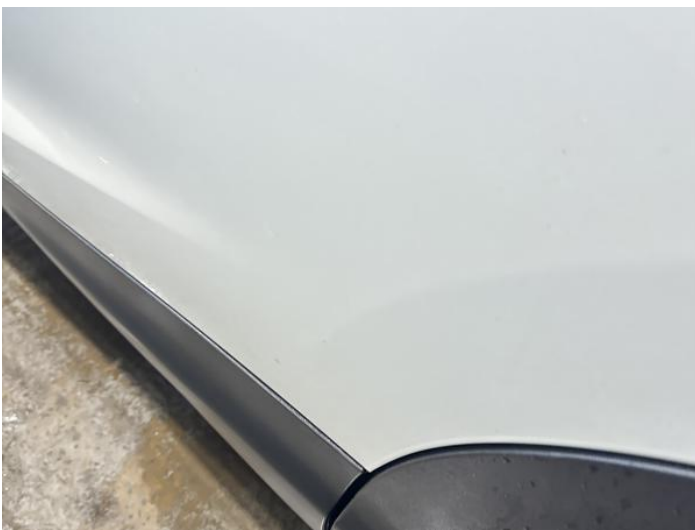
7: Door nsr
Dented
Between 10mm + 30mm

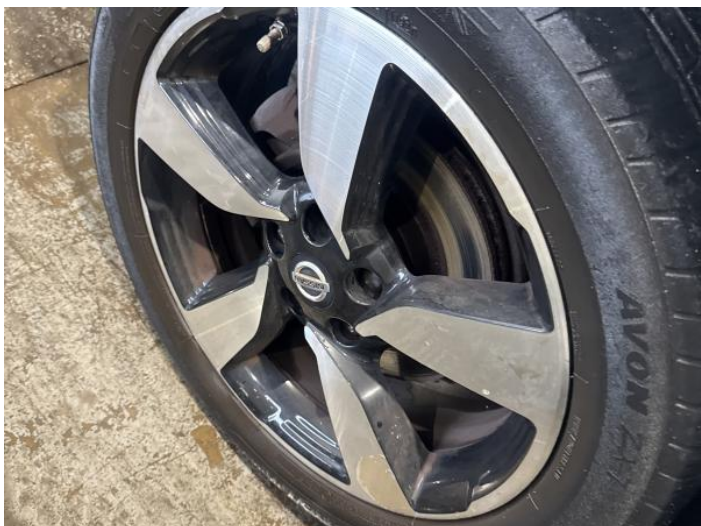
9: Wheel nsf
Scratched
Over 50mm

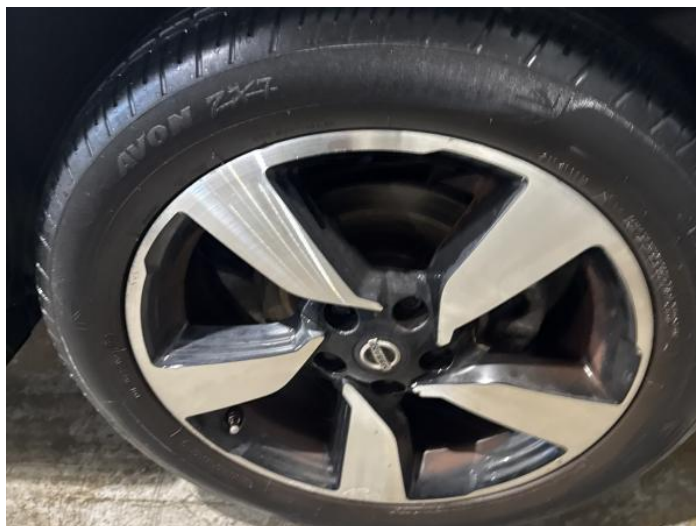
10: Wheel nsr
Scratched
Over 50mm

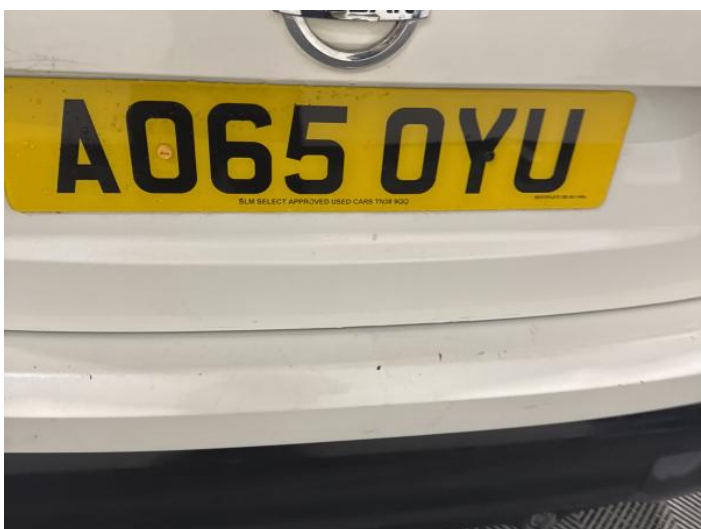
11: Bumper Rear
Scratched
Over 100mm Thru Paint

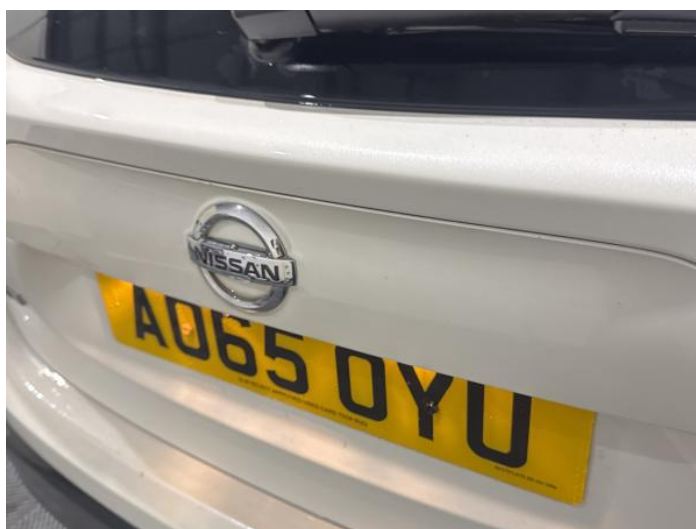
12: Boot Lid
Chipped
1 To 5

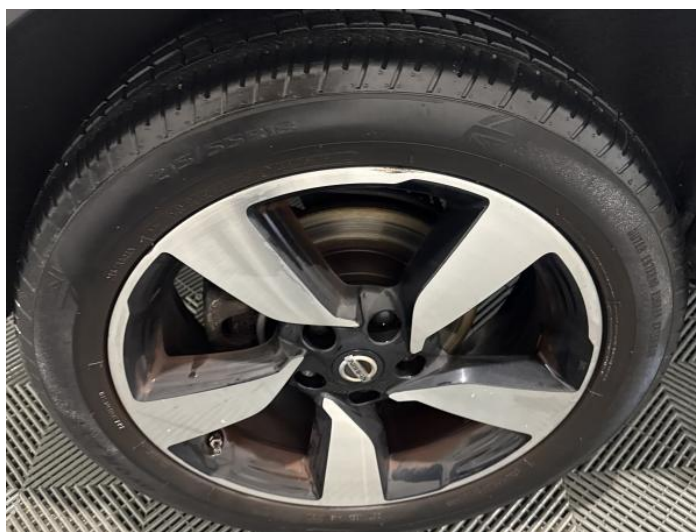
14: Wheel osr
Scratched
Over 50mm

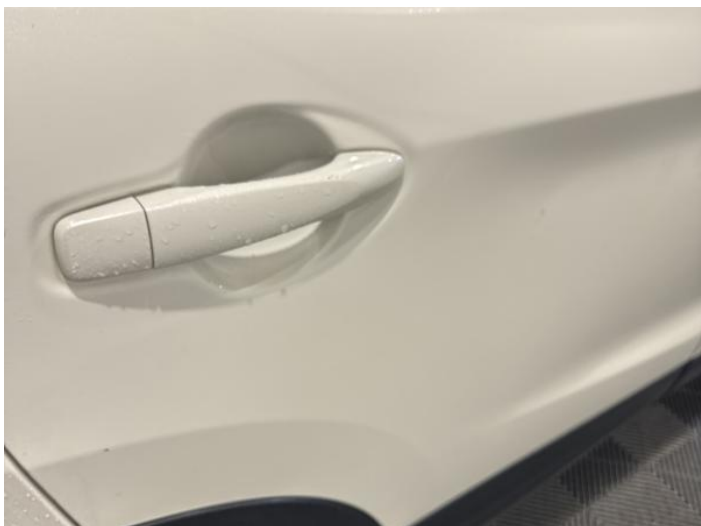
15: Door osr
Chipped
1 To 5

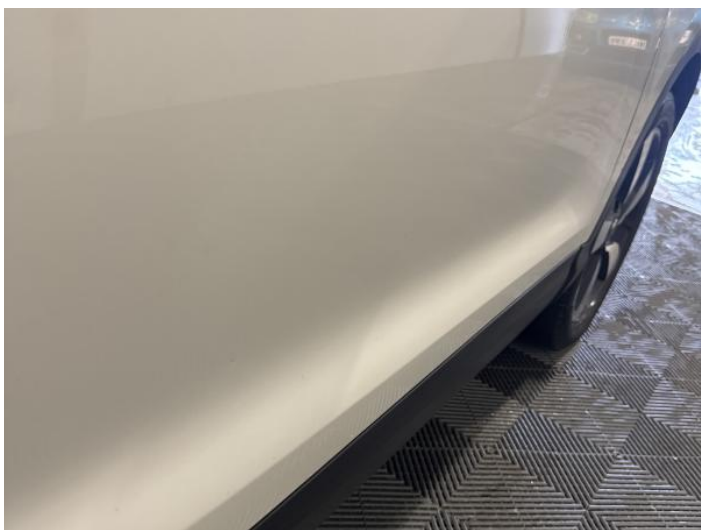
17: Door osf
Dented
Between 10mm + 30mm

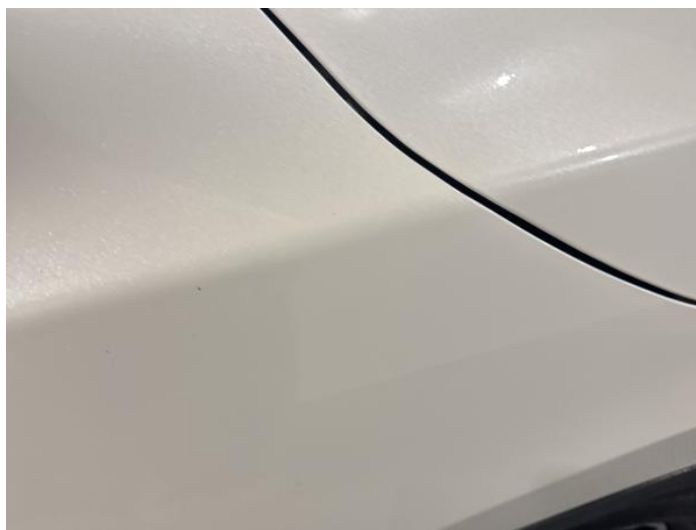
18: Wing osf
Chipped
1 To 5

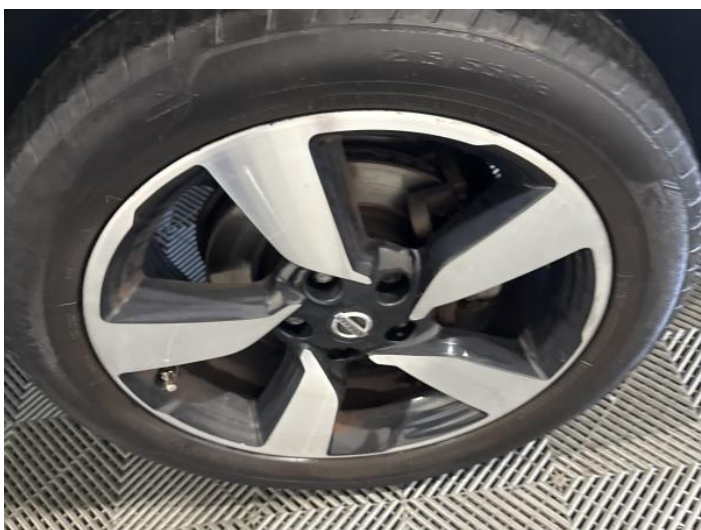
19: Wheel osf
Scratched
Over 50mm

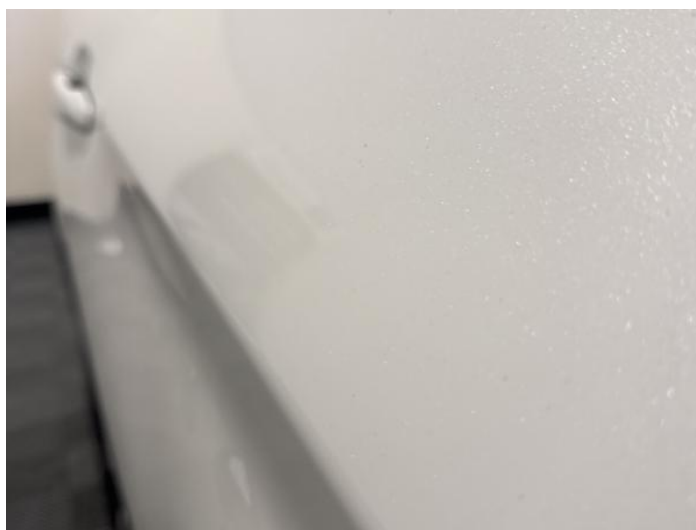
20: Door osr
Dented
Over 2 UpTo 10mm
