VEHICLE INSPECTION REPORT

RO69YBF

Hyundai Kona 150kW Premium 64kWh 5dr Auto

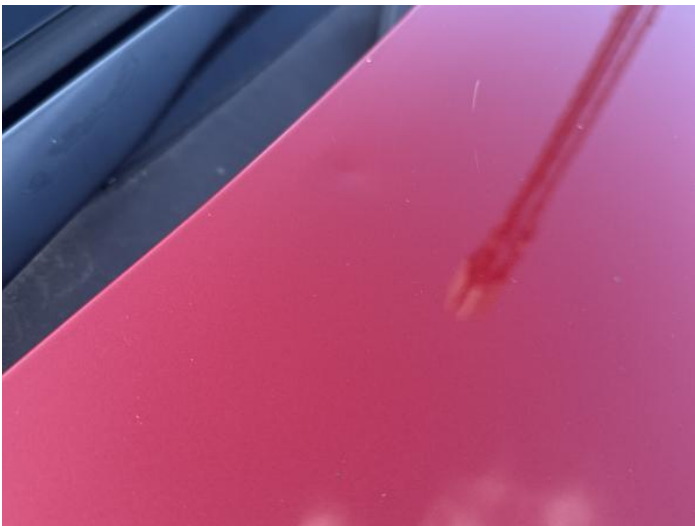
1: Bonnet
Dented
Between 10mm + 30mm

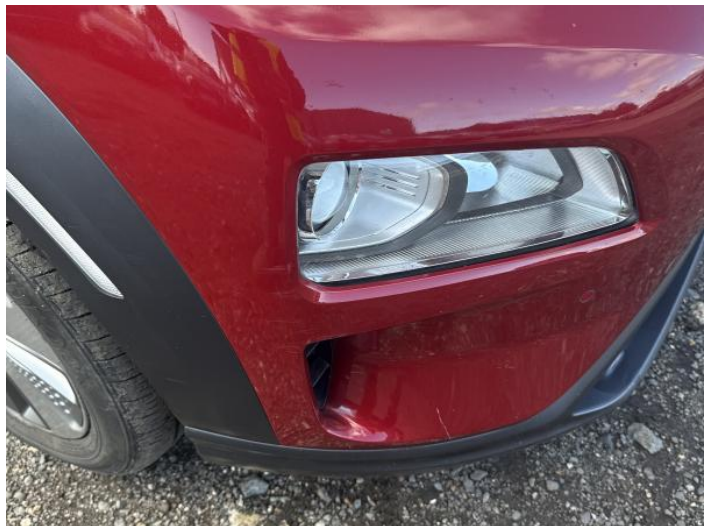
2: Bumper Front
Scratched
Over 100mm Thru Paint

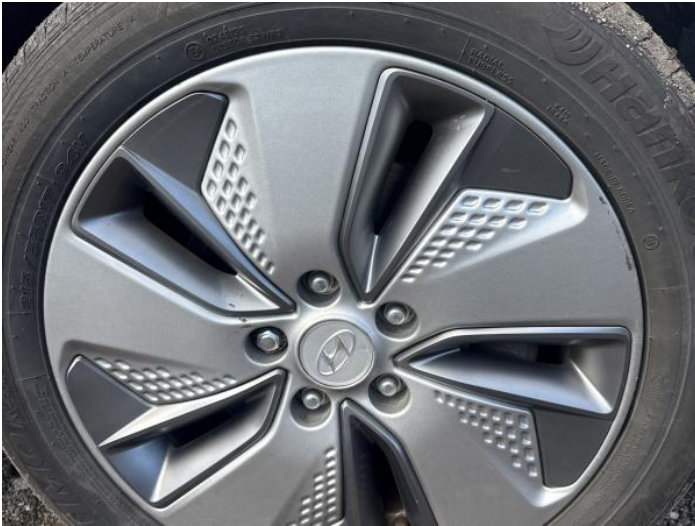
3: Wheel osf
Scratched
Up To 50mm

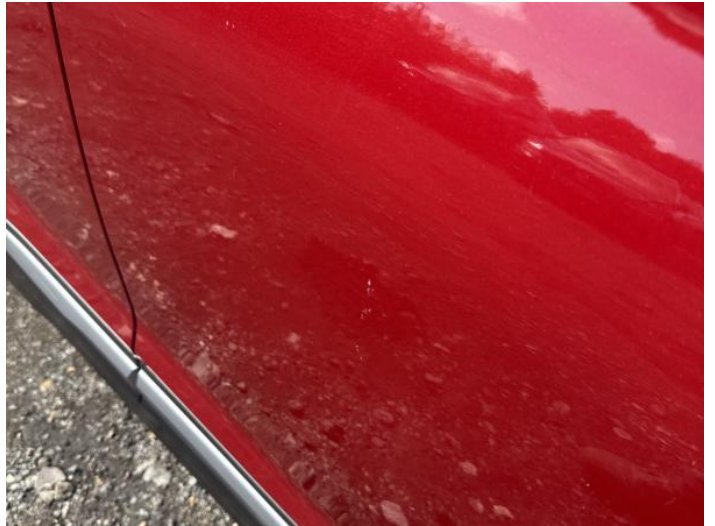
4: Door osf
Scratched
Over 25mm Thru Paint

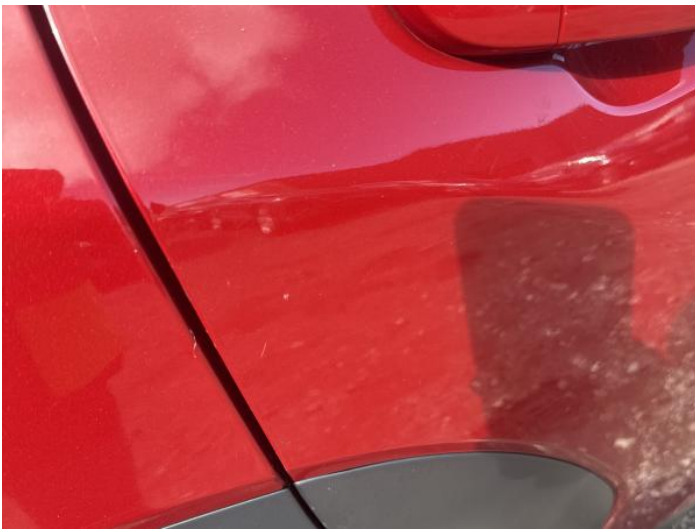
5: Door osr
Scratched
Up To 25mm Thru Paint

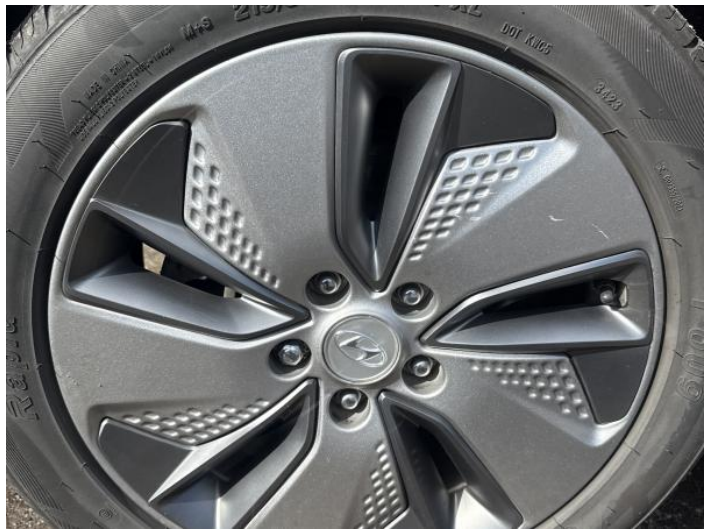
6: Wheel osr
Scratched
Over 50mm

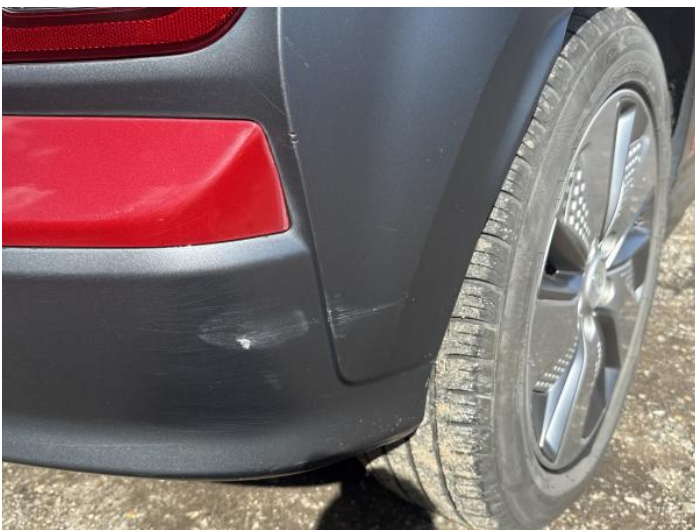
7: Bumper Rear Moulding
Scratched (Painted)
Over 25mm Thru Paint

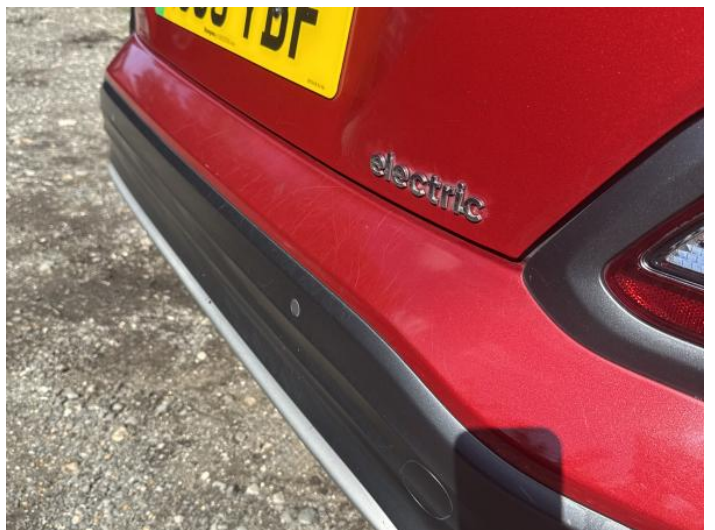
8: Bumper Rear
Scratched
Over 100mm Thru Paint

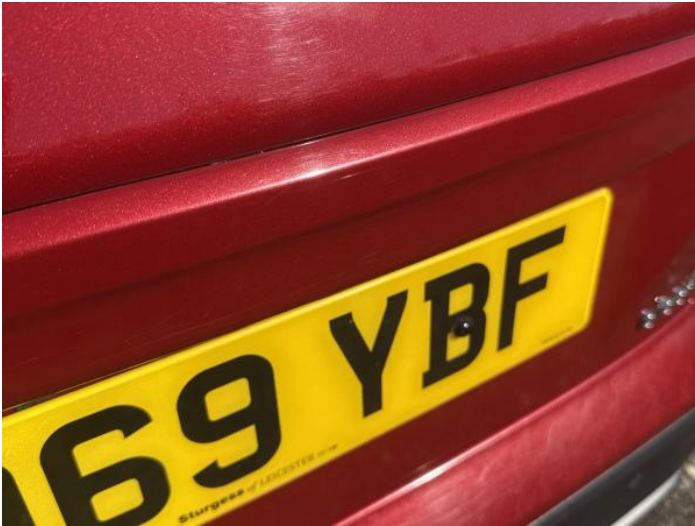
9: Tailgate Trim Panel
Scratched (Painted)
Over 25mm Thru Paint

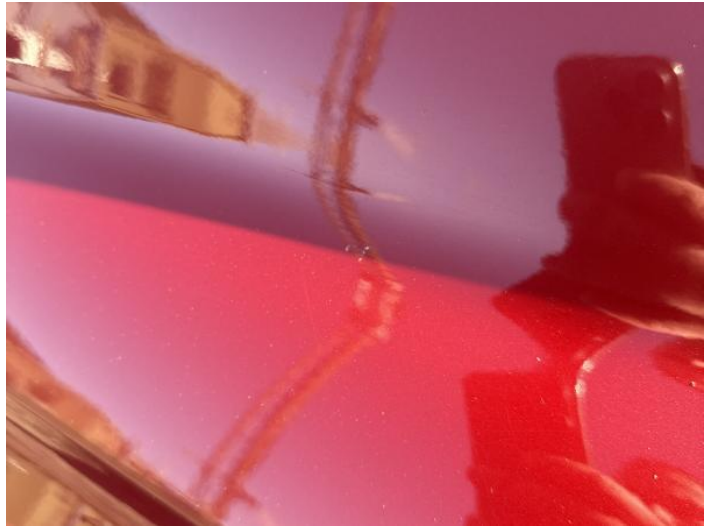
10: Qtr Panel nsr
Scratched
UpTo 25mm Thru Paint

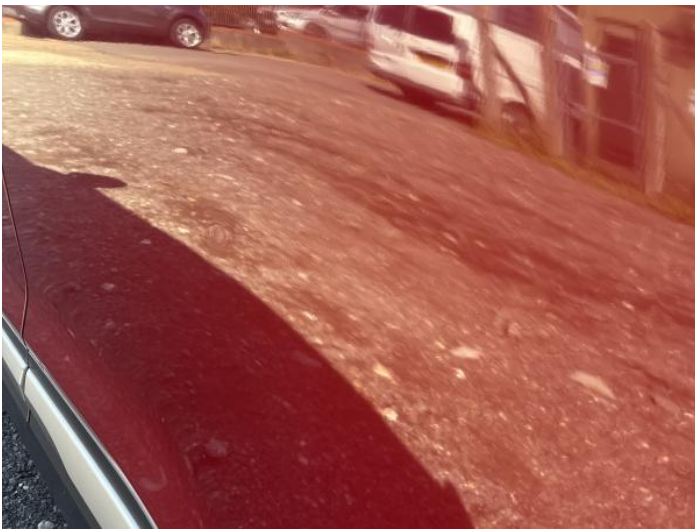
11: Door nsr
Dented
Between 10mm + 30mm

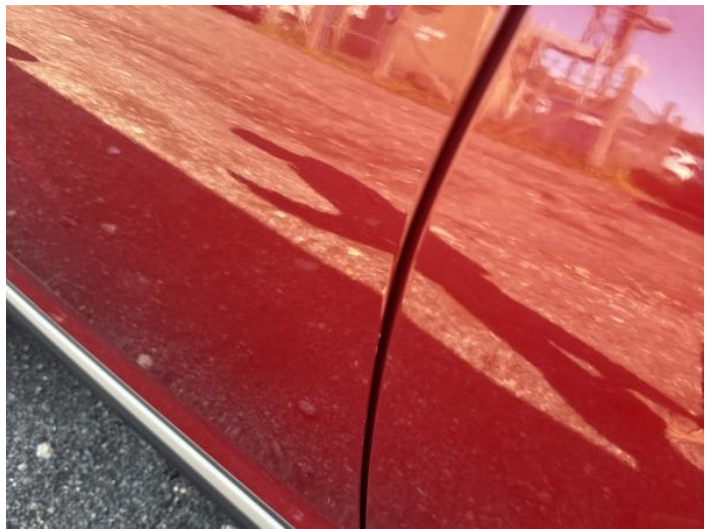
12: Door nsf
Chipped
Edge Chip

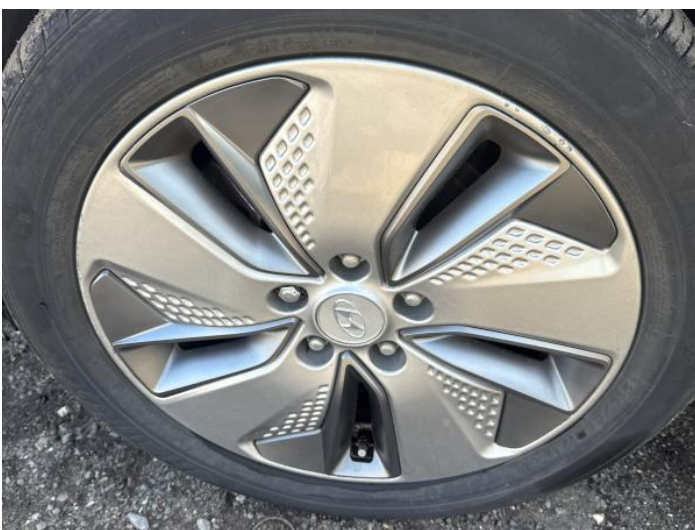
13: Wheel nsf
Scratched
Over 50mm

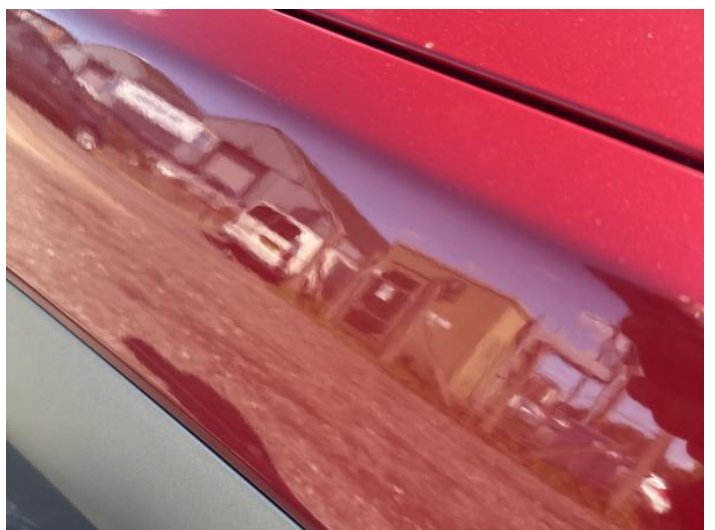
14: Wing nsf
Chipped
1 To 5

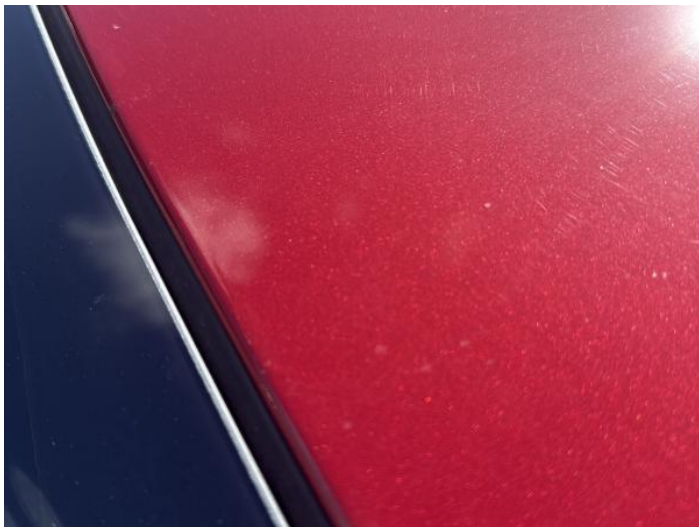
15: Roof
Chipped
Edge Chip
