# VEHICLE INSPECTION REPORT

**SV62WHH**

## Audi A1 1.4 TFSI S Line 5dr S Tronic

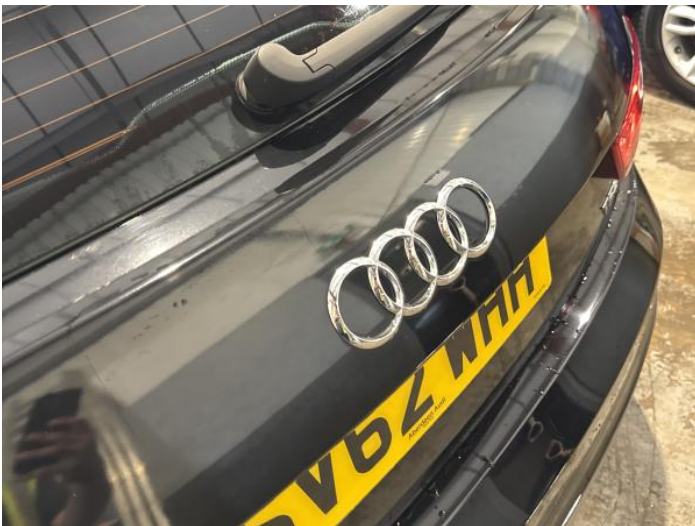
1: Boot Lid  
Poor Previous Repair  
Poor Paint

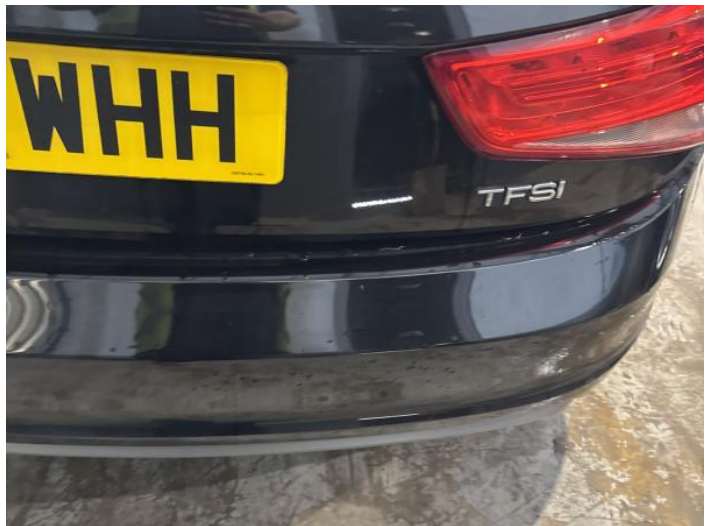
2: Bumper Rear  
Poor Previous Repair  
Poor Paint

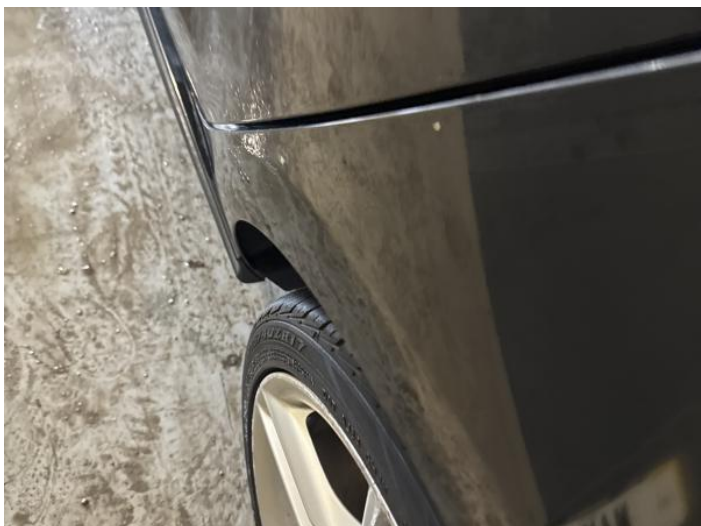
3: Qtr Panel nsf  
Dented  
Over 2 UpTo 10mm

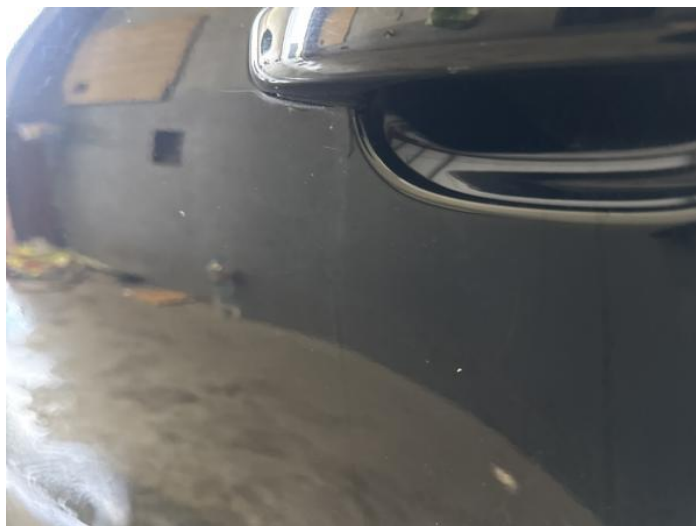
4: Door nsf  
Chipped  
1 To 5

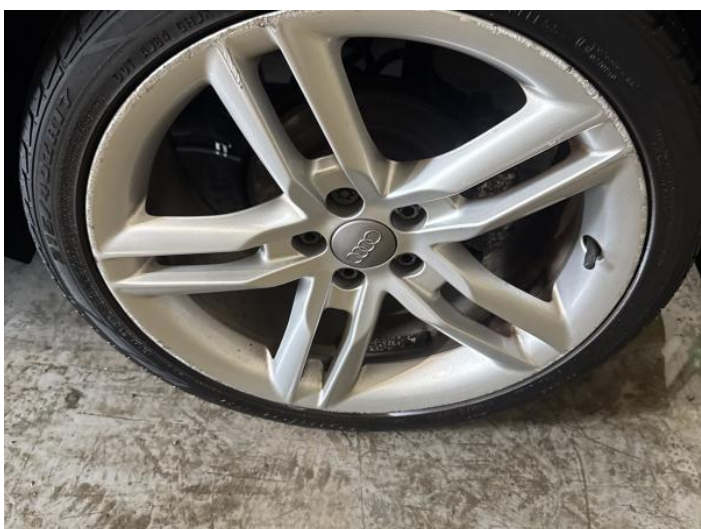
5: Wheel nsf  
Scratched  
Over 50mm

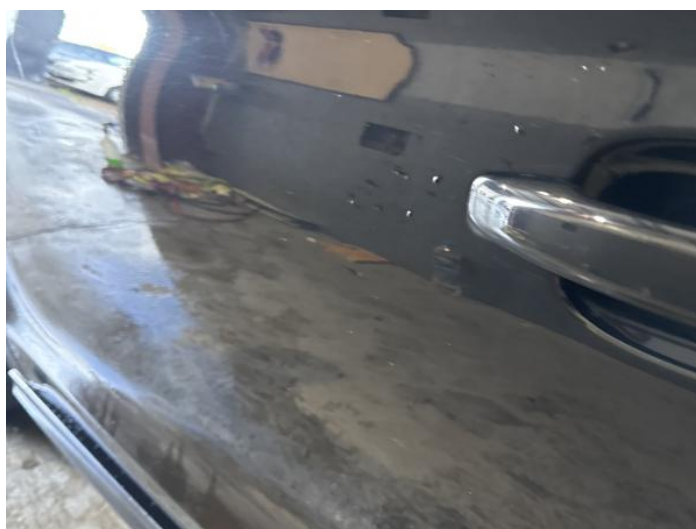
6: Door nsf  
Poor Previous Repair  
Poor Paint

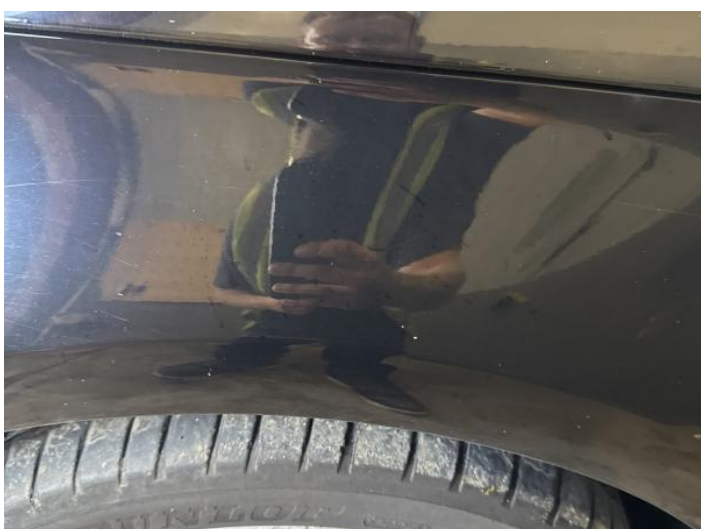
7: Wing nsf  
Chipped  
1 To 5

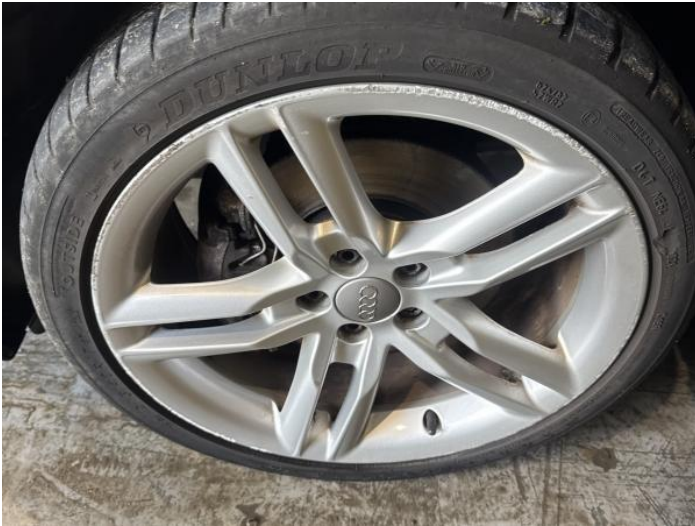
9: Wheel nsf  
Scratched  
Over 50mm

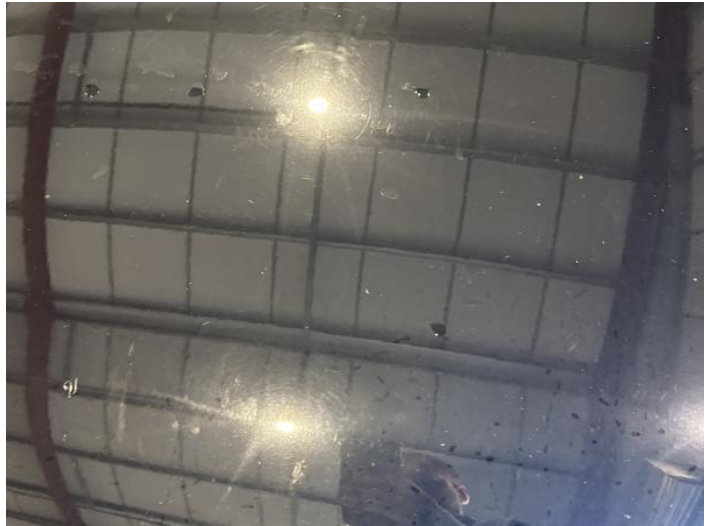
10: Bonnet  
Poor Previous Repair  
Poor Paint

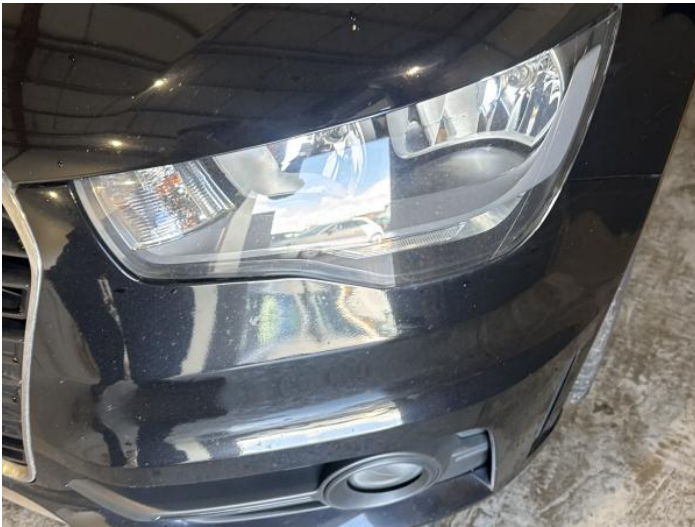
11: Bumper Front  
Poor Previous Repair  
Poor Paint

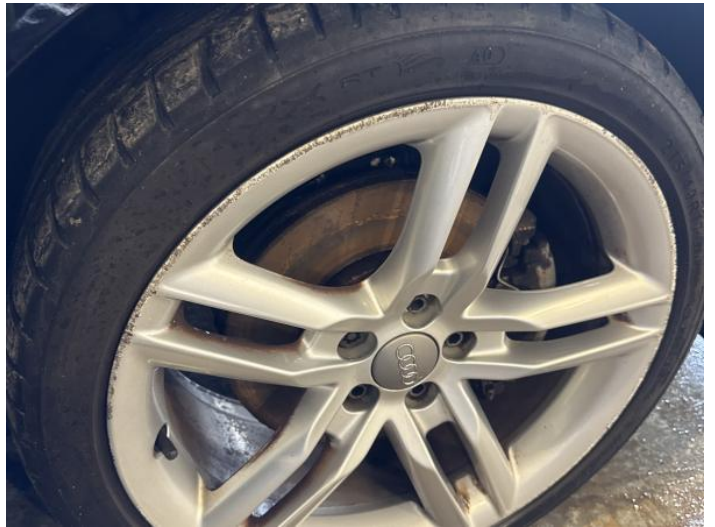
12: Wheel osf  
Scratched  
Over 50mm

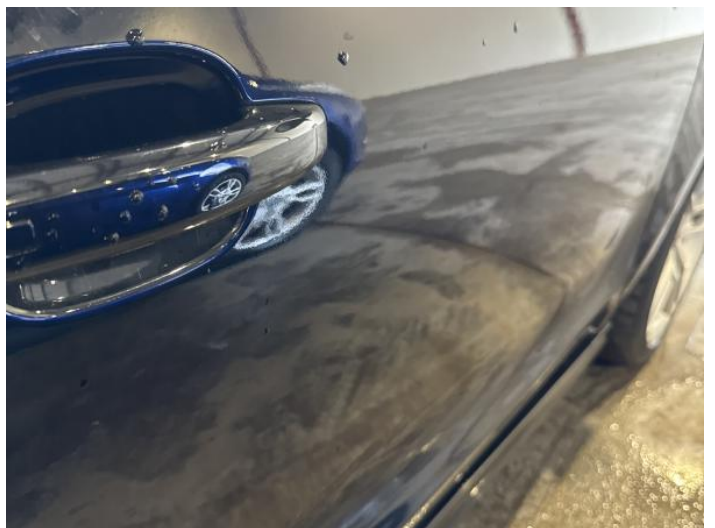
14: Door osf  
Dented  
Over 2 UpTo 10mm

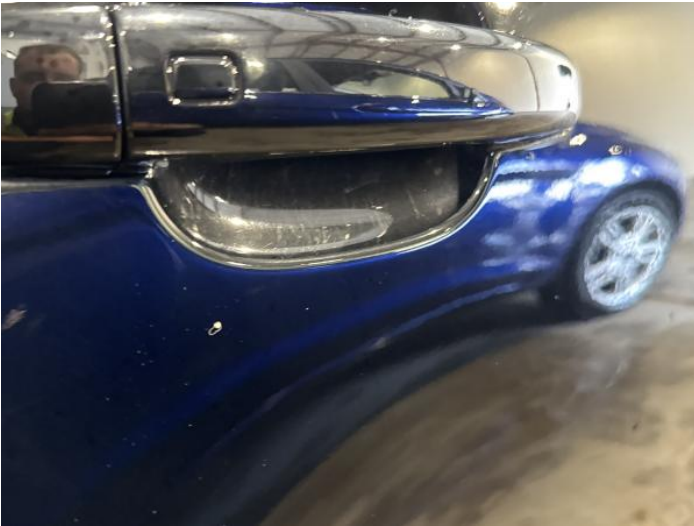
15: Door osr  
Chipped  
1 To 5

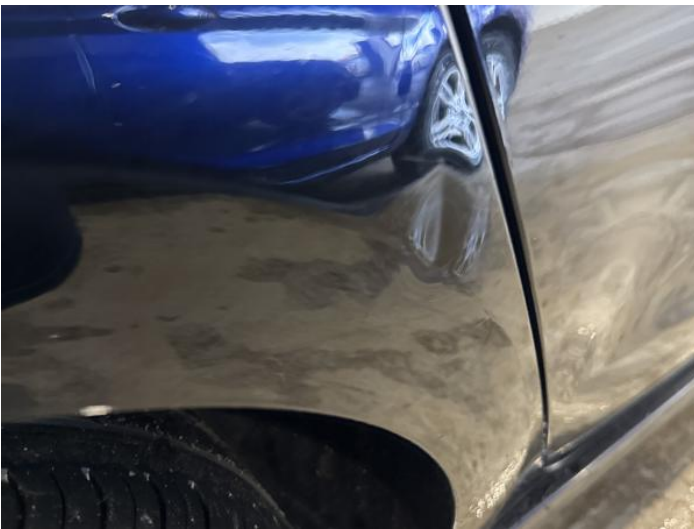
17: Qtr Panel osr  
Dented  
Between 10mm + 30mm

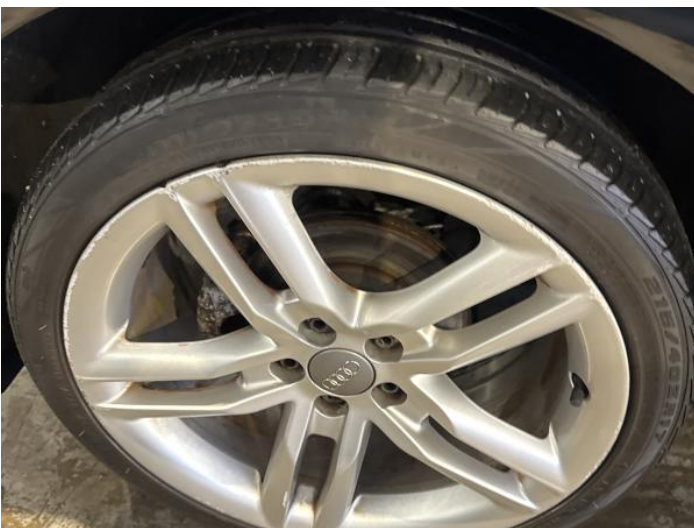
19: Wheel osf  
Scratched  
Over 50mm

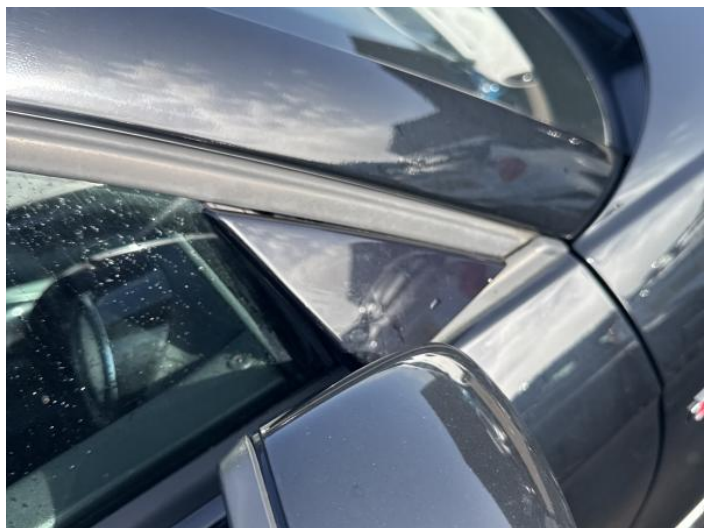
20: Door Mirror Assy osf  
Broken  
Replace
