VEHICLE INSPECTION REPORT

GU64GDJ

Mini Hatchback 1.5 Cooper 3dr

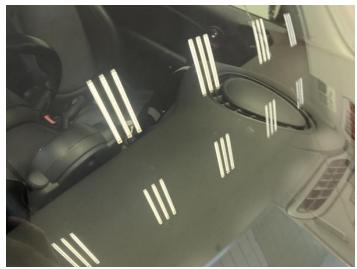
1: Screen Front Chipped UpTo 10mm

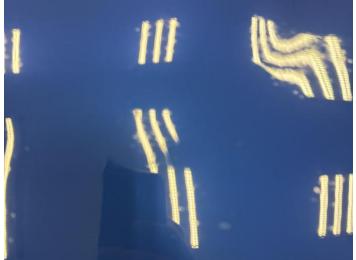
2: Bonnet Chipped 1 To 5

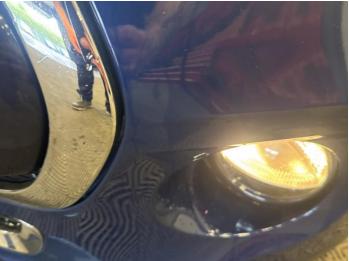
3: Bumper Front Chipped 1 To 5

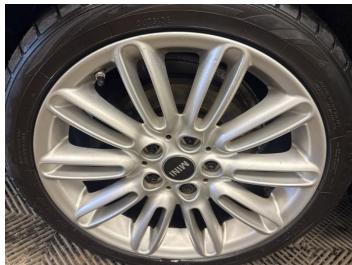
4: Wheel nsf Scratched Over 50mm

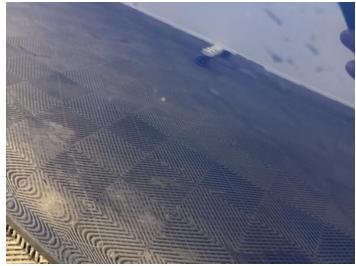
5: Door nsf Chipped 1 To 5

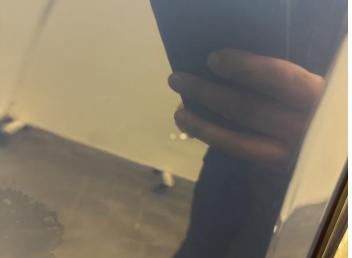
6: Qtr Panel nsr Chipped 1 To 5

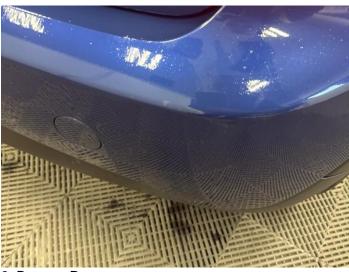
8: Bumper Rear Chipped Multiple Chips

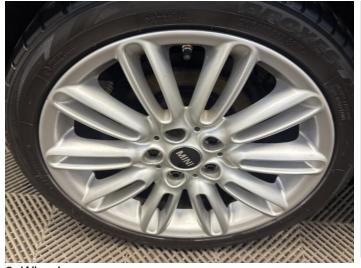
9: Wheel osr Corroded Light
