VEHICLE INSPECTION REPORT

GU68XSX

Hyundai IX20 1.6 SE Nav 5dr

nama
 GRADE
3

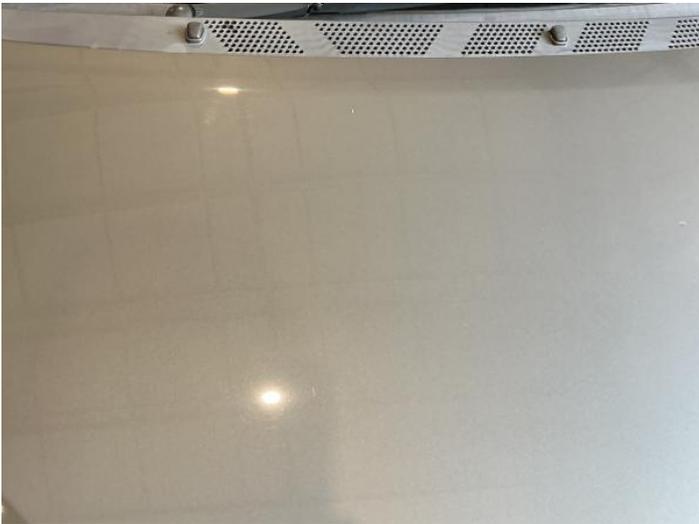
1: Bonnet
Chipped
1 To 5

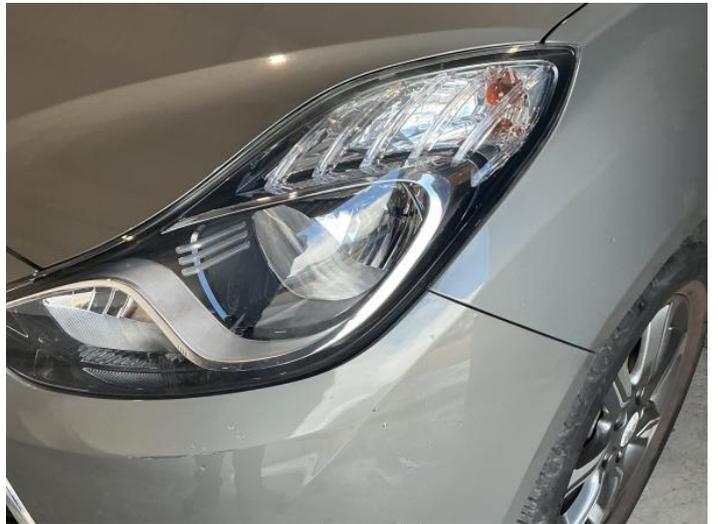
2: Bumper Front
Scratched
25 to 100mm Thru Paint

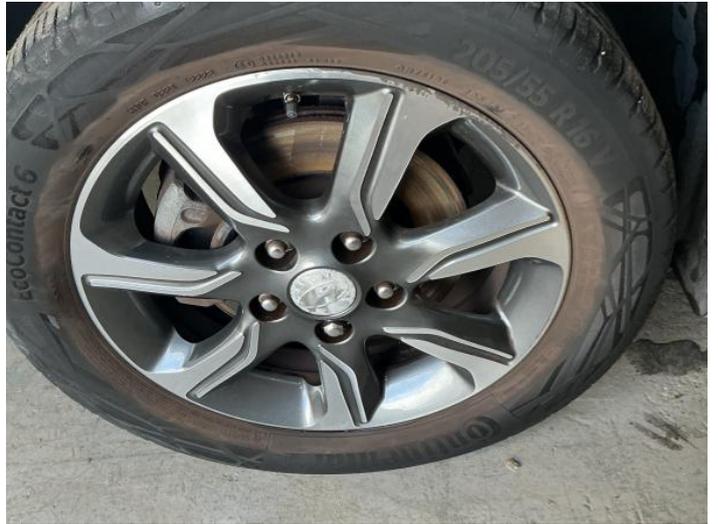
4: Wheel nsf
Scratched
Over 50mm

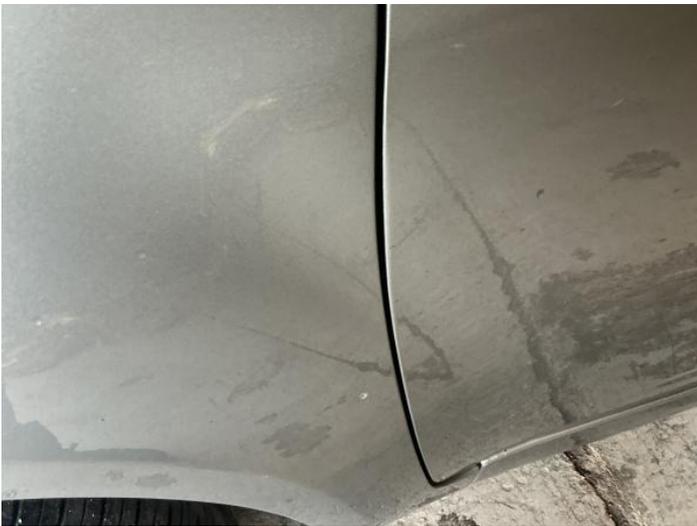
5: Wing nsf
Dented
Over 2 UpTo 10mm

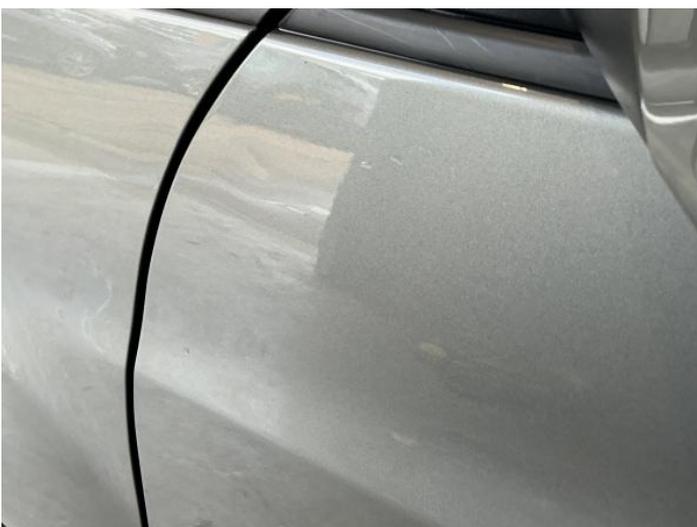
7: Door nsf
Dented
Between 10mm + 30mm

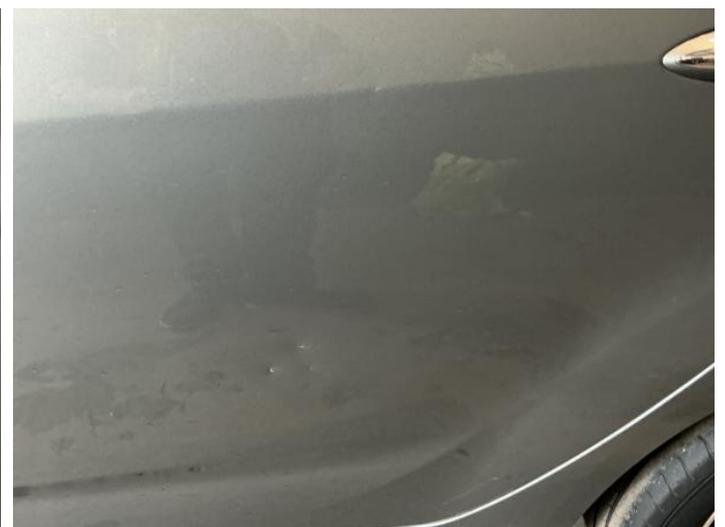
8: Door nsr
Dented
With Paint Damage

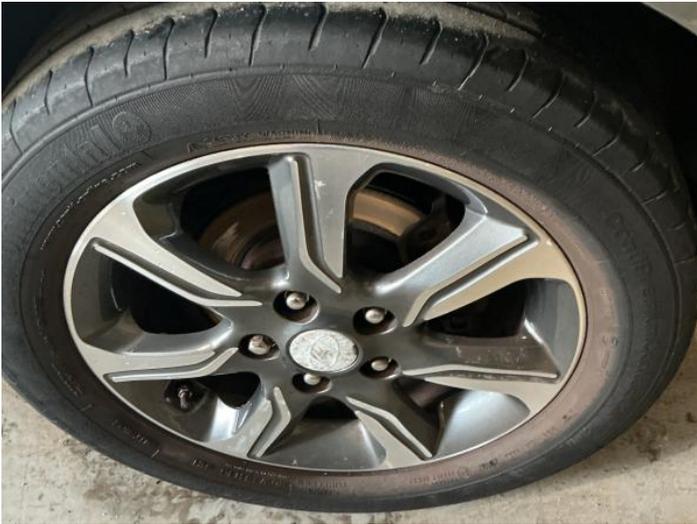
9: Wheel nsr
Scratched
Over 50mm

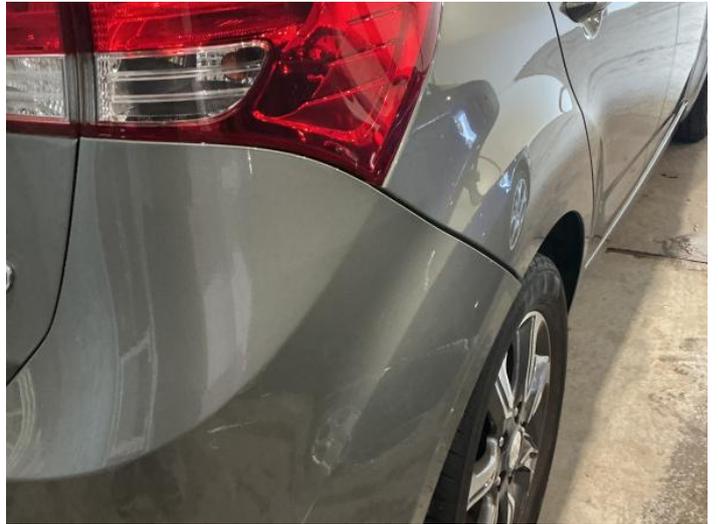
10: Bumper Rear
Scratched
Over 100mm Thru Paint

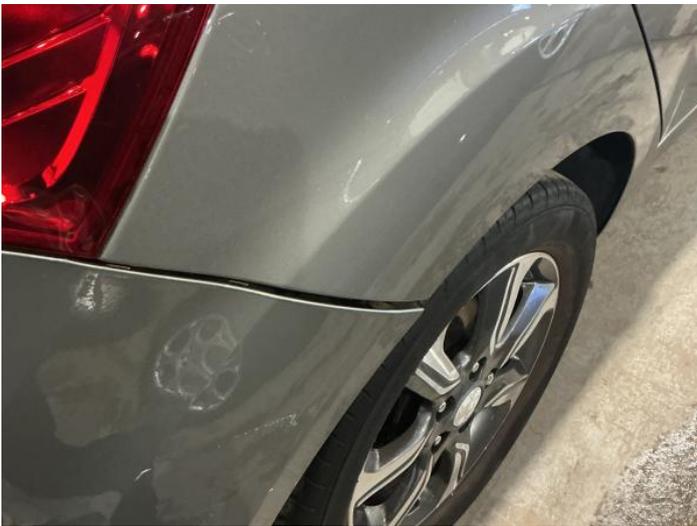
11: Bumper Rear
Insecure
Action Required

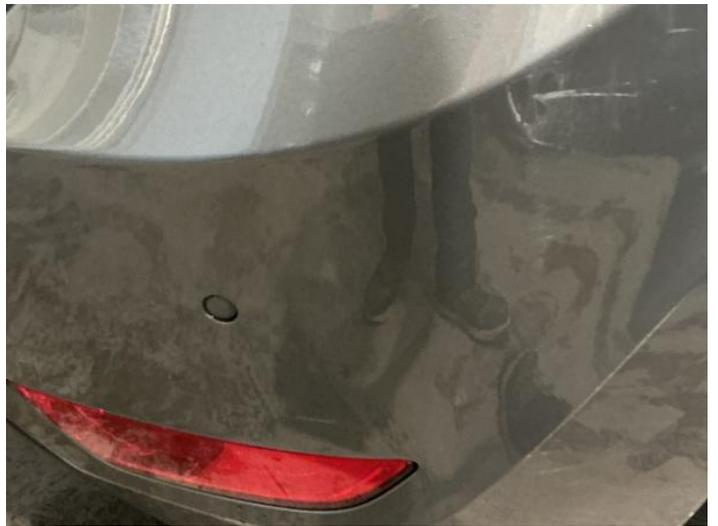
12: Parking Sensor Rear
Broken
Replace

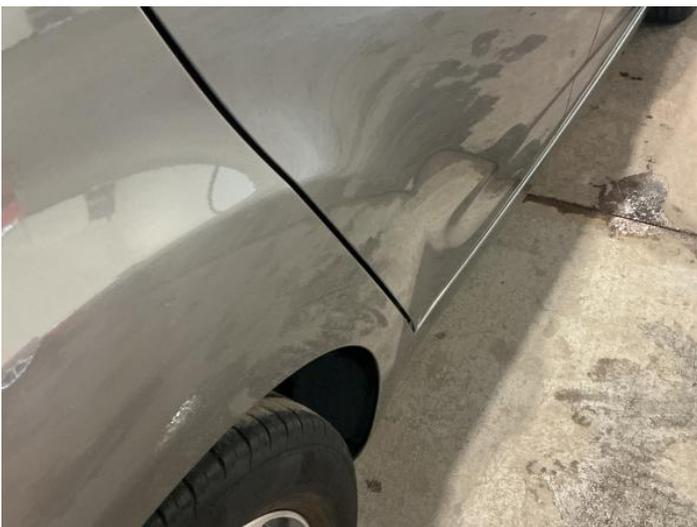
13: Qtr Panel osr
Dented
2 Or Less UpTo 10mm

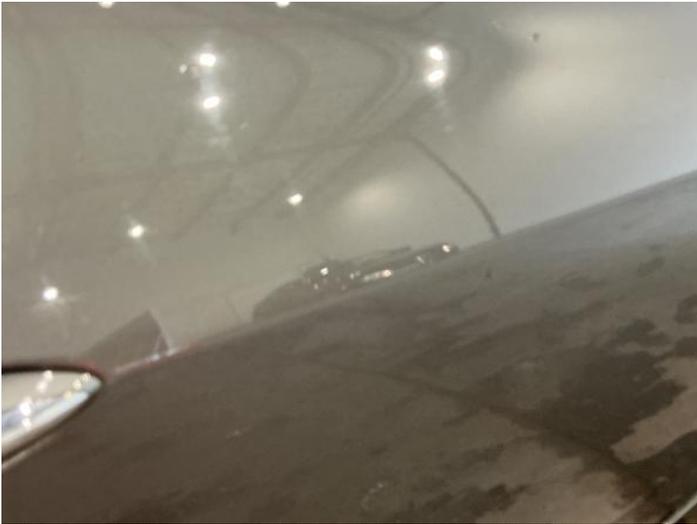
15: Door osr
Dented
Over 2 UpTo 10mm

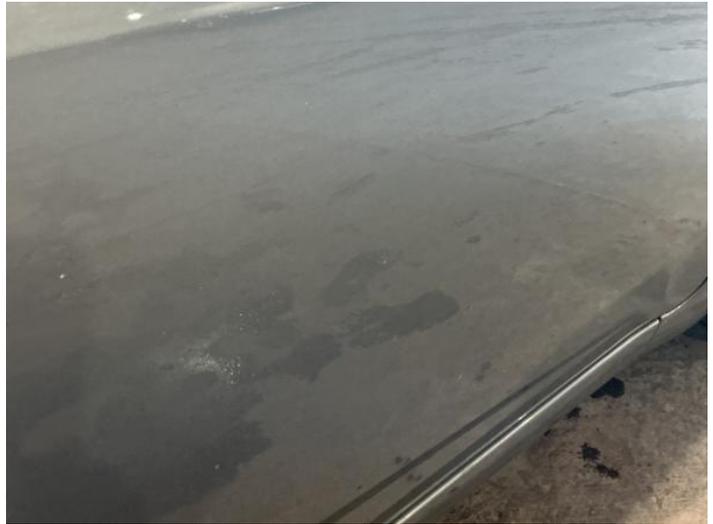
16: Door osf
Chipped
1 To 5

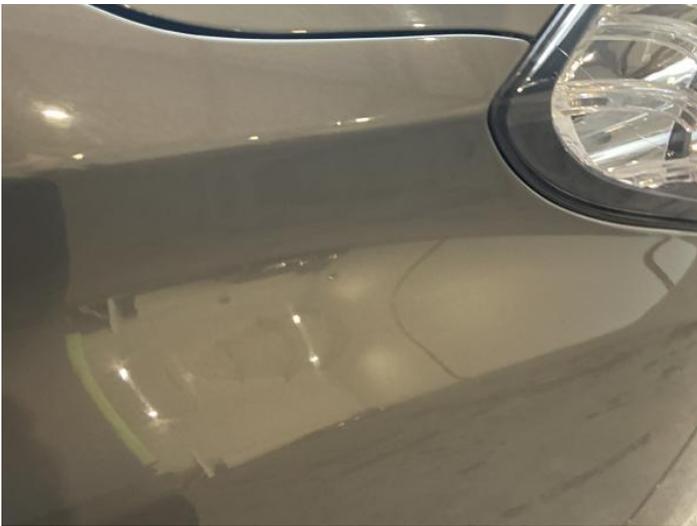
17: Wing osf
Chipped
1 To 5

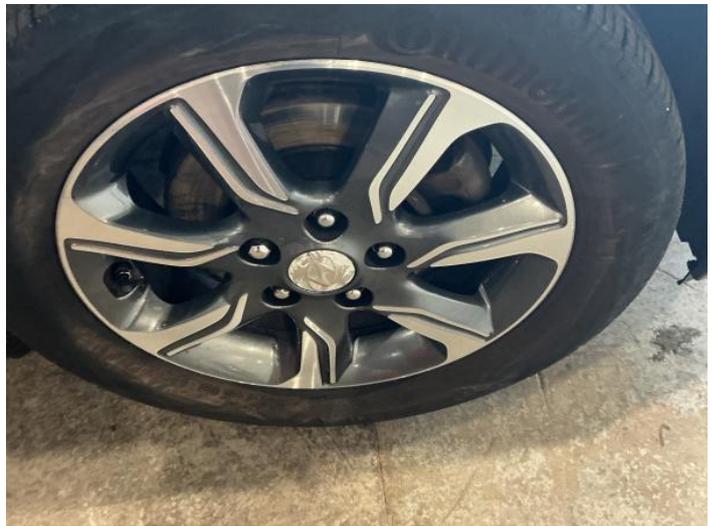
18: Wheel osf
Scratched
Over 50mm
