VEHICLE INSPECTION REPORT

GV15LRA

Nissan Micra 1.2 Acenta 5dr CVT

nama
GRADE
5

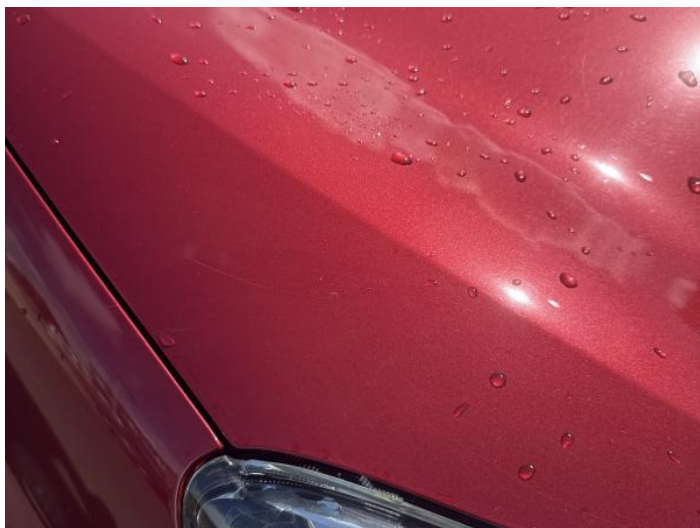
1: Bonnet
Scratched
Over 25mm Thru Paint

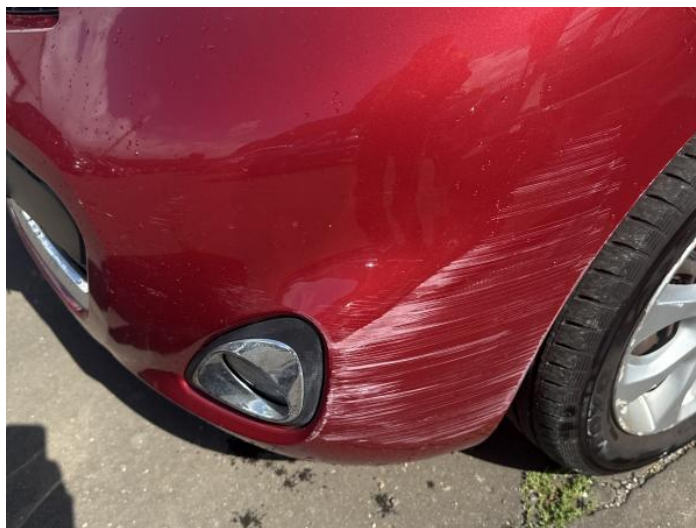
2: Bumper Front
Scratched
Over 100mm Thru Paint

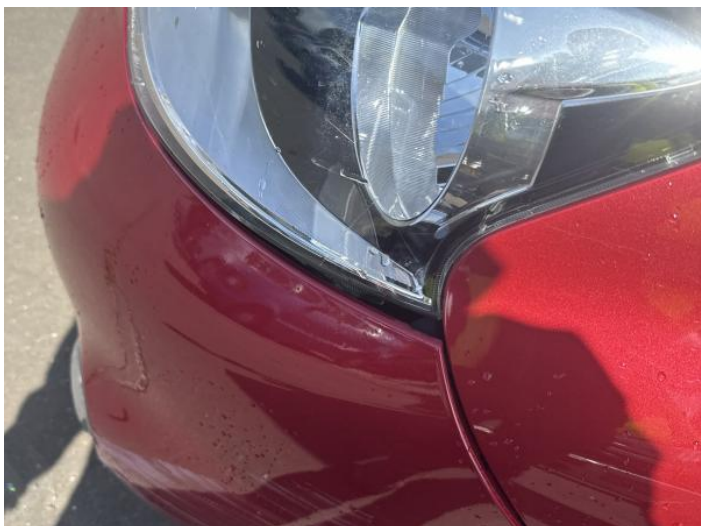
3: Bumper Front
Insecure
Action Required

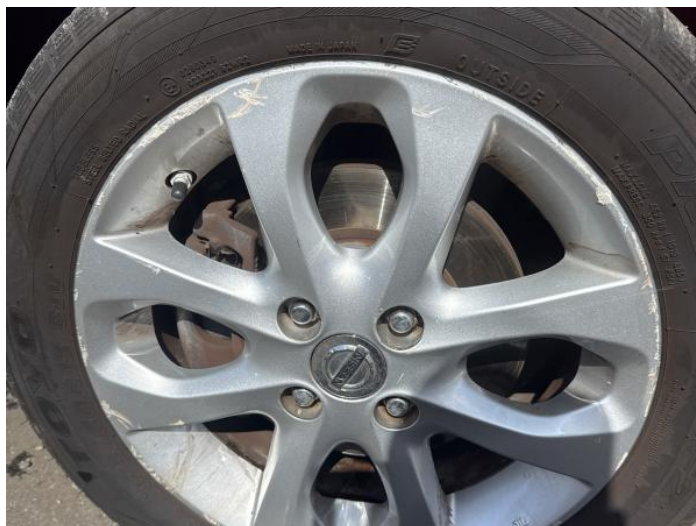
4: Wheel nsf
Scratched
Over 50mm

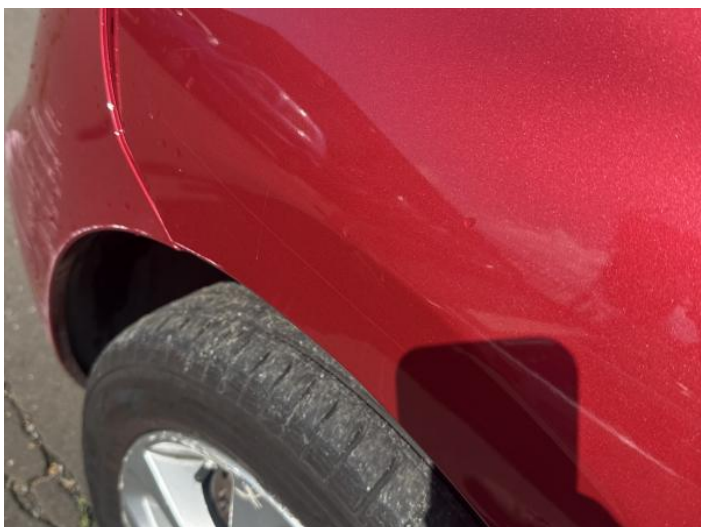
5: Wing nsf
Scratched
Over 25mm Thru Paint

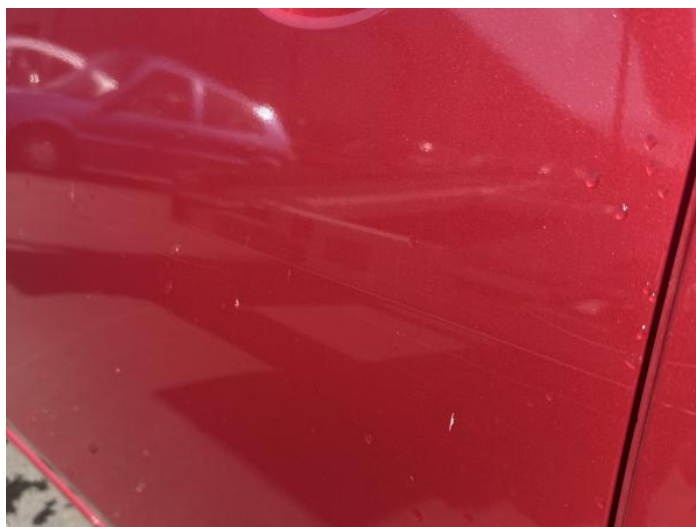
6: Door nsf
Scratched
Over 25mm Thru Paint

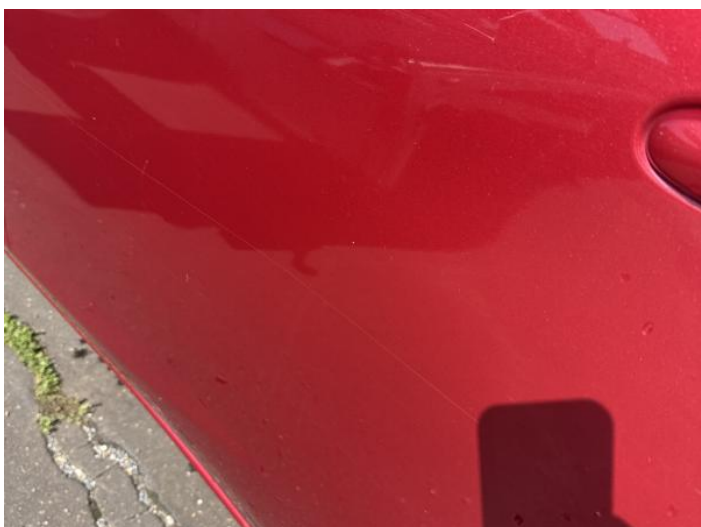
7: Door nsr
Dented
With Paint Damage

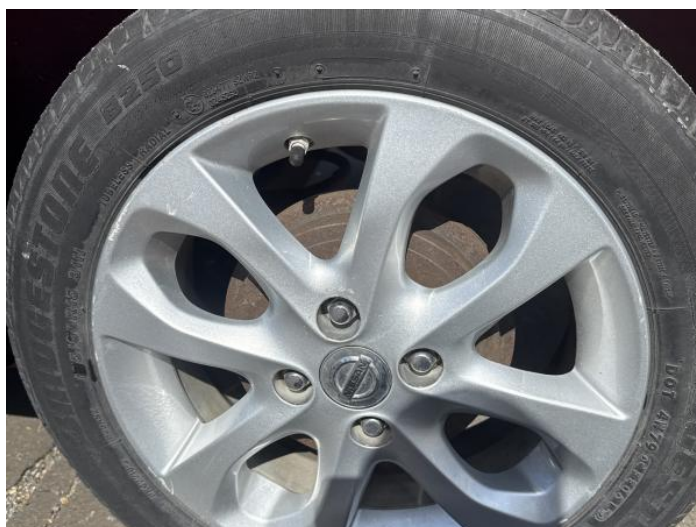
8: Wheel nsr
Scratched
Over 50mm

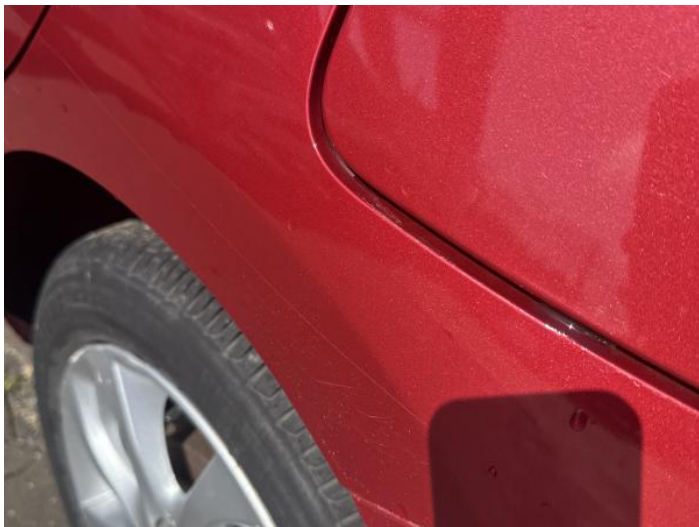
9: Qtr Panel nsr
Scratched
Over 25mm Thru Paint

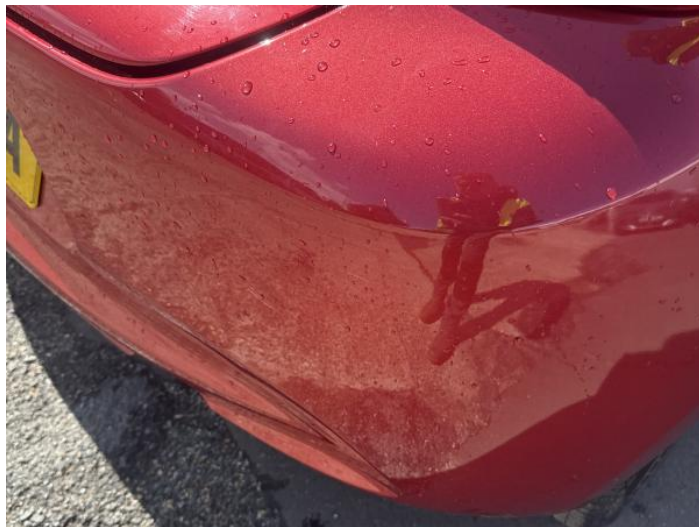
10: Bumper Rear
Scratched
Over 100mm Thru Paint

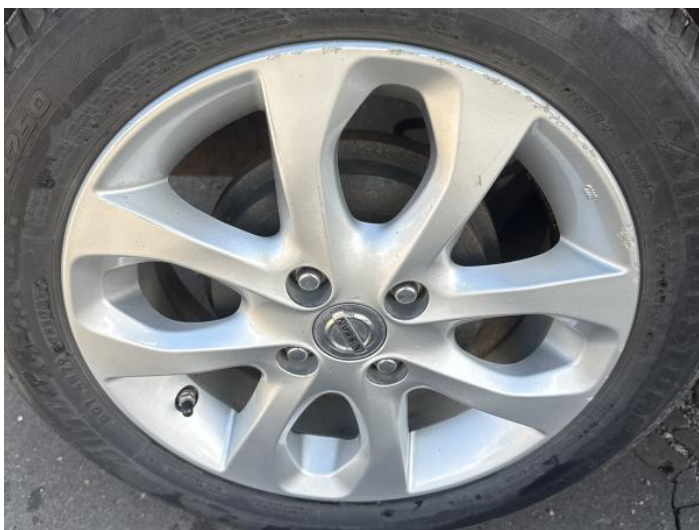
11: Wheel osr
Scratched
Over 50mm

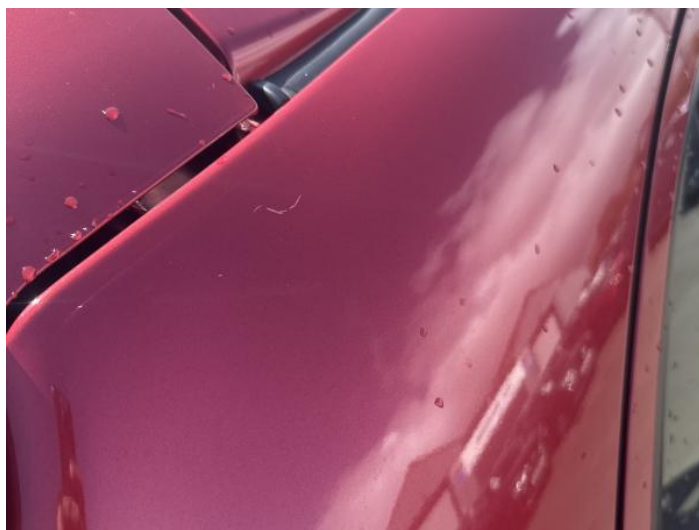
12: Qtr Panel osr
Scratched
UpTo 25mm Thru Paint

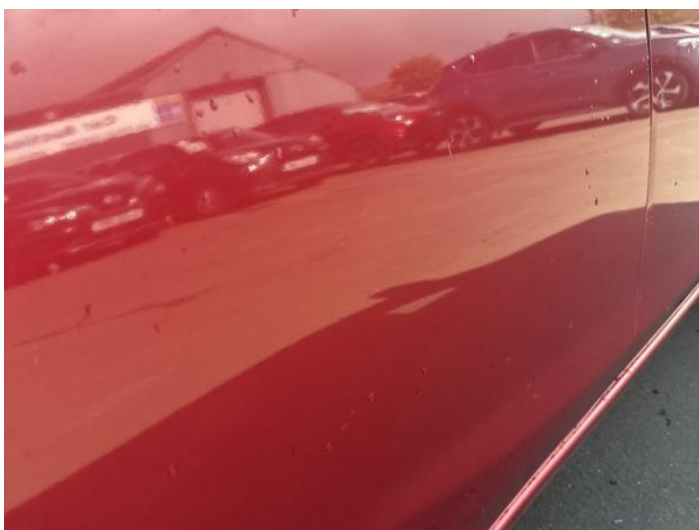
13: Door osr
Scratched
Over 25mm Thru Paint

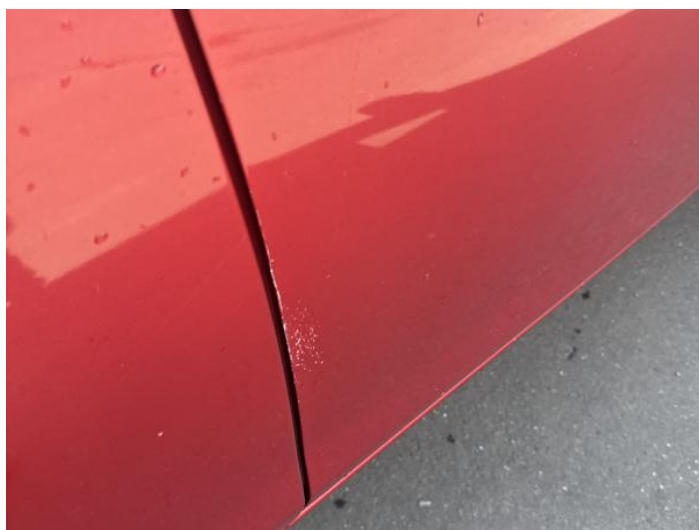
14: Door osf
Scratched
Over 25mm Thru Paint

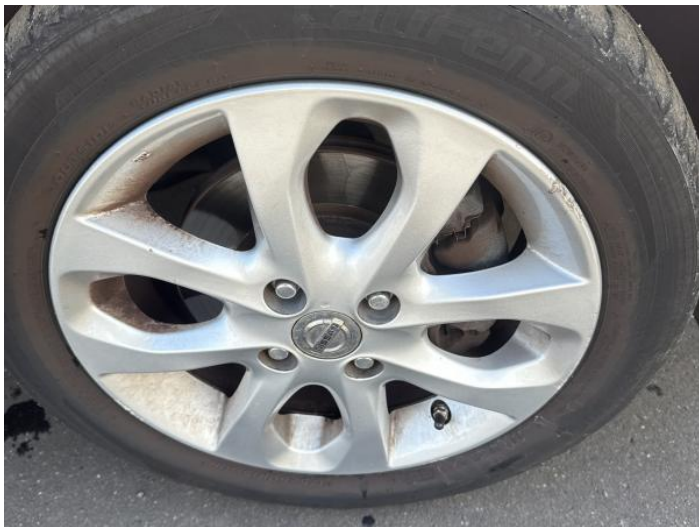
15: Wheel osf
Scratched
Over 50mm

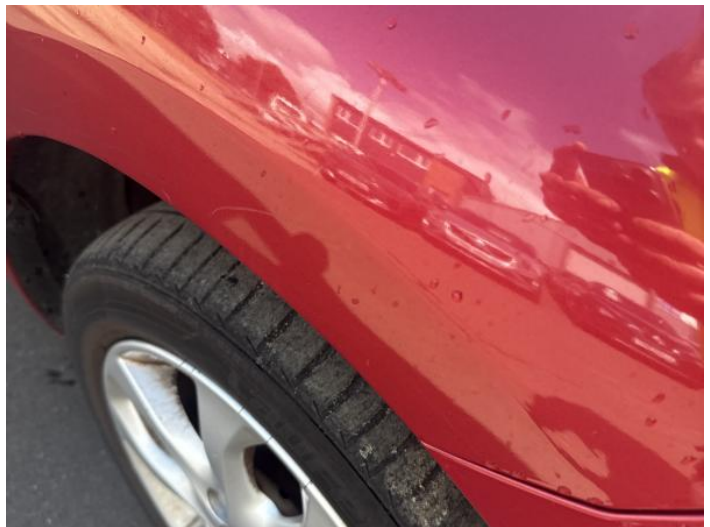
16: Wing osf
Scratched
Over 25mm Thru Paint

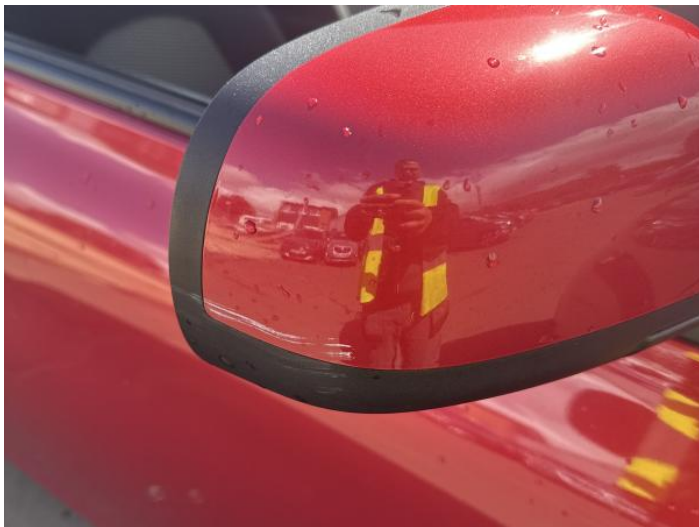
17: Door Mirror Assy osf
Scratched (Painted)
Over 25mm Thru Paint

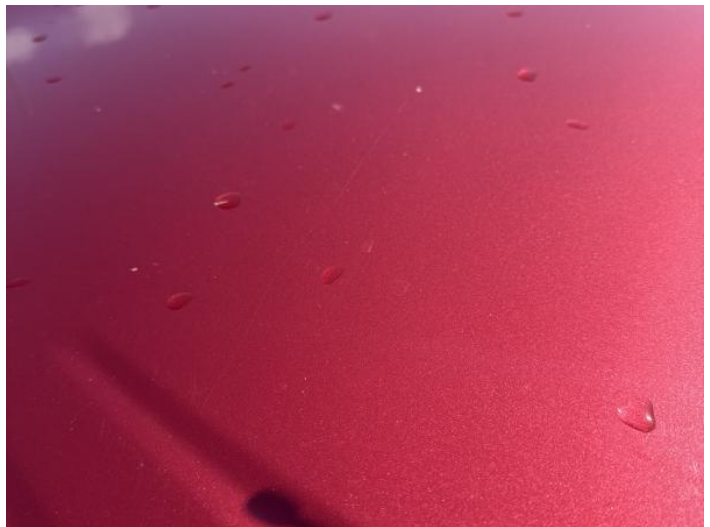
18: Roof
Scratched
Over 25mm Thru Paint
